Peterborough Utilities Commission Water Utility Asset Management Plan

ASSET MANAGEMENT INSPECTION REPORT

Low Lift Pumps –
Peterborough Water
Treatment Plant
1230 Water Street North,
Peterborough ON

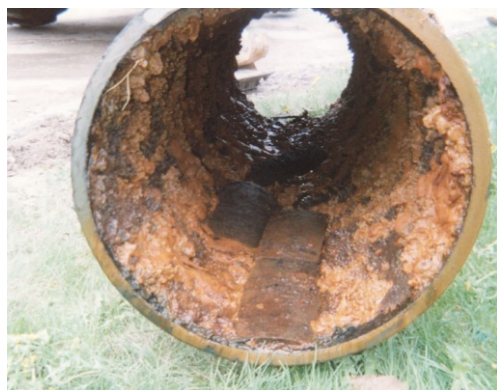
Figure 10: Cast Iron Pipe Tuberculation

When pressure and flow fluctuate, particulates due to corrosion can break away from the wall of the pipe and into the flow, causing discolouration and other aesthetic issues within the water. Internal corrosion also significantly contributes to pipe failure. Cement Mortar Lining (CML) of iron watermain provides a smooth inner lining which eliminates the roughness, reduces future corrosion potential, and helps minimize associated water quality issues.

Additional benefits of CML are improved hydraulic properties of the pipes (better water flow, lower pumping costs), and internal pipe corrosion is inhibited by the CML which adds considerably to the life of the pipe. Depending on the age, condition, and physical properties of the pipe, CML can add an estimated 30 years to the useful life of watermain. An important advantage of the CML program is improved customer satisfaction and fewer subsequent customer complaints.

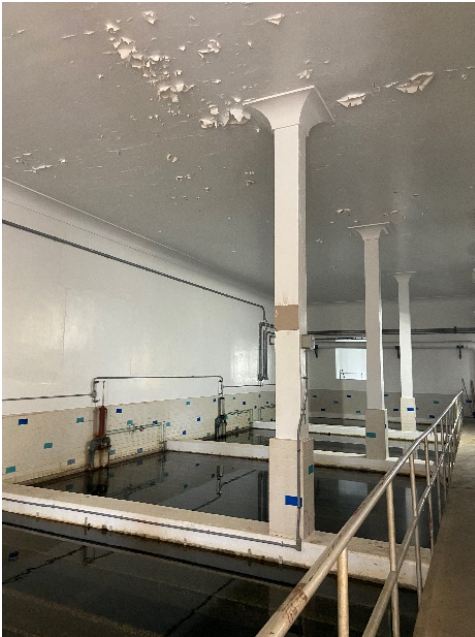
Figure 11: Filter Beds #3, 4, 5 and 6, ceiling in need of repairs

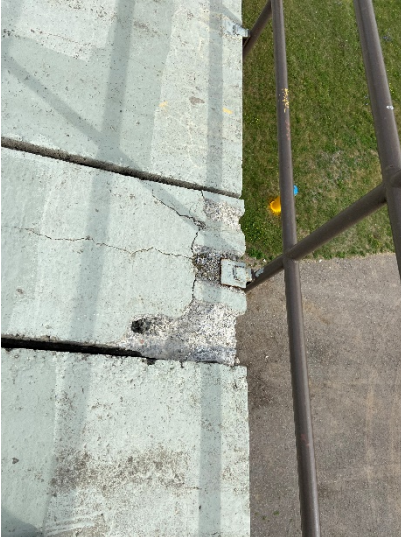
Figure 1: Cracks in concrete roof

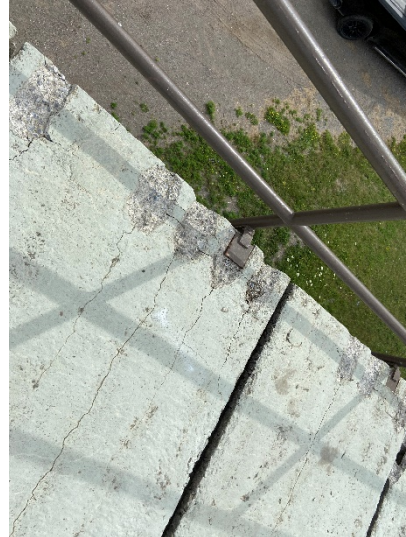
Figure 2: Cracks in concrete roof

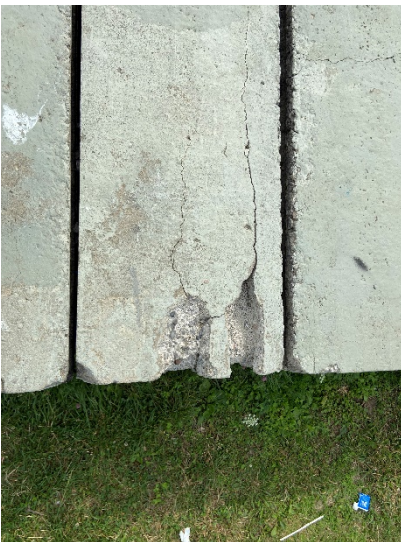
Figure 3: Cracks in concrete roof

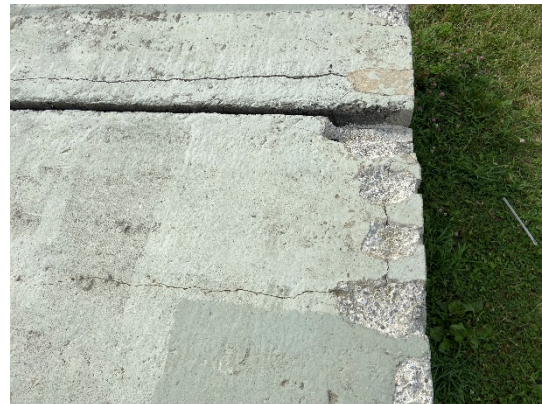
Figure 4: Cracks in concrete roof

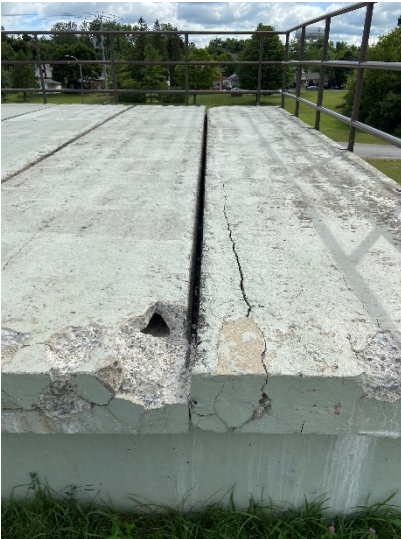
Figure 5: Cracks in concrete roof
