Peterborough Utilities Commission Water Utility Asset Management Plan

ASSET MANAGEMENT INSPECTION REPORT

Low Lift Pumps –
Peterborough Water
Treatment Plant
1230 Water Street North,
Peterborough ON

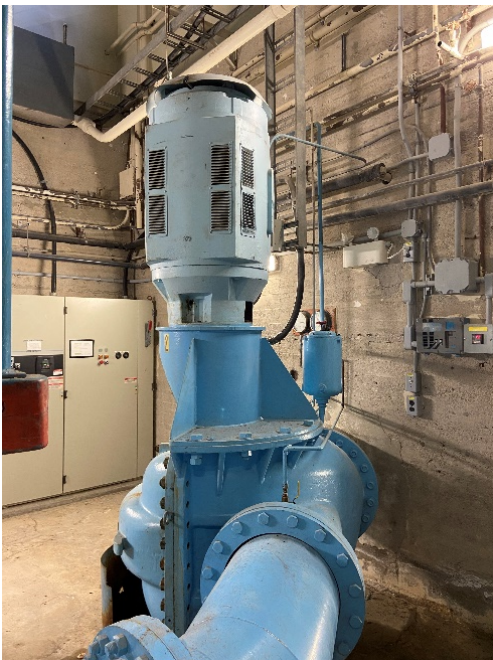
Figure 3: Electric Low Lift Pump #2

The pumps, check valves and piping are in fair condition.

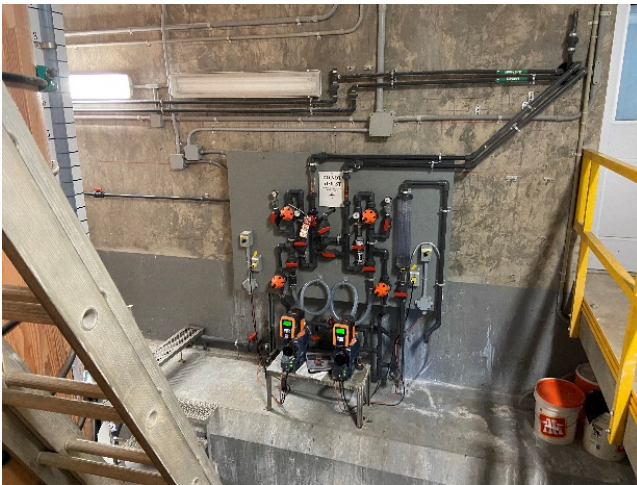
Figure 5: Sodium Hydroxide Pumps, Piping and Controls

The chemical pumps are in good condition. Standby pumps are available for redundancy purposes. Duty and standby mixers are both in good condition.

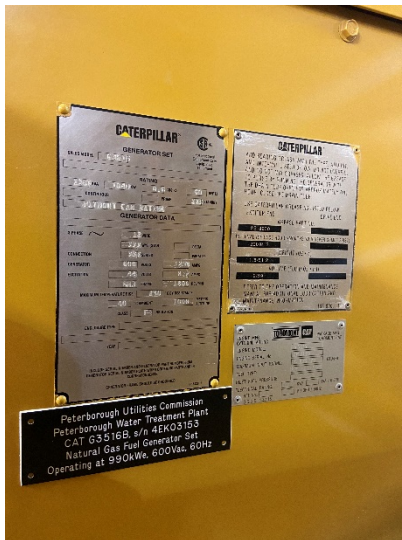
Figure 6: Generator Controls

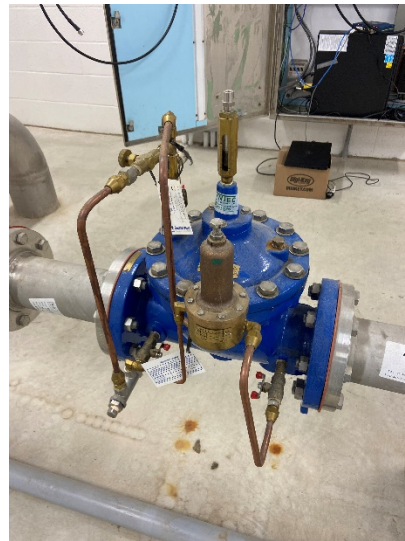
Figure 15: Discharge gate valve on pressure reducing valve

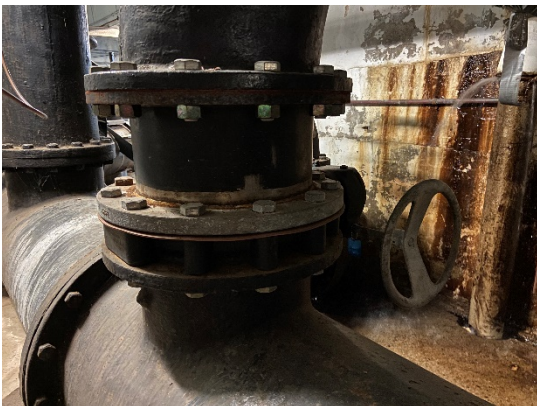
Figure 30: Disused gate valve
