Peterborough Utilities Commission Water Utility Asset Management Plan

ASSET MANAGEMENT INSPECTION REPORT

Low Lift Pumps –
Peterborough Water
Treatment Plant
1230 Water Street North,
Peterborough ON

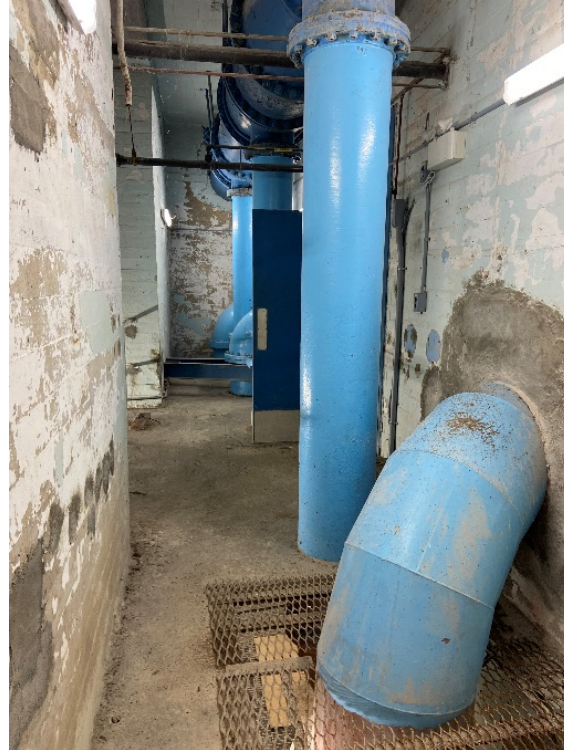
Figure 2: Intake Piping between wet well and low lift pumps

The pumps, check valves and piping are in fair condition.

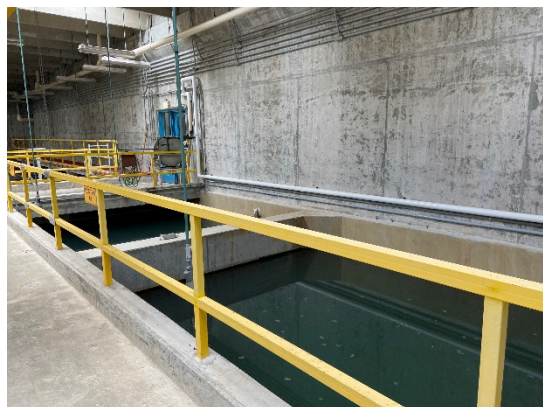
Figure 1: Floc Tank 6B(foreground) and 6C (background)

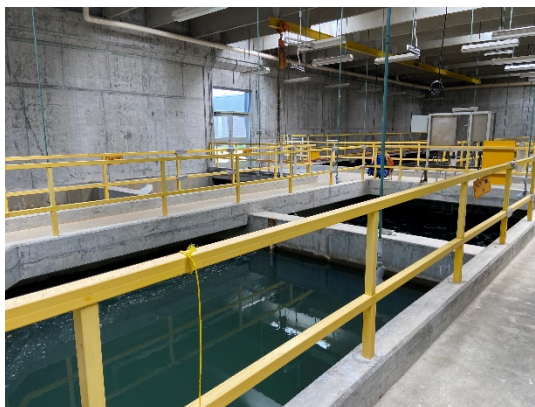
Figure 2: Floc Tank 6A(foreground) and 5C(background)

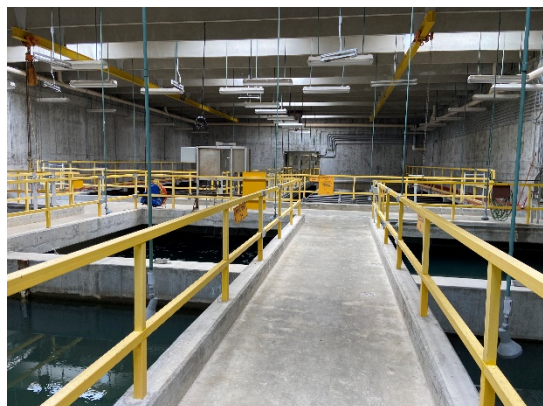
Figure 3: Floc Tanks 5/6(foreground) and Sedimentation Basins 5/6(background)

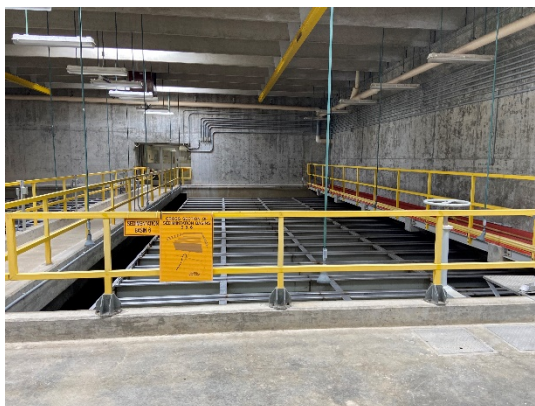
Figure 4: Sedimentation Basin 6

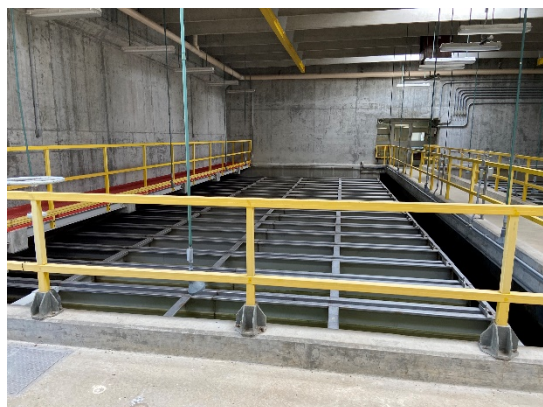
Figure 5: Sedimentation Basin 5

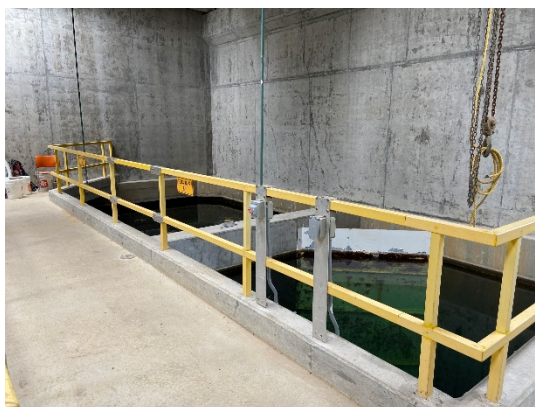
Figure 6: Floc Tanks 5B(foreground) and 5A(background)

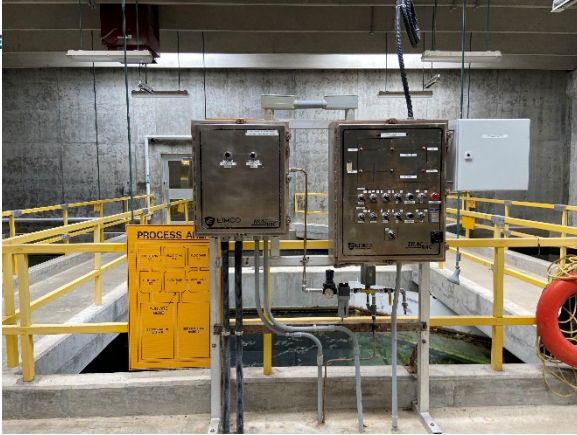
Figure 7: Sedimentation Basins 5 and 6 Controls

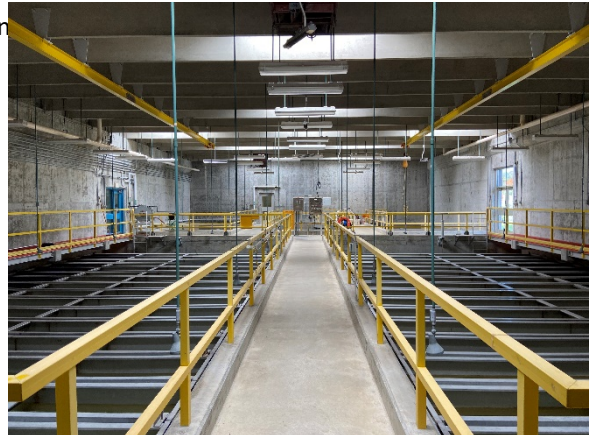
Figure 8: Sedimentation Basins 5 and 6 (foreground) and Floc Tanks 5A, 5B, 5C, 6A, 6B and 6C (background)

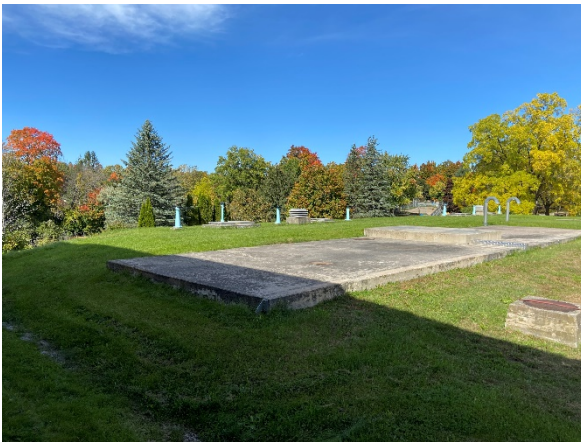
The below grade flocculation tanks and sedimentation basins were installed in 1922. A condition survey was completed in 1990. The report indicated that the top slab was showing signs of stress. The earth above the tank was removed to lessen the dead load on the tank. The addition that houses the Flocculation tanks and sedimentation basins 5 and 6 was constructed in 1997 and is in good condition. No deficiencies were identified during the inspection.

Figure 9: Below Grade Floc Tanks and Sedimentation Basins

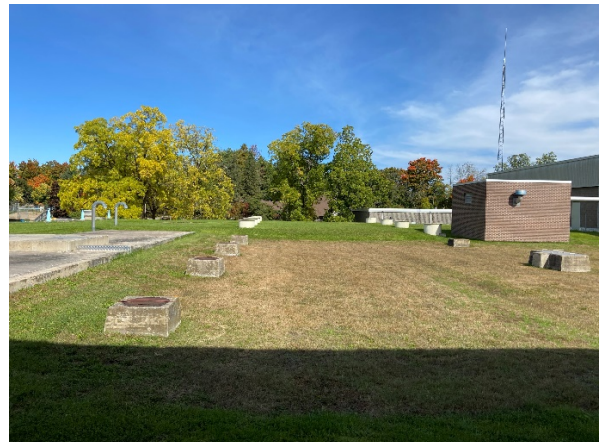
Figure 10: Below Grade Floc Tanks and Sedimentation Basins

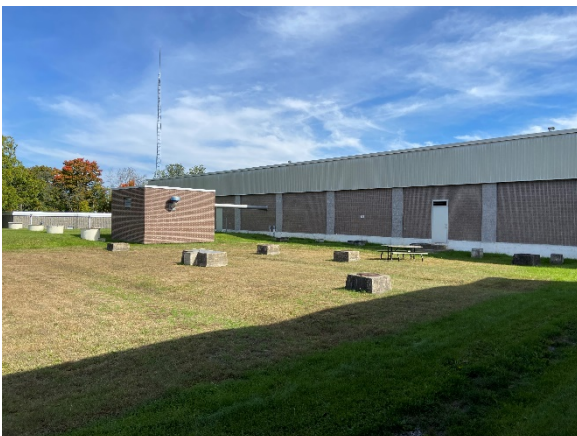
Figure 11: Below Grade Floc Tanks and Sedimentation Basins

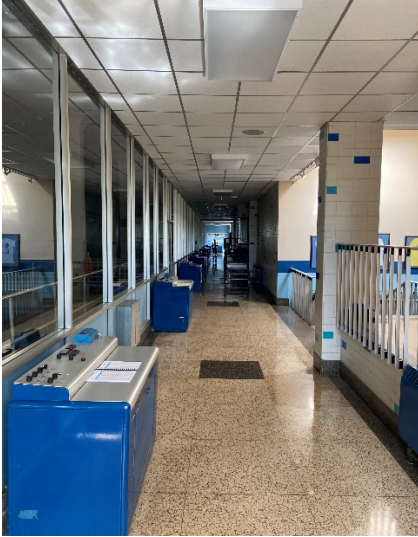
Figure 1: Filter Control Gallery looking North

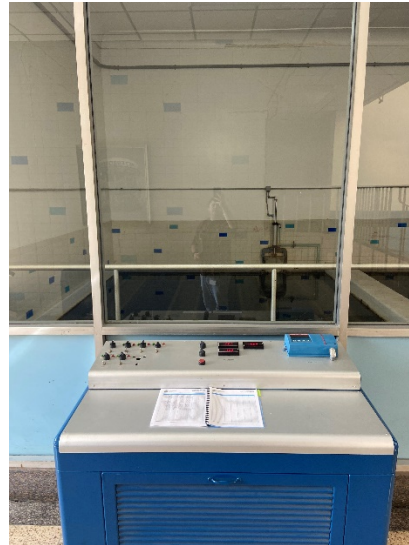
Figure 2: Filter Bed #1 and Controls

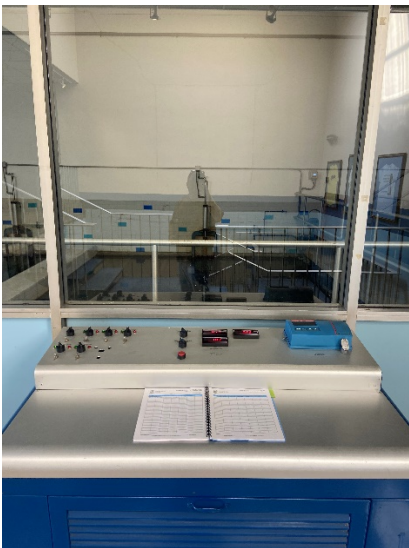
Figure 3: Filter Bed #2 and Controls

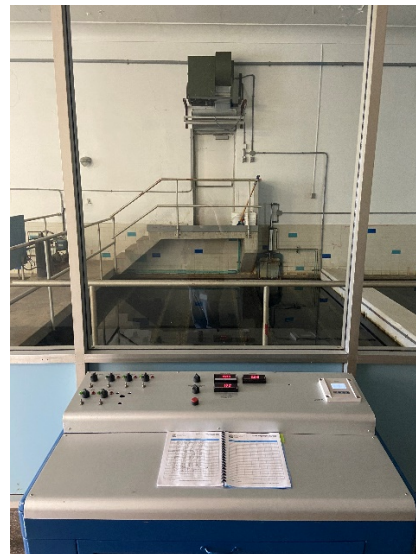
Figure 4: Filter Bed #3 and Controls

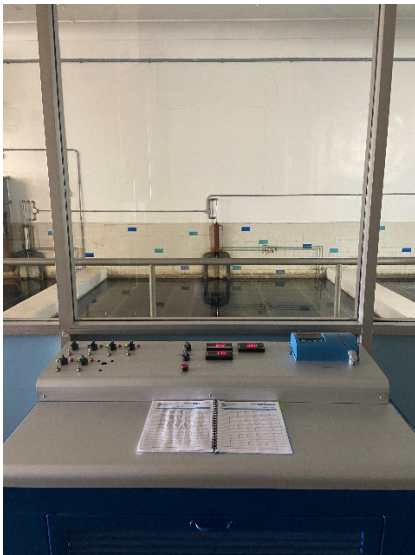
Figure 5: Filter Bed #4 and Controls

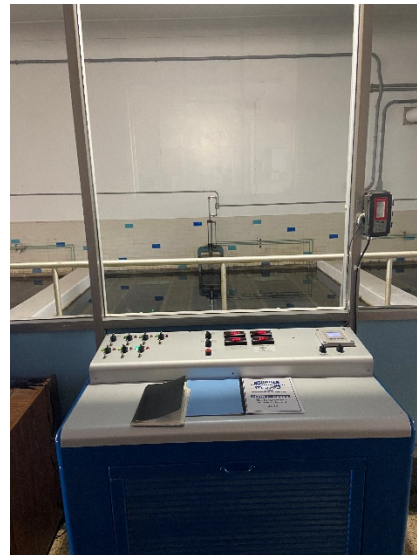
Figure 6: Filter Bed #5 and Controls

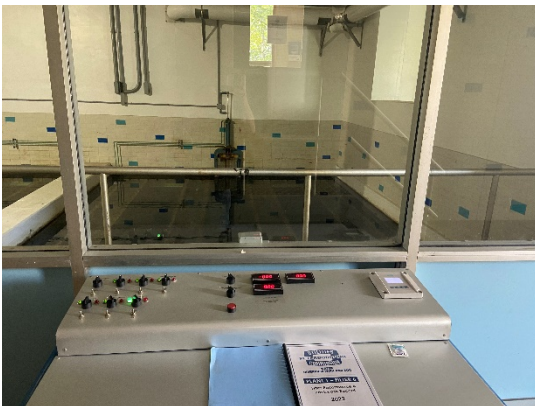
Figure 7: Filter Bed #6 and Controls

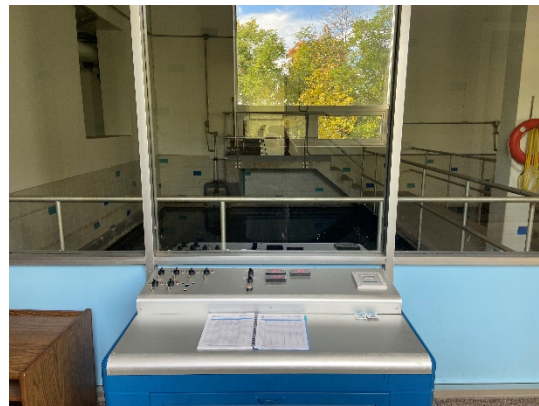
Figure 8: Filter Bed #7 and Controls

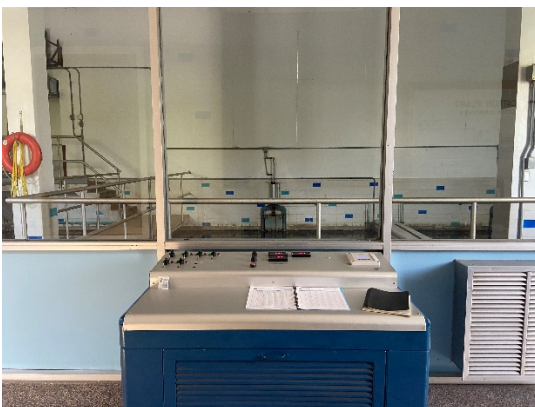
Figure 9: Filter Bed #8 and Controls

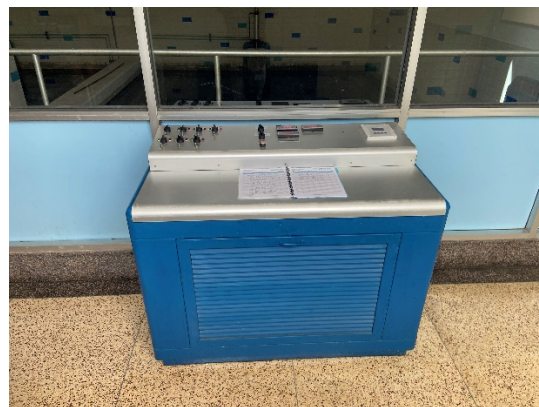
Figure 10: Filter Bed #9 and Controls

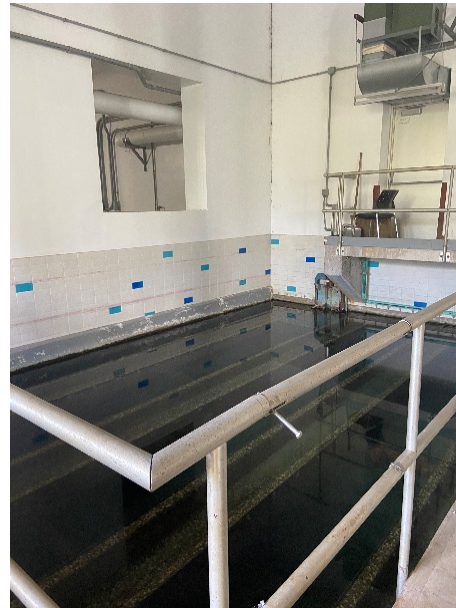
Figure 12: Filter Bed #7

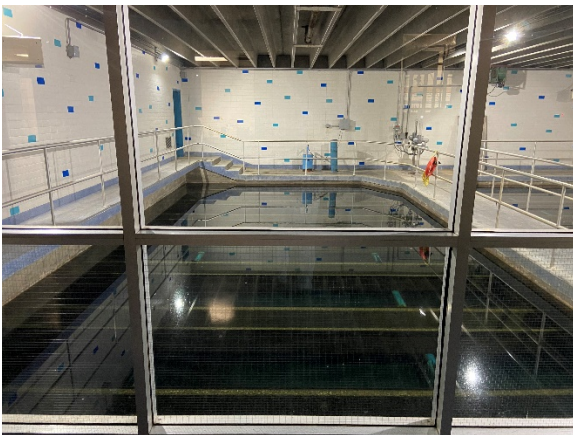
Figure 13: Filter Bed #10

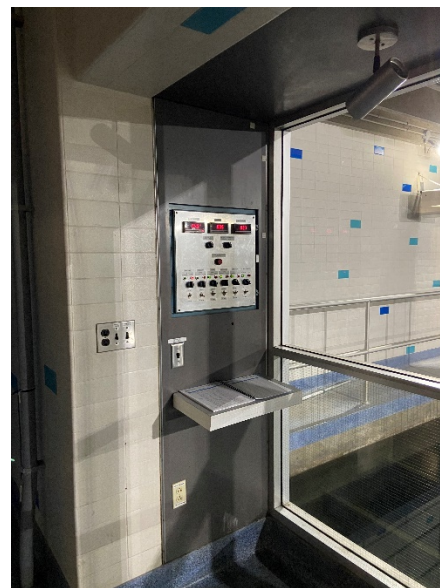
Figure 14: Filter Bed #10 Controls

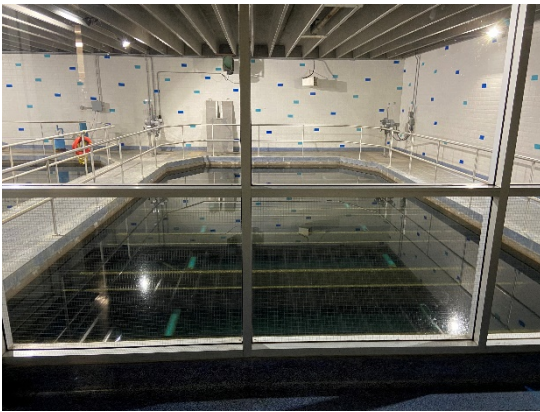
Figure 15: Filter Bed #11

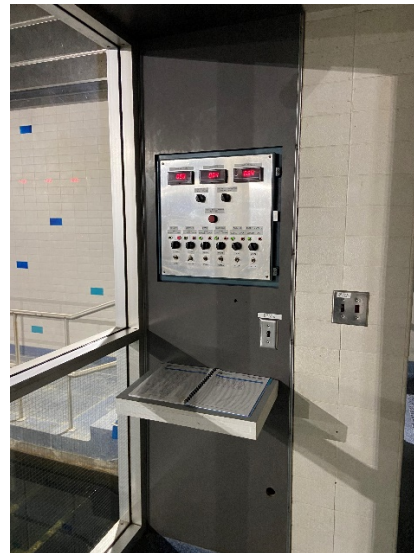
Figure 16: Filter Bed #11 Controls

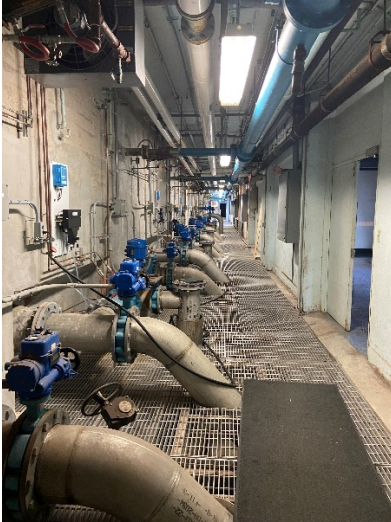
The associated piping for each filter bed is located directly beneath the filter beds, on the 1st floor of the Water Treatment Plant. There are two pipe galleries, one for each Plant. The pipe gallery for Plant #1 was constructed in 1922 and underwent a rehabilitation in 2010. The pipe gallery for Plant #2 was constructed in 1967. No concerns were identified within each pipe gallery and generally is in fair condition.

Figure 1: Plant #1 Pipe Gallery looking North

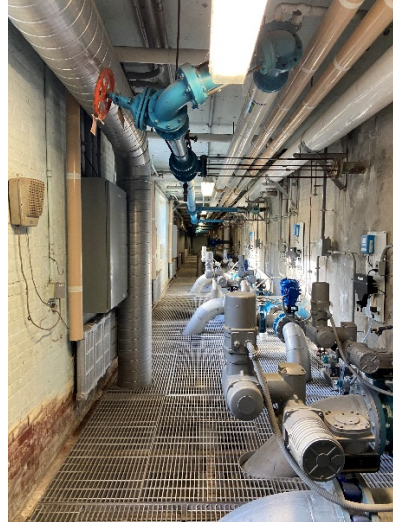
Figure 2: Plant #1 Pipe Gallery looking South

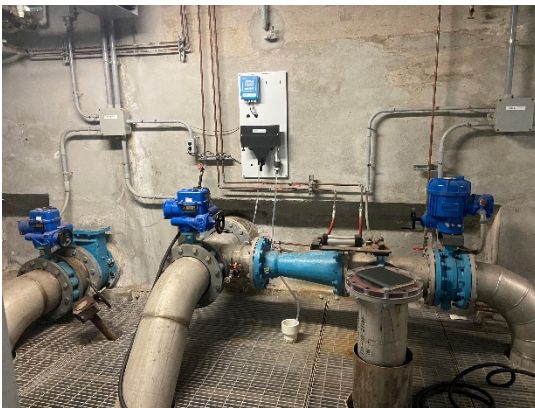
Figure 3: Filter Bed #1 Piping

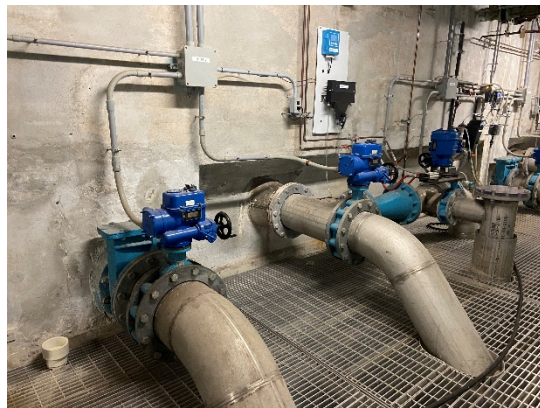
Figure 4: Filter Bed #2 Piping

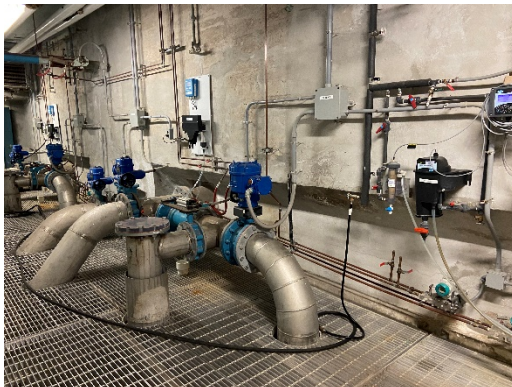
Figure 5: Filter Bed #3 Piping

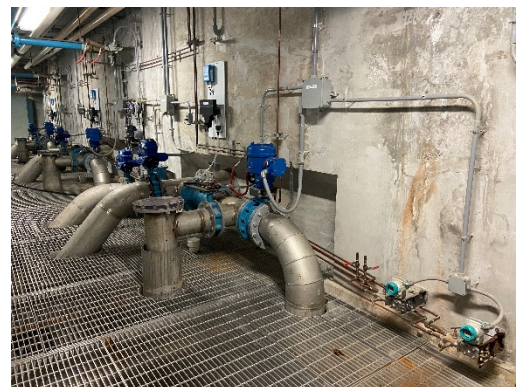
Figure 6: Filter Bed #4 Piping

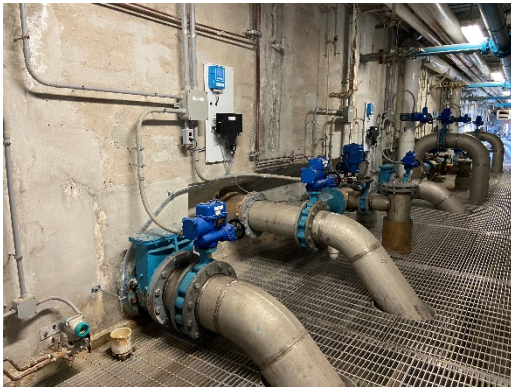
Figure 7: Filter Bed #5 Piping

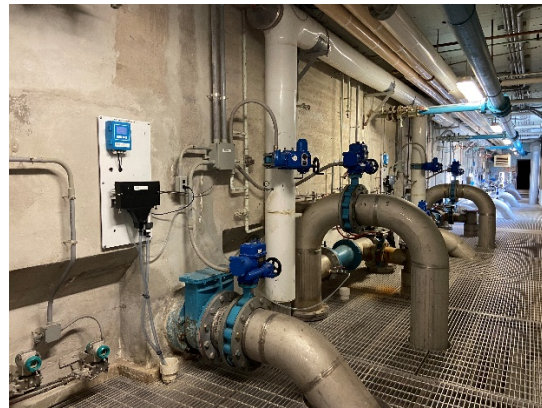
Figure 8: Filter Bed #6 Piping

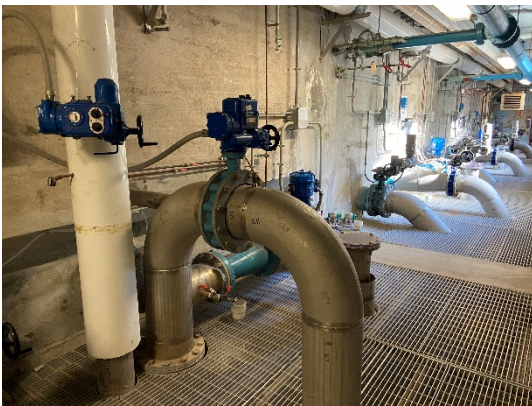
Figure 9: Filter Bed #7 Piping

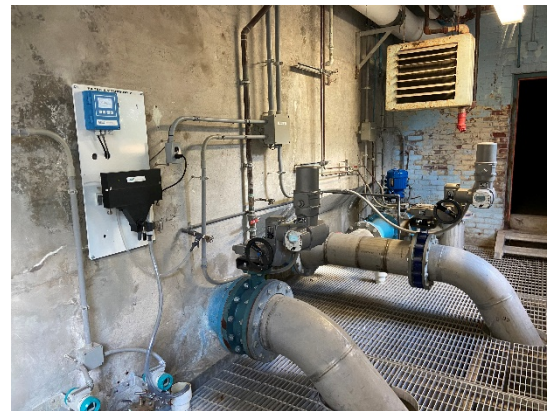
Figure 10: Filter Bed #9 Piping

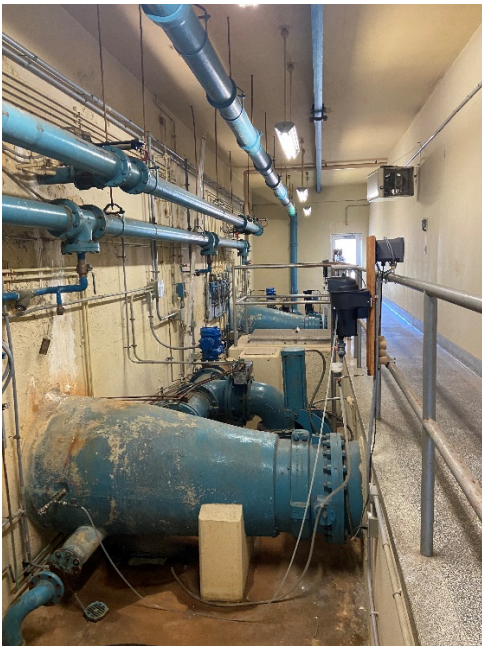
Figure 11: Plant #2 Pipe Gallery looking West

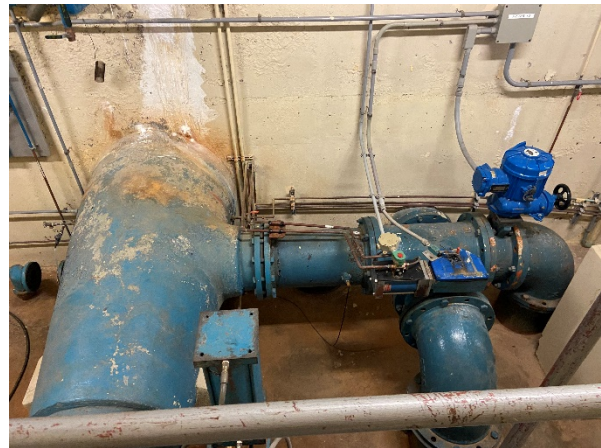
Figure 12: Filter Bed #10 Piping

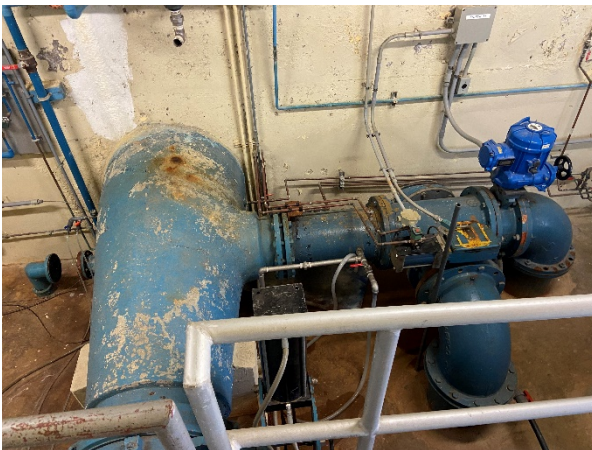
Figure 13: Filter Bed #11 Piping

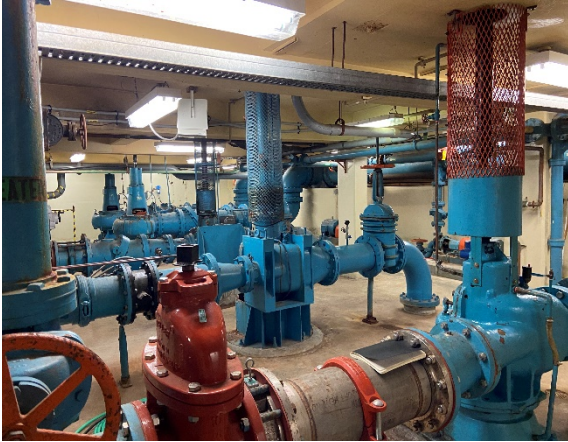
Figure 1: High Lift Pumps at Water Treatment Plant

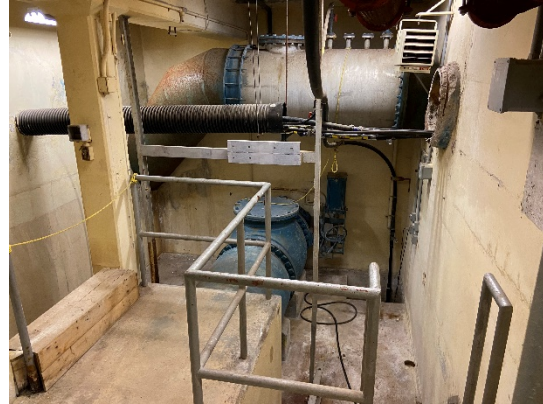
Figure 2: Chamber 'A' Backwash Piping

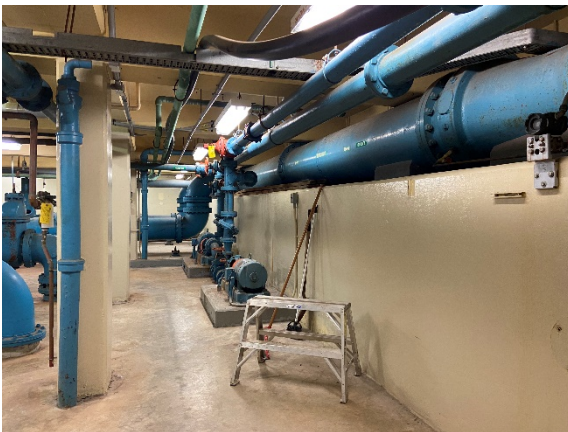
Figure 3: High Lift Pump Pipe Gallery

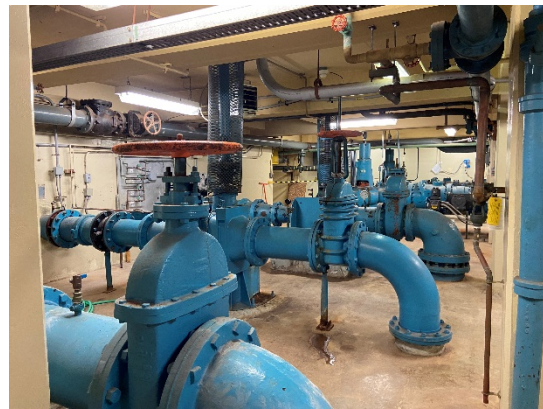
The piping is generally cast iron and in fair condition. Where replacement piping has been installed, stainless steel pipe was chosen. All pipes and bends are in good condition. The high lift pumps are functioning satisfactorily, and it is not recommended that the pipes be replaced. No deficiencies were observed at the time of the inspection.

Figure 4: High Lift Pumps – Valves and Piping

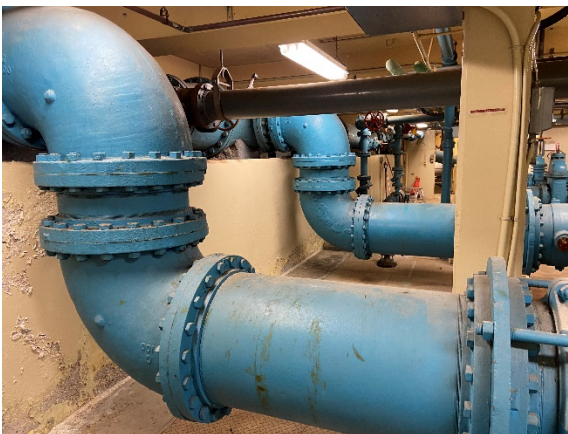
Figure 5: High Lift Pumps Piping

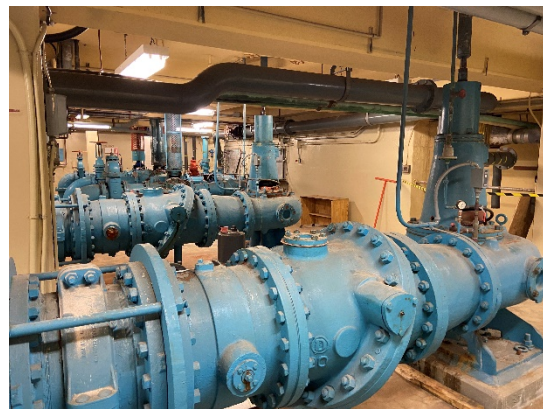
All gate valves, butterfly valves and check valves appear to be in good condition. The generator is capable of running the lighting and instrumentation for the water treatment plant.

Figure 6: High Lift Pumps Check Valves

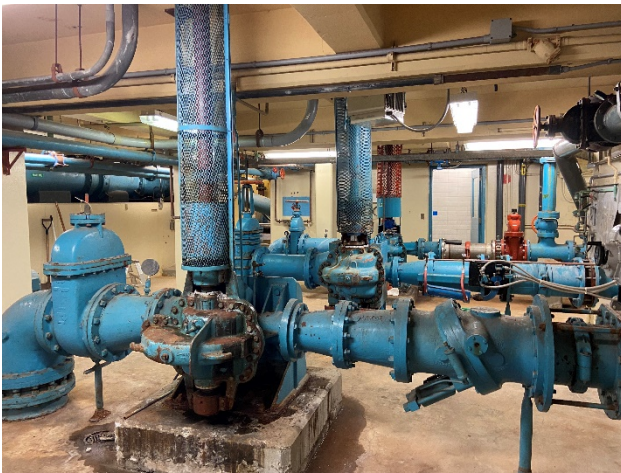
Figure 7: High Lift Pumps #1, #2 and #3

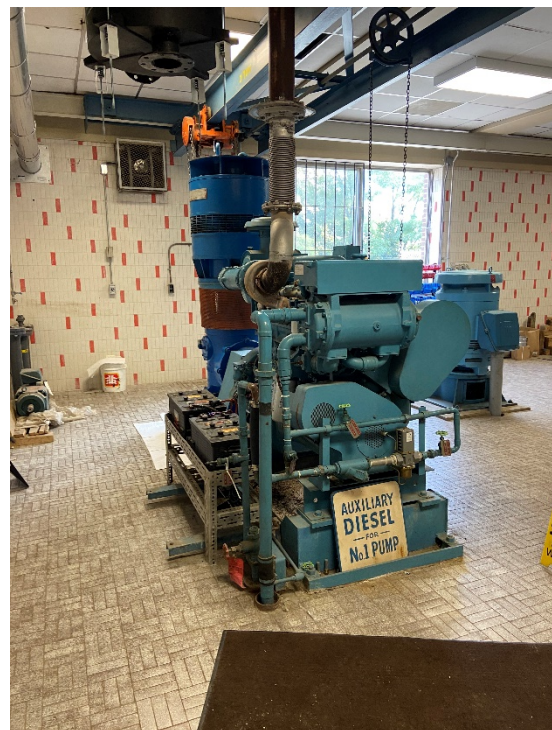
Figure 8: Pump #1 Diesel Motor

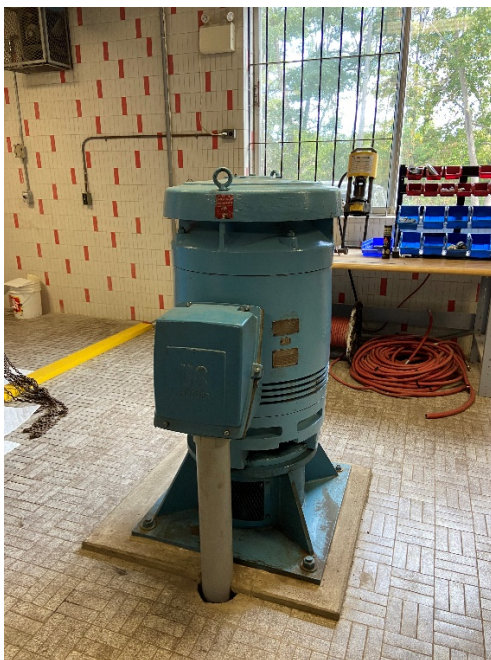
Figure 9: High Lift Electric Motor #2

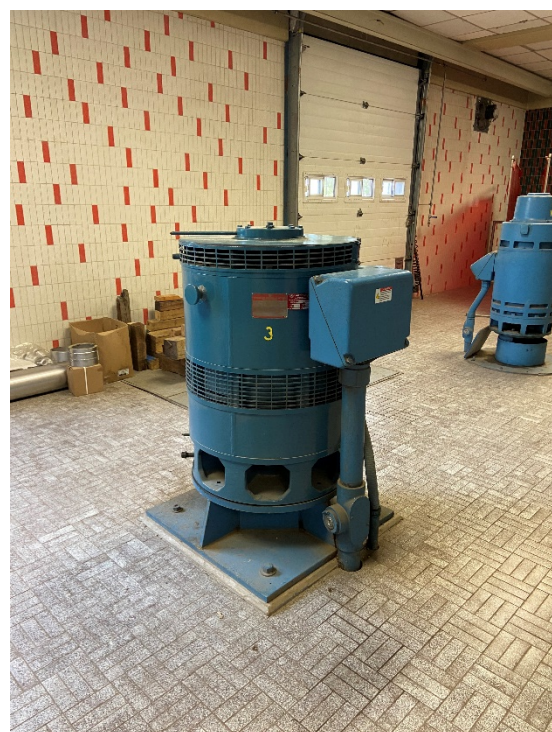
Figure 10: High Lift Electric Motor #3

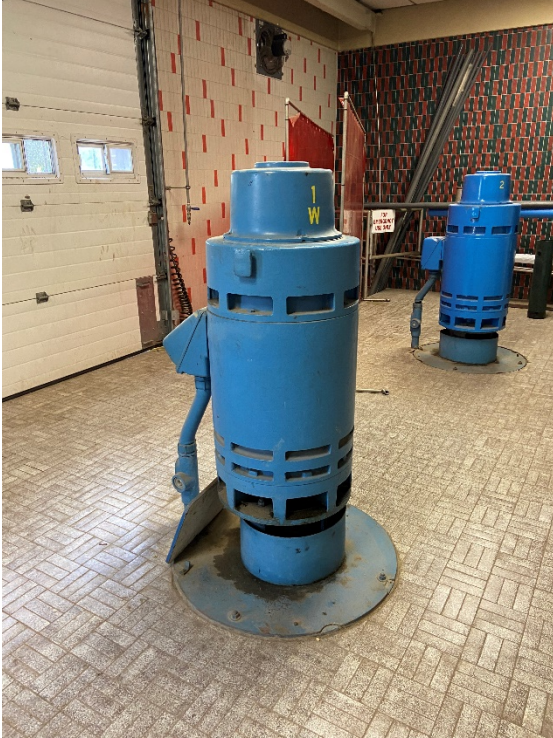
Figure 11: Backwash Electric Motor #1

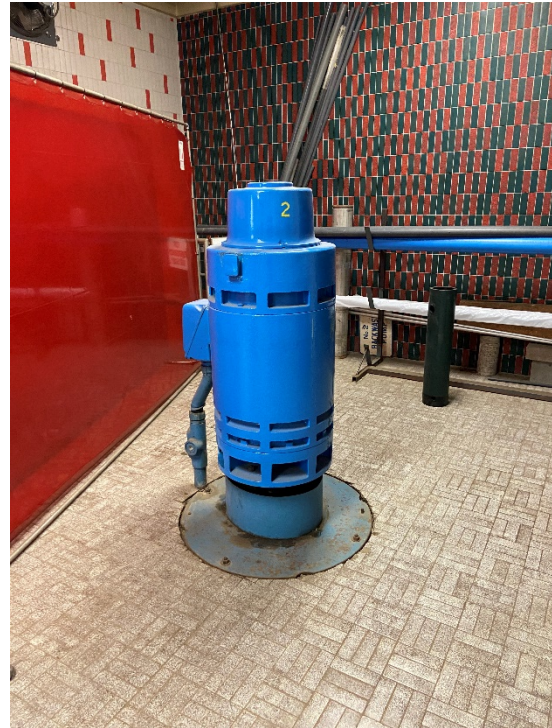
Figure 12: Backwash Electric Motor #2

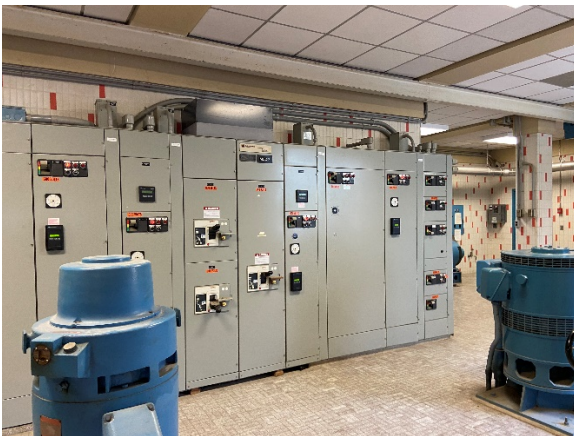
Figure 13: Electrical Panel and MCC

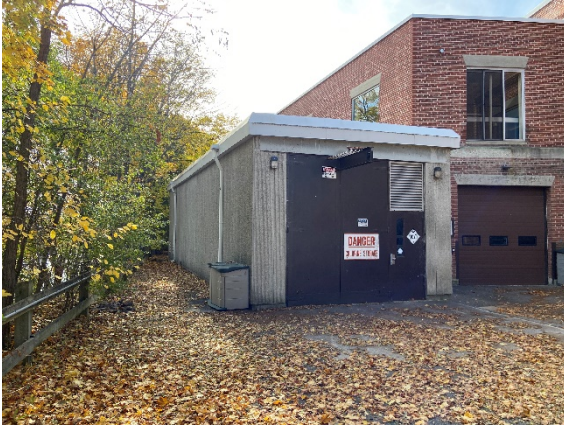
The Chlorine Storage Building is adjacent to the water treatment plant. It is a brick, one storey building on the East side of the main building. The Chlorine Storage Building can house up to 18 - 1 ton chlorine gas cylinders. Immediately to the south, is the chlorine gas scrubber. No concerns were identified with the chlorine storage building or the chlorine injector room, and is in good condition.

Figure 1: Chlorine Storage Building

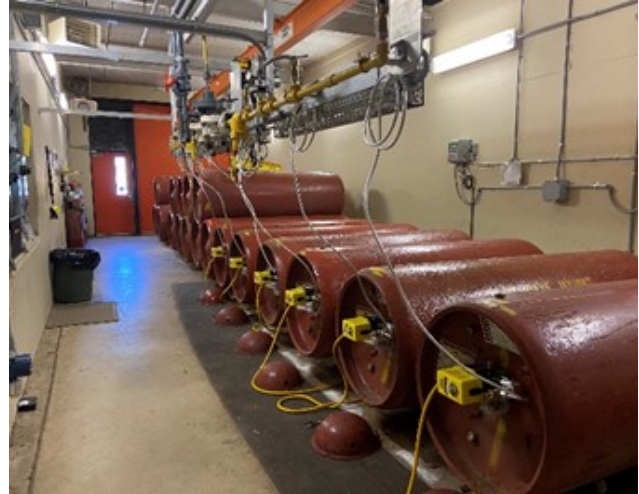
Figure 2: 18 – 1 ton Chlorine Gas Cylinders

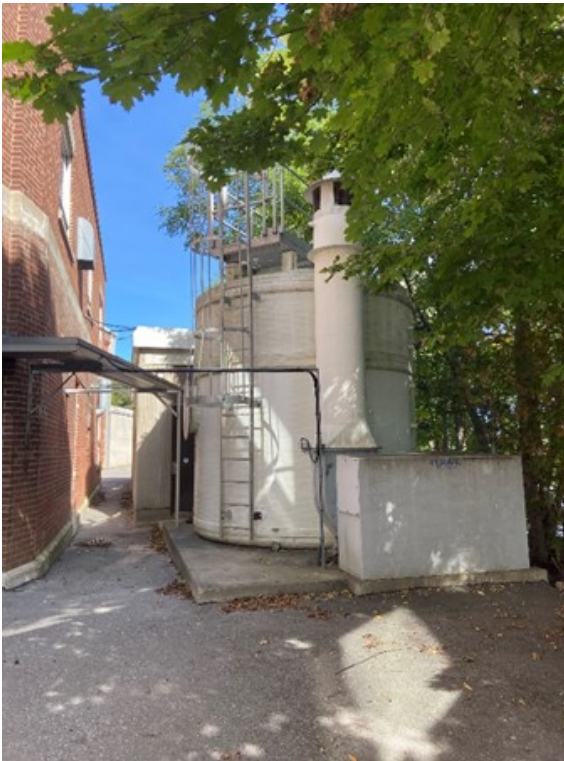
Figure 3: Chlorine Scrubber

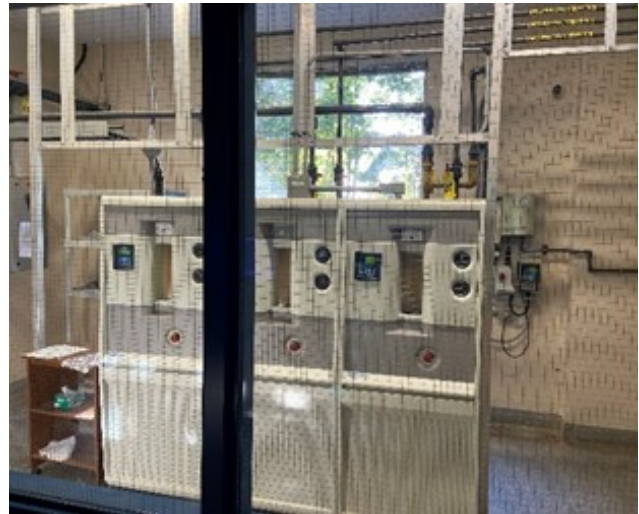
There are four (4) chlorinators located in the chlorine injector room. The chlorinators are for disinfection, back-up, post feed and zebra-mussel control. The associated valves and injectors are in good condition.

Figure 4: Chlorinator

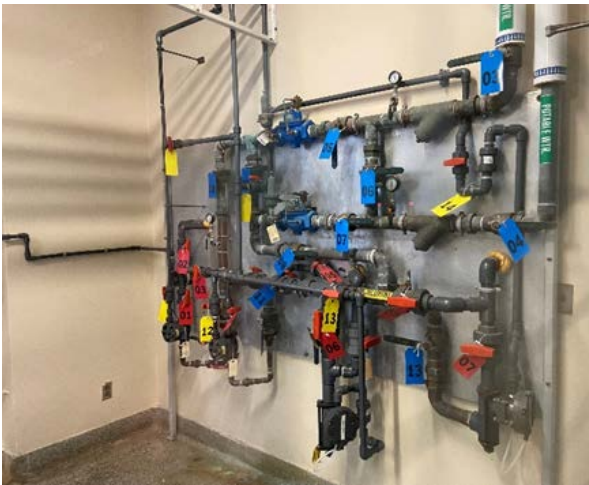
Figure 5: Chlorine Zebra-Mussel Control, Pre and Post Injectors

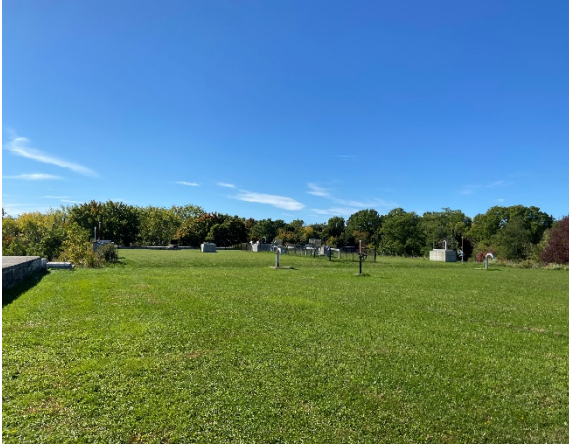
Figure 1: Chlorine Contact Tank #1 Above Grade looking South, Contact Tank #2 and Clear Well #4 in background

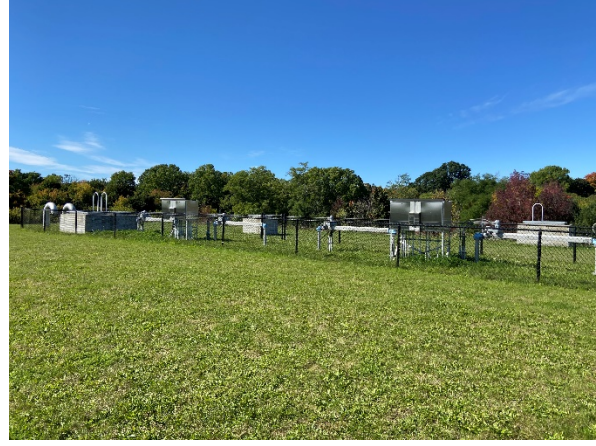
Figure 2: Clear Well #4 and Weir Wall Controls Above Grade

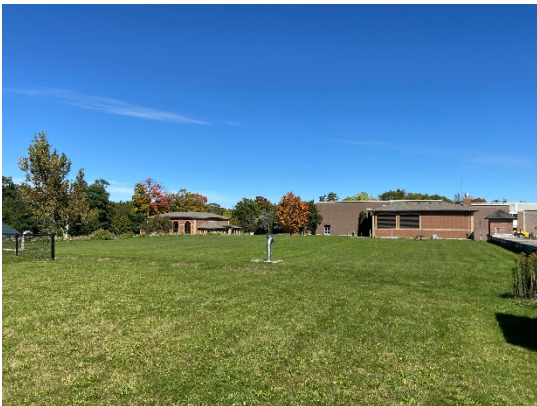
Figure 3: Looking North at Chlorine Contact Tank #1 (right) and Clear Well #3 (left)

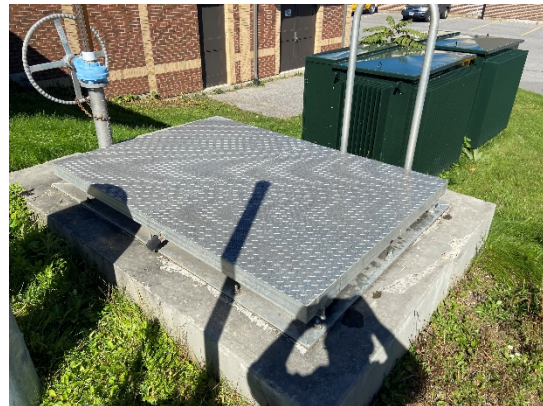
Figure 4: Access Hatch to Chlorine Contact Tank #1

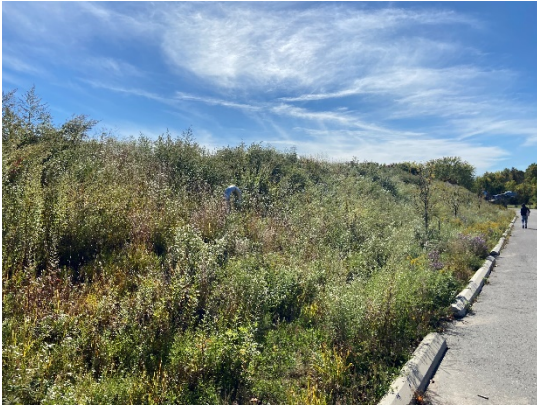
Figure 5: West bank of Clear Well #3, looking South

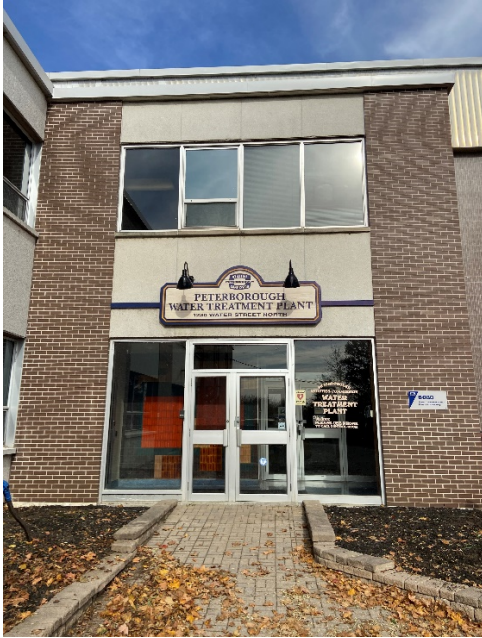
Figure 1: Main Entrance

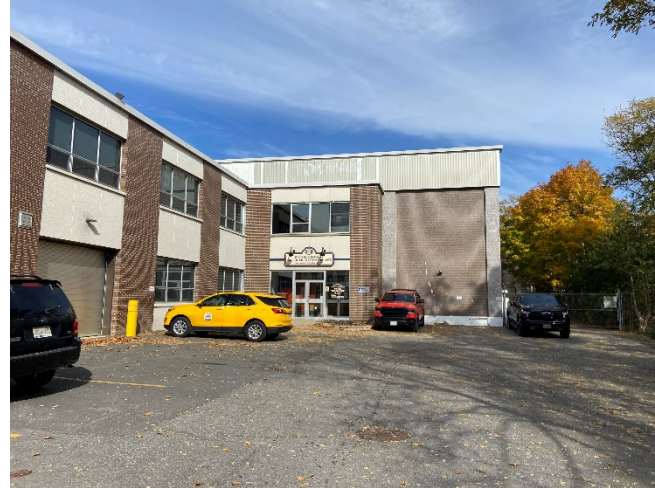
Figure 2: Main Entrance, Employee Parking

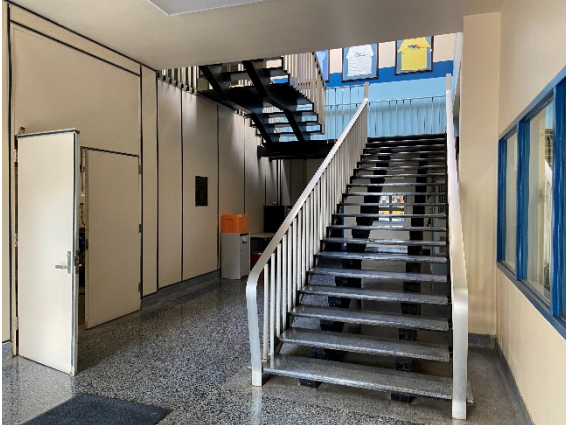
Figure 3: Main Foyer

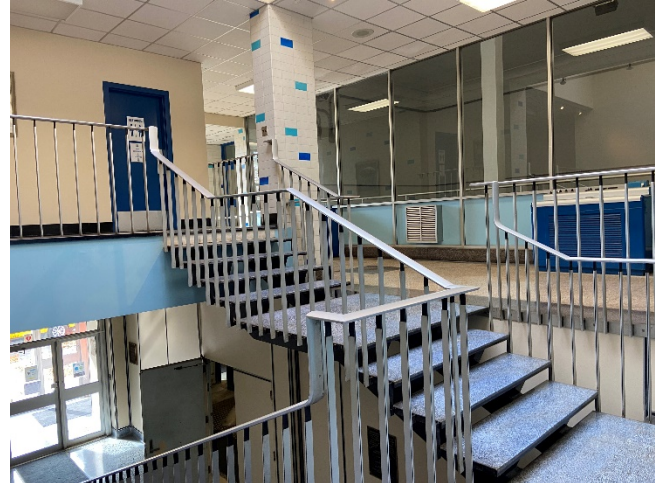
Figure 4: Second Floor, Filter Bed 6 (background)

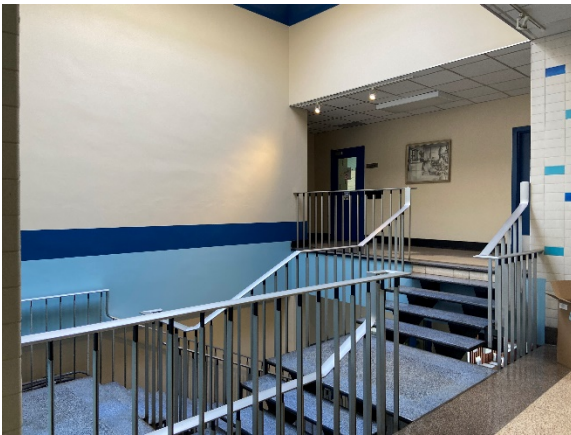
Figure 5: Second Floor, Laboratory (background)

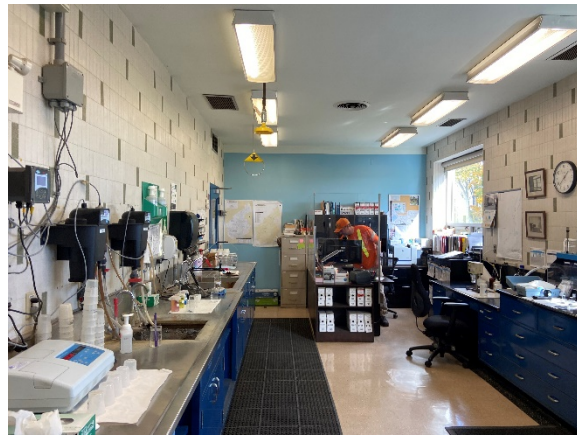
Figure 6: Laboratory

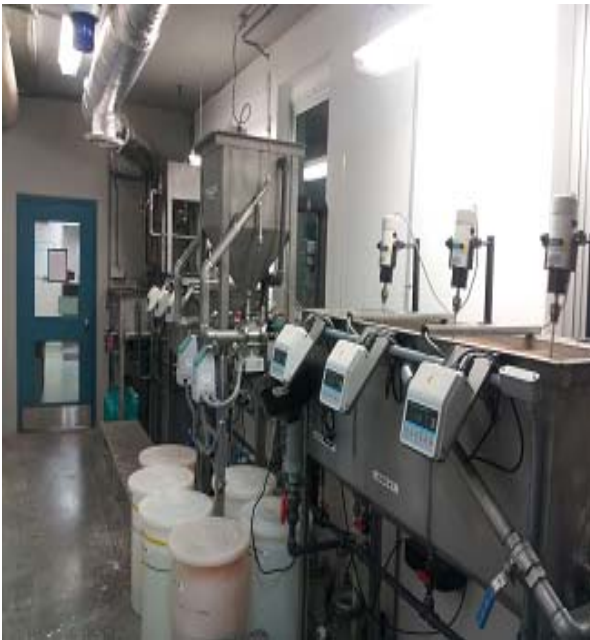
Figure 1: Upper Floor of Pilot Plant – Conventional Treatment Train

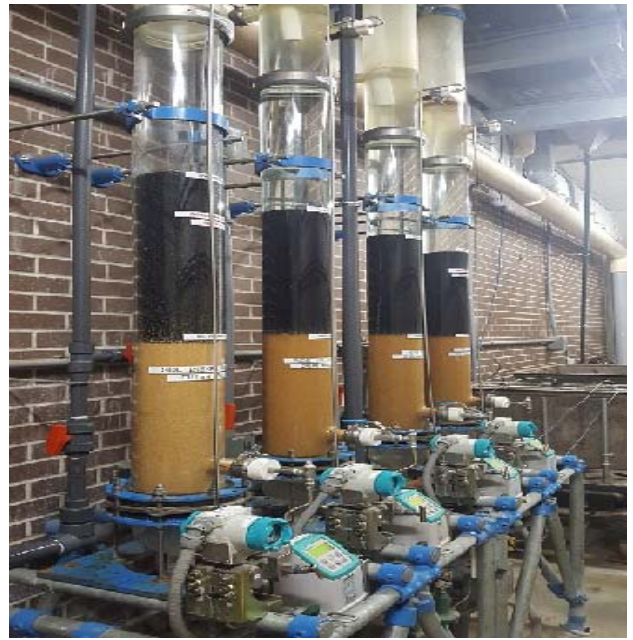
Figure 2: Pilot Plant Dual-Media Filters

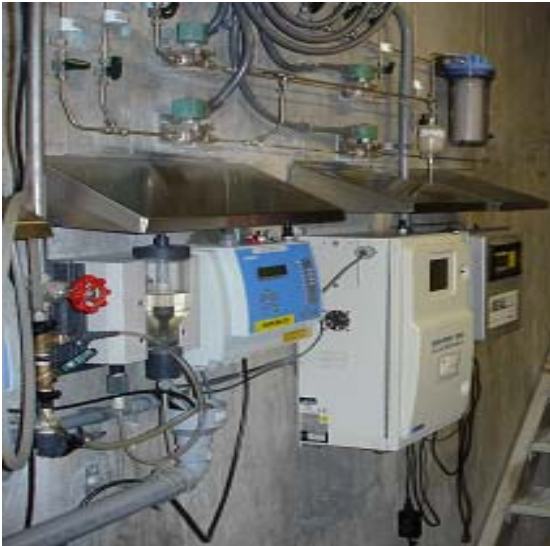
Figure 3: Lower Floor of Pilot Plant – Analytical Equipment

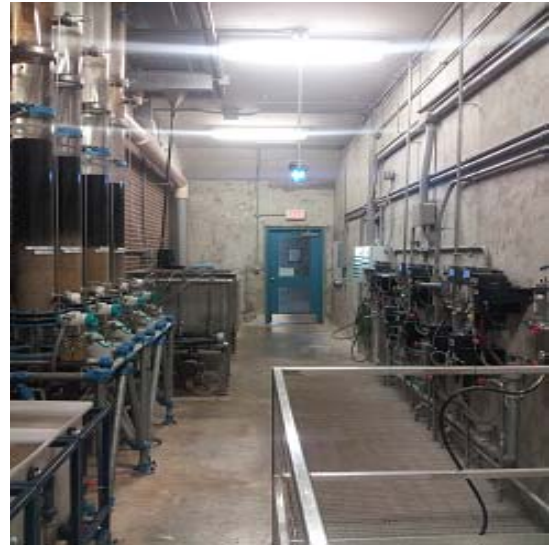
Figure 4: Main Floor of Pilot Plant

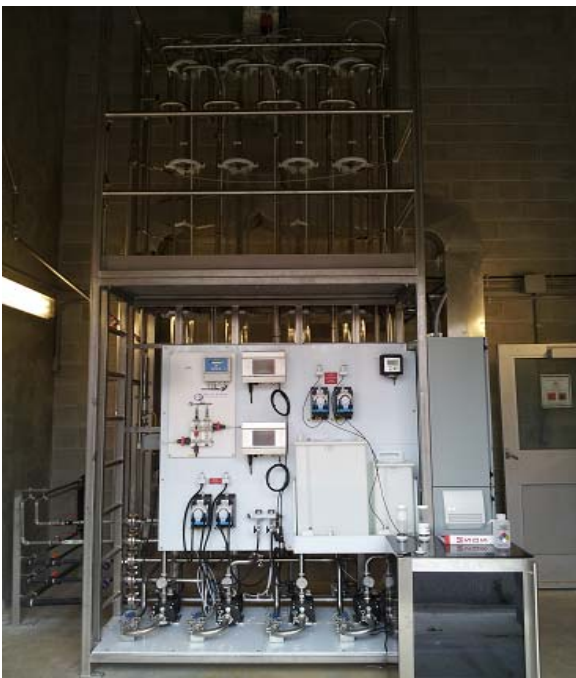
Figure 5: Ozone Pilot Plant

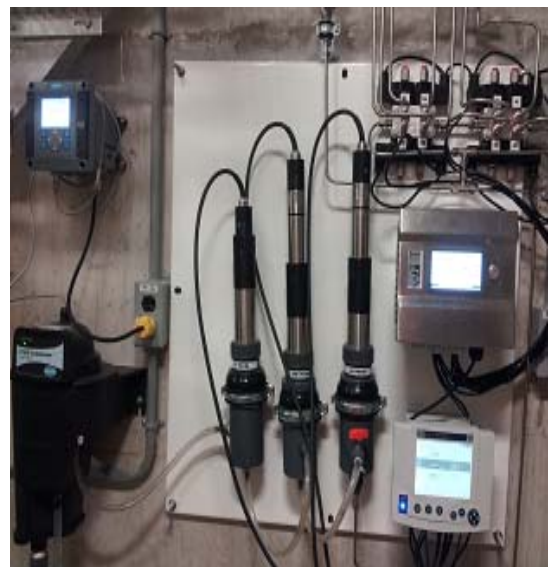
Figure 6: Lower Floor of Pilot Plant – Analytical Equipment

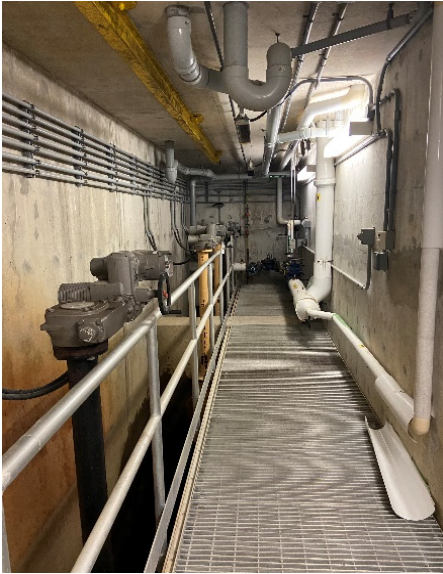
Figure 1: Decant Tanks

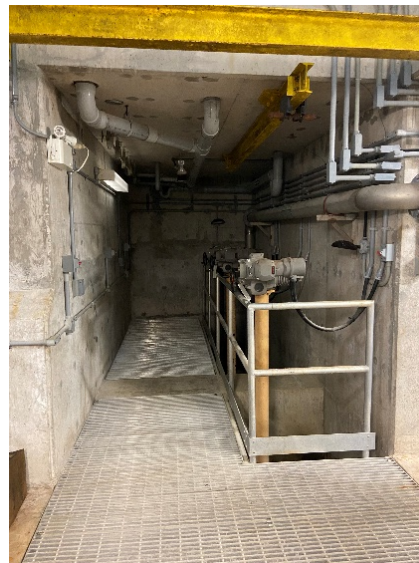
Figure 2: Decant Tanks

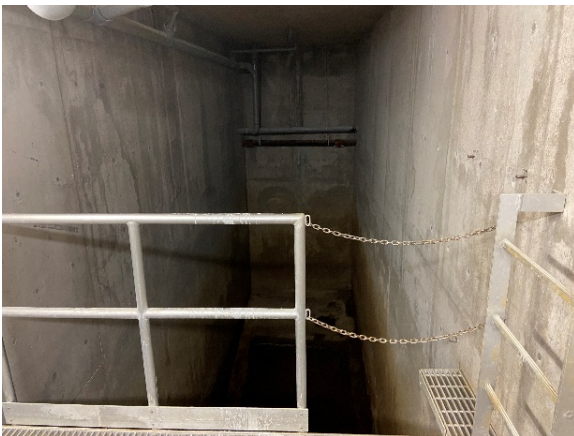
Figure 3: Sludge Tank

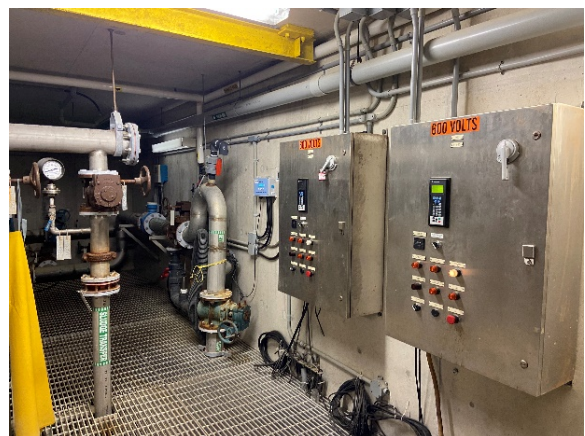
Figure 4: Sludge Tank Controls

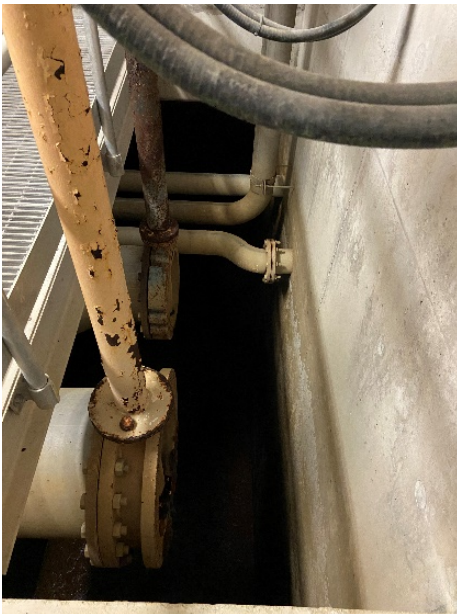
Figure 5: Decant Tank Inlet Piping

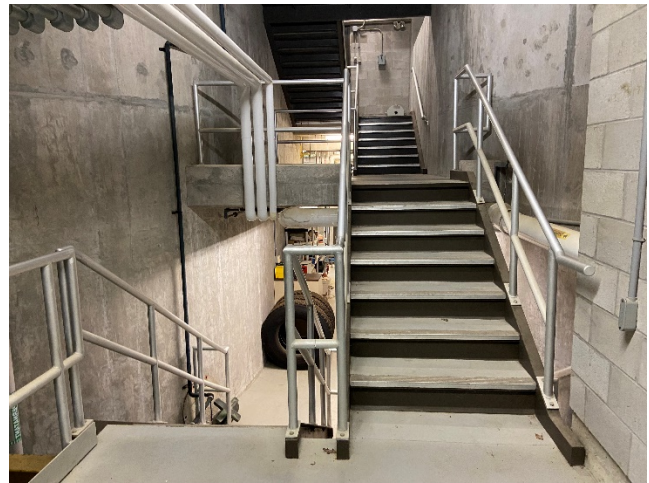
Figure 6: Stairwell between the Ground Floor, Decant/Sludge Tanks and Thickening Tanks
