Peterborough Utilities Commission Water Utility Asset Management Plan

ASSET MANAGEMENT INSPECTION REPORT

Low Lift Pumps –
Peterborough Water
Treatment Plant
1230 Water Street North,
Peterborough ON

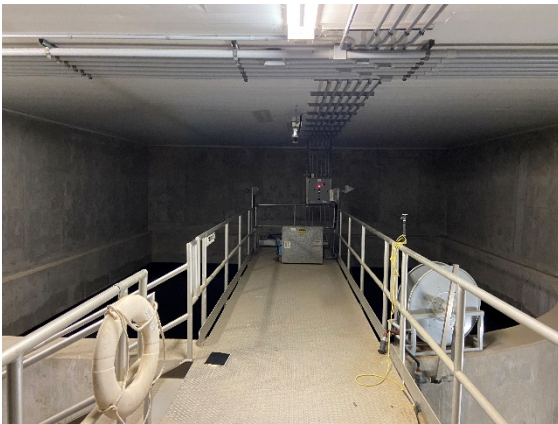
Figure 7: Thickening Tank #1

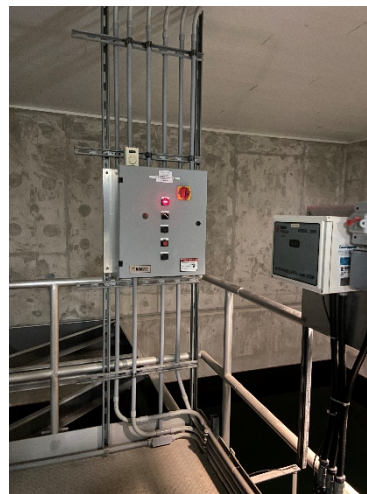
Figure 8: Thickening Tank #1 Controls

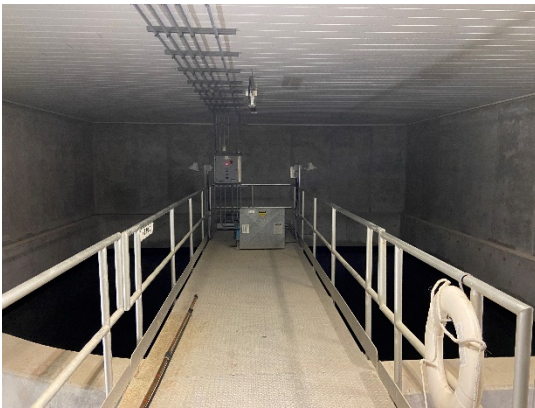
Figure 9: Thickening Tank #2

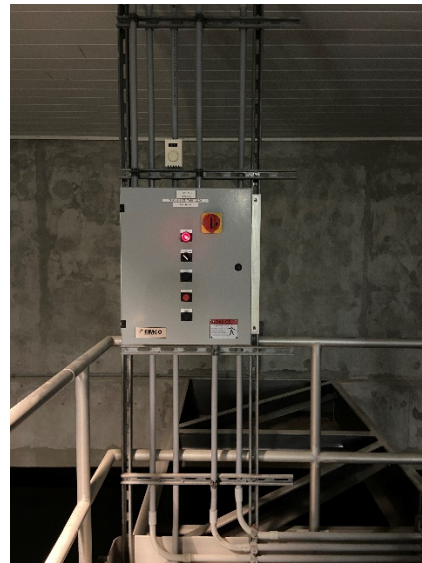
Figure 10: Thickening Tank #2 Controls

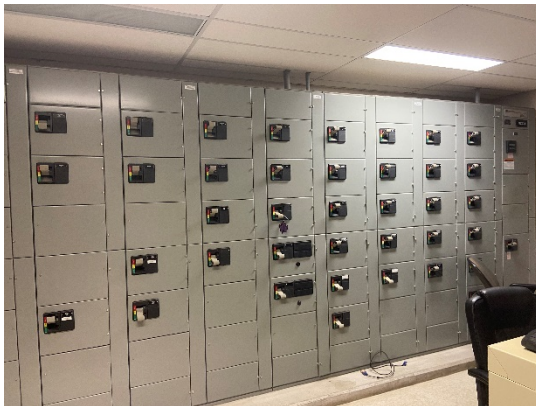
Figure 11: Electrical Switch Gear

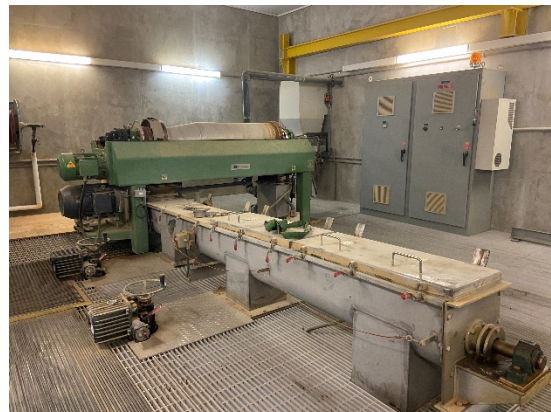
Figure 12: Centrifuge

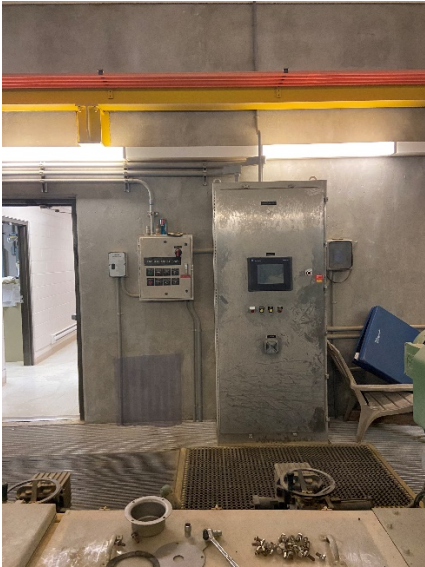
Figure 13: Centrifuge MCC

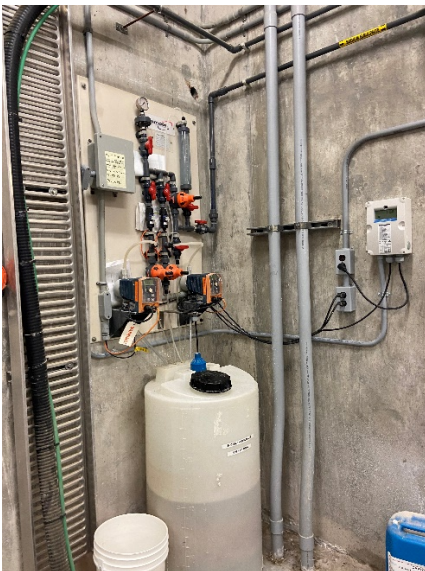
Figure 15: Dechlorination Station

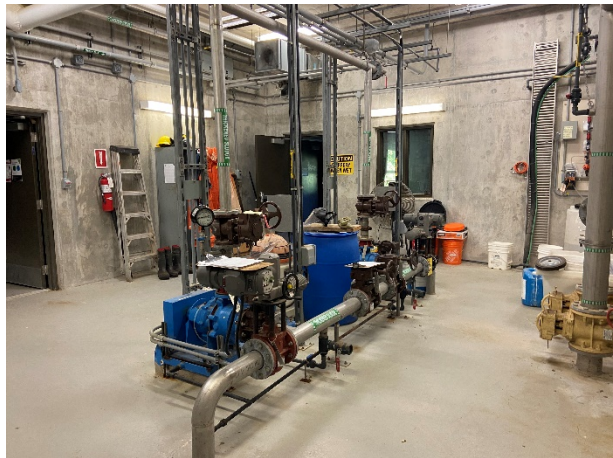
Figure 14: Thickened Sludge Pumps

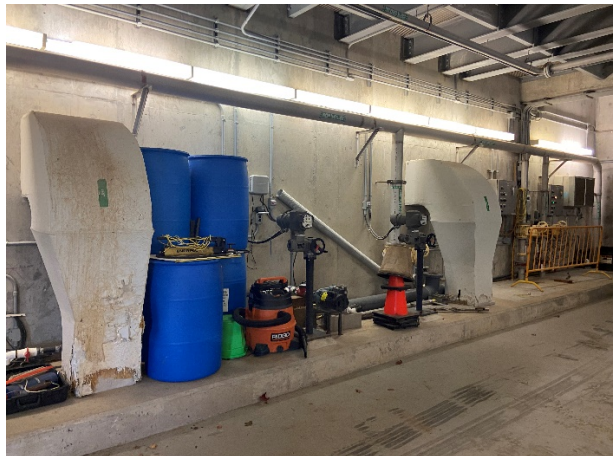
Figure 16: Dewatered Cake Loading Bay

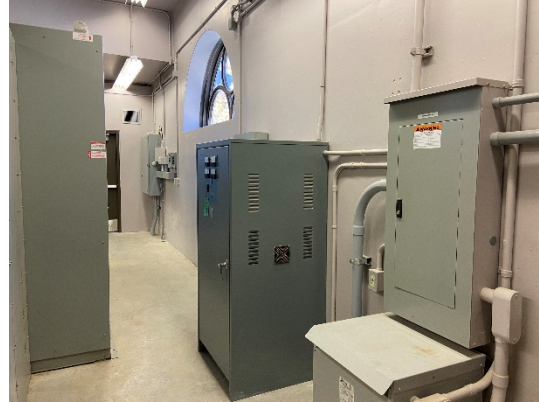
Figure 2: Switch Gear and SCADA

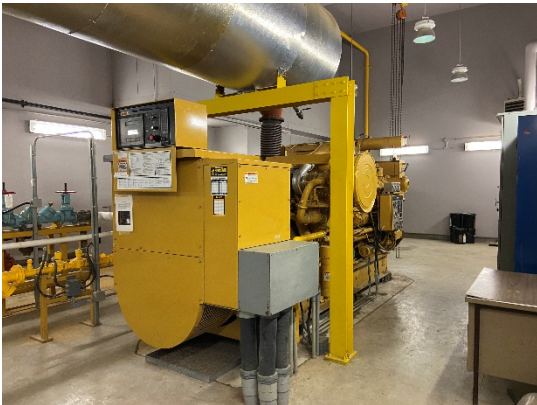
Figure 3: Motor with Gen Set

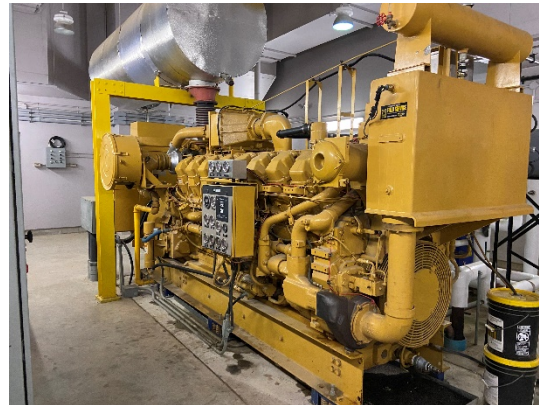
Figure 4: Caterpillar Motor

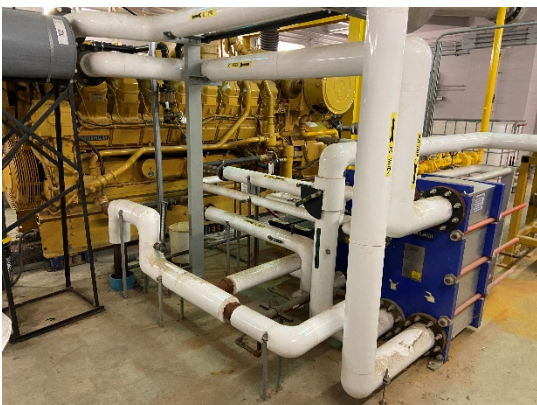
Figure 5: Cooling Piping

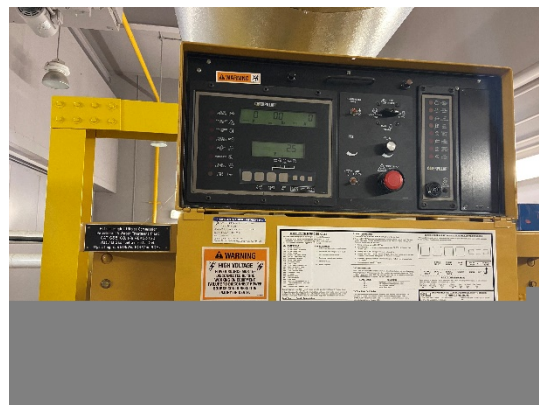
Figure 6: Generator Controls

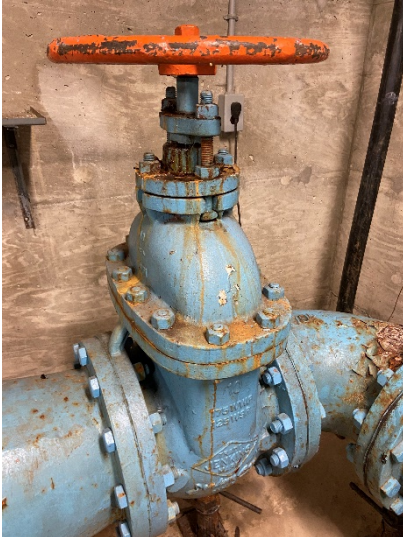
Figure 1: Gate valve in the southwest corner of the station

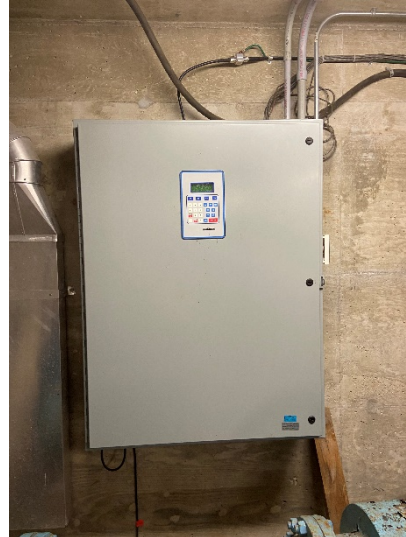
Figure 2: Electrical box

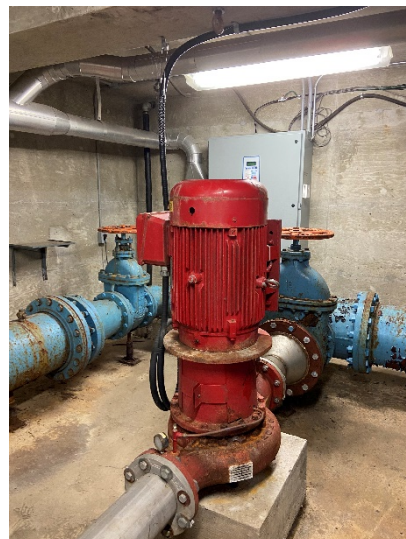
Figure 4: Pump 2

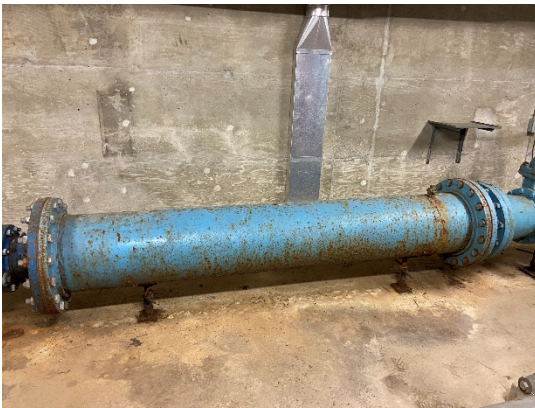
Figure 5: Pump 1

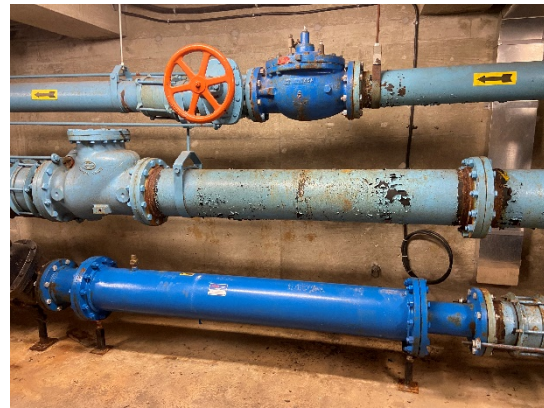
Figure 6: Pump 3, check valve and pressure reducing valve

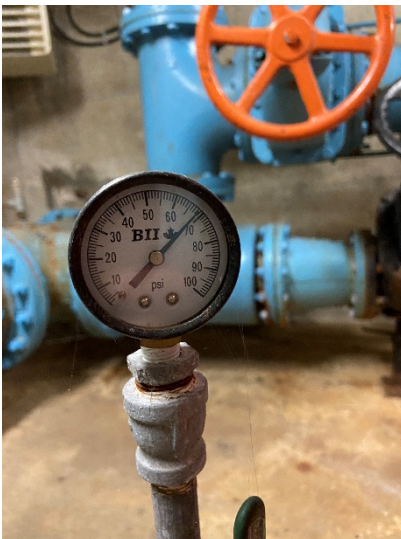
Figure 7: Discharge pressure gauge on pump 2

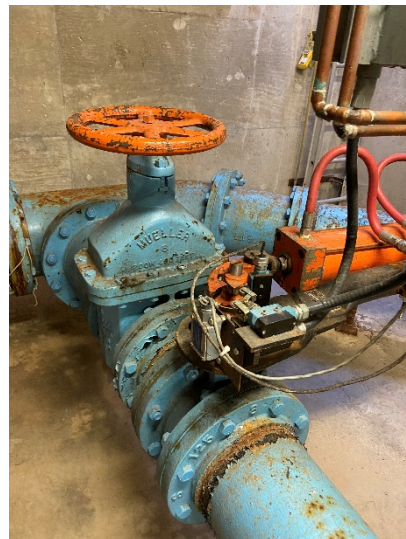
Figure 8: Gate and Butterfly valve on pump 2

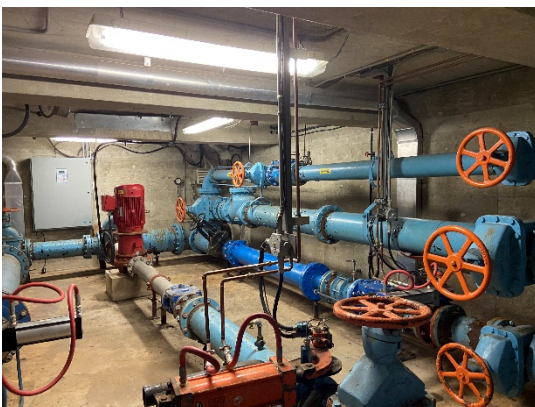
Figure 9: View of station facing the northwest corner

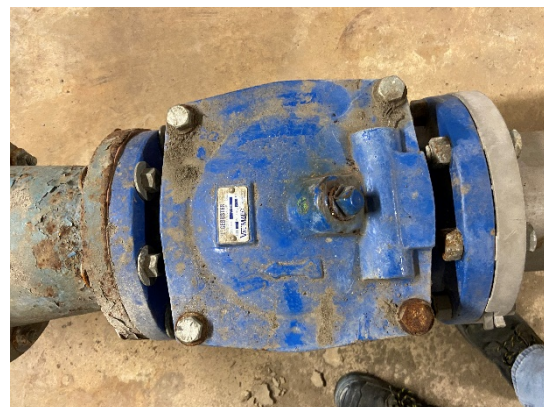
Figure 10: Swing check valve on pump 2

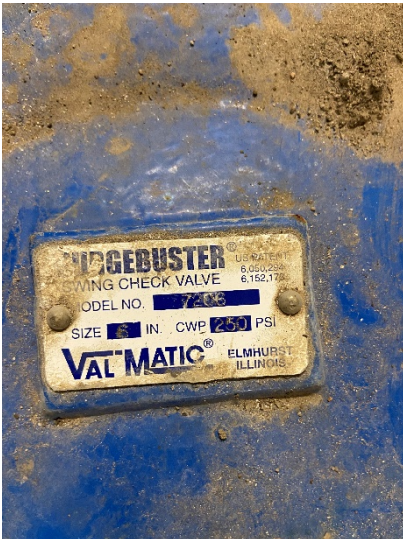
Figure 11: Label on switch check valve

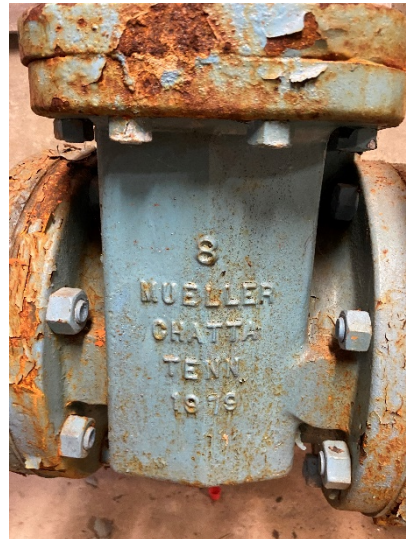
Figure 12: Gate valve

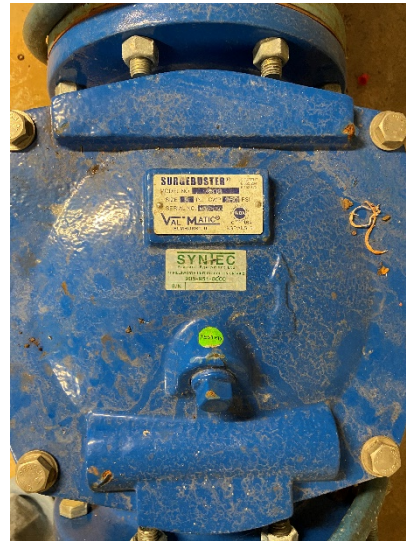
Figure 14: Swing check valve on pump 3

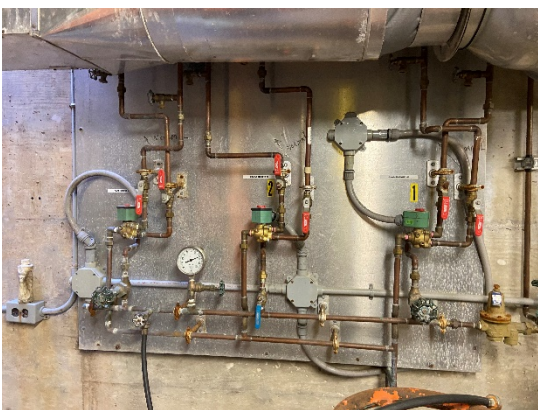
Figure 15: Automatic valve controls

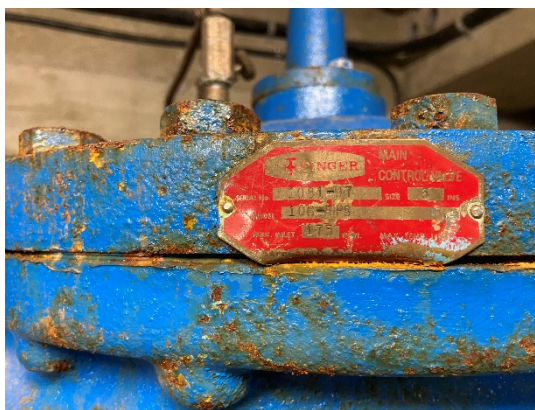
Figure 16: Label on pressure reducing valve

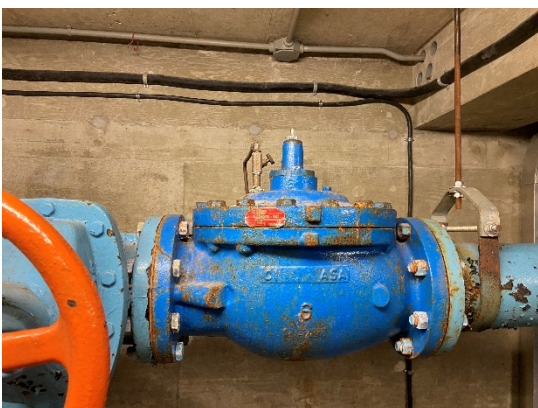
Figure 17: Pressure reducing valve

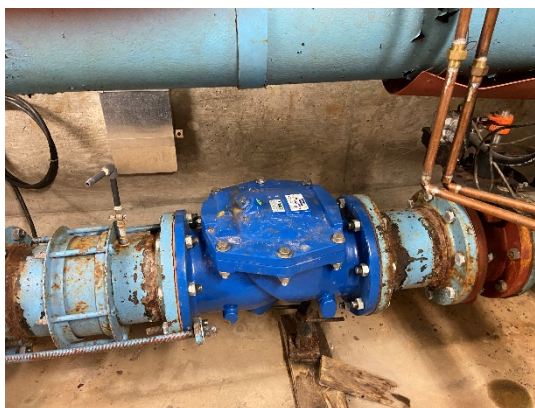
Figure 18: Check valve

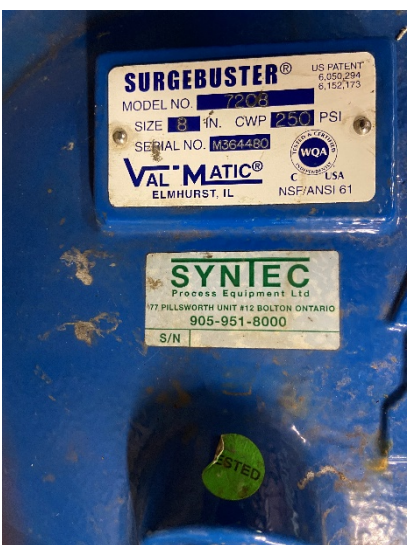
Figure 19: Label on check valve

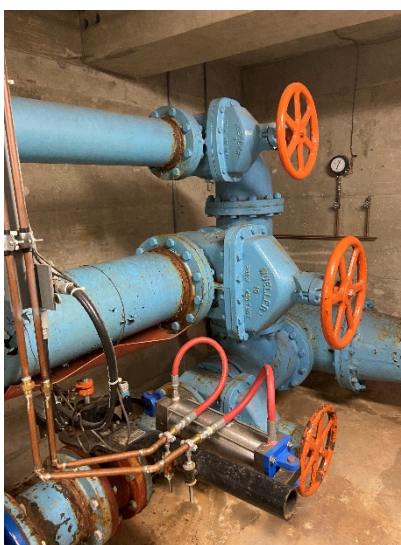
Figure 20: Gate valves

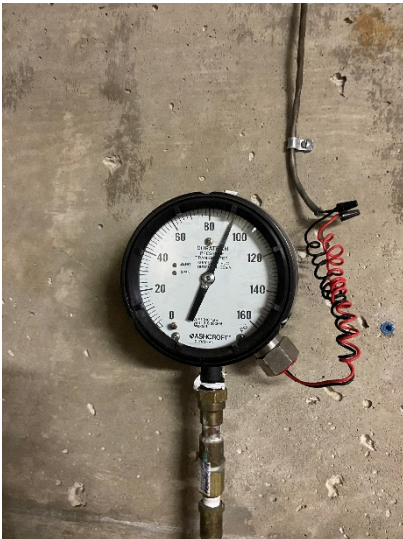
Figure 21: Discharge pressure gauge (Zone 2)

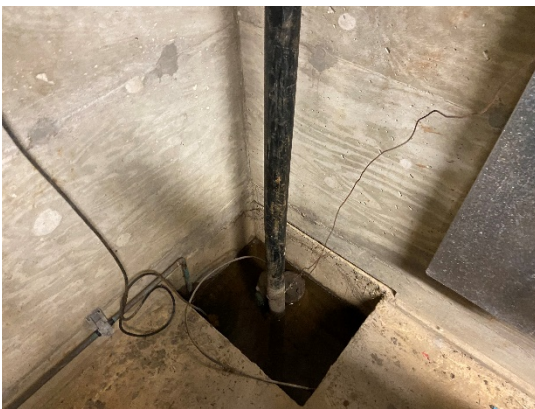
Figure 23: Sump pump

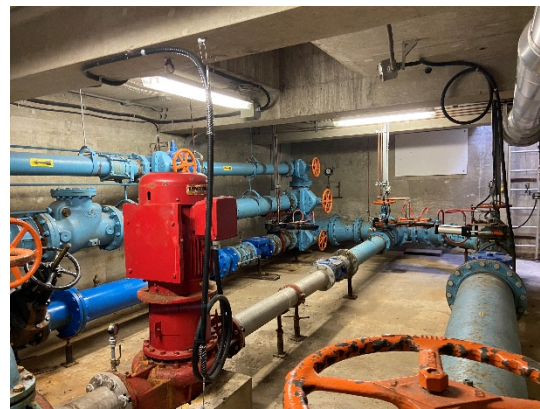
Figure 24: View of station facing northwest

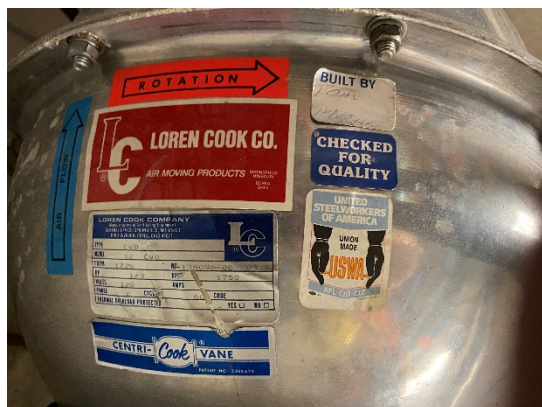
Figure 25: Exhaust Fan

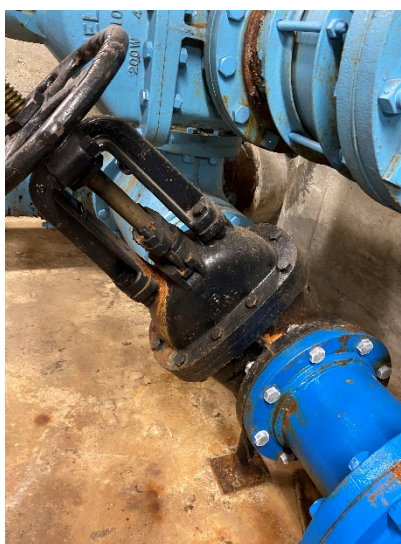
Figure 26: Gate valve on pump 3

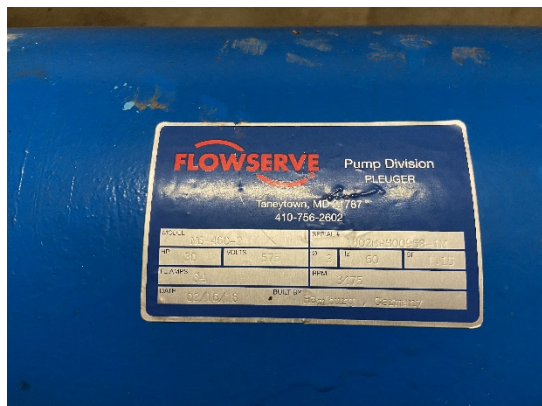
Figure 27: Label on pump 3

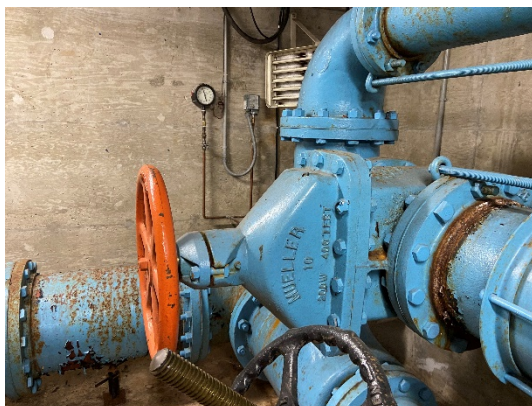
Figure 28: Gate valve on by-pass

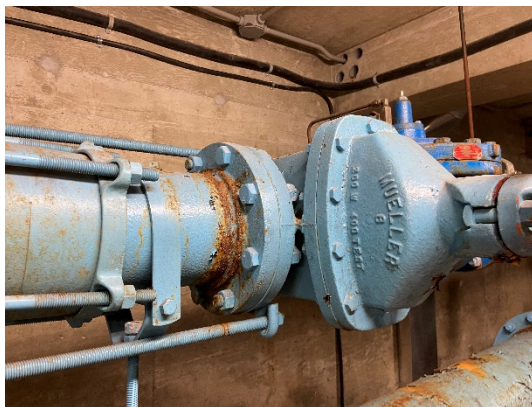
Figure 30: Gate valve on pressure reducing valve

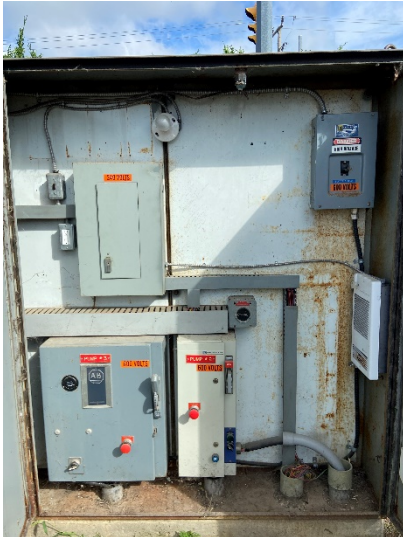
Figure 31: West electrical cabinet

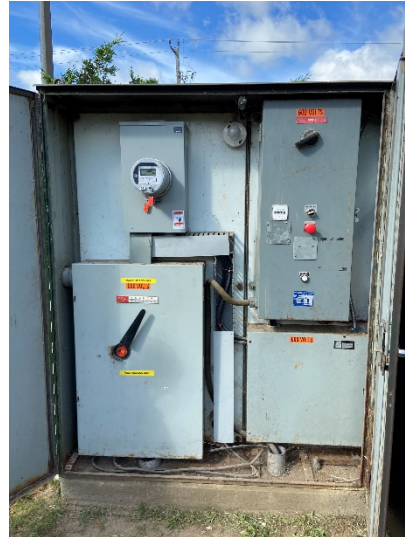
Figure 32: North electrical cabinet

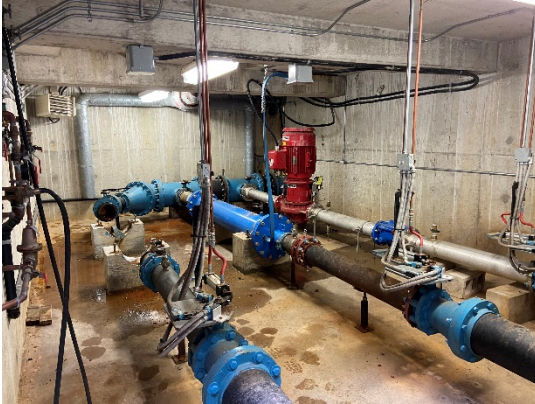
Figure 1: Northwest corner of the station

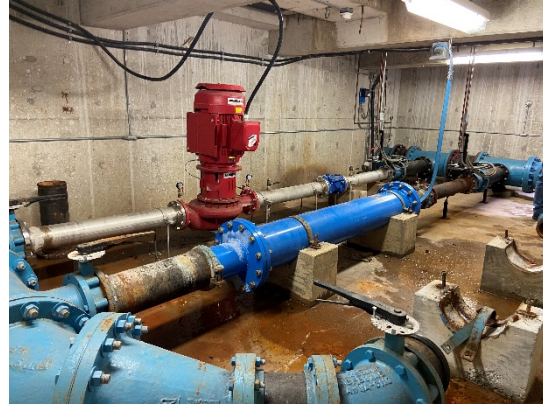
Figure 2: Northeast corner of the station

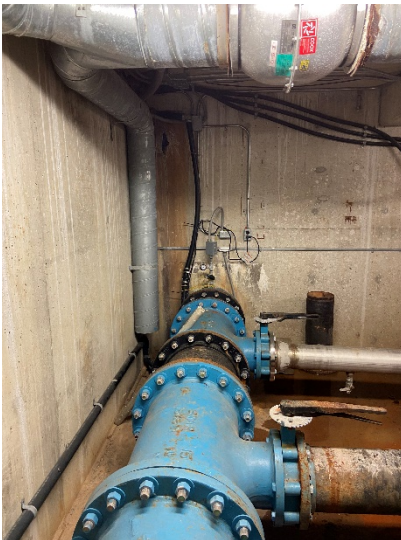
Figure 3: Discharge end of pumps, feeding back to system

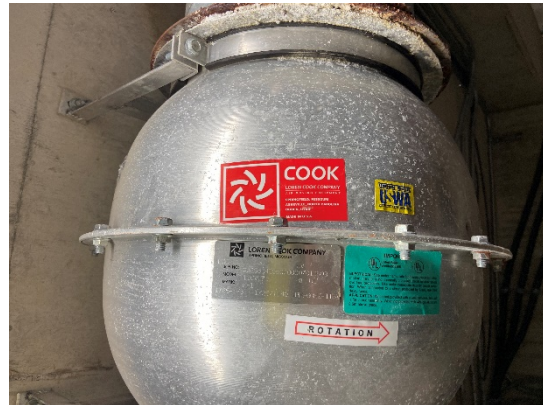
Figure 4: Exhaust Fan

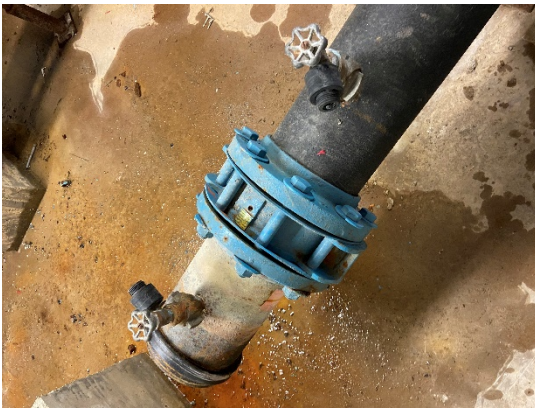
Figure 5: Coupling

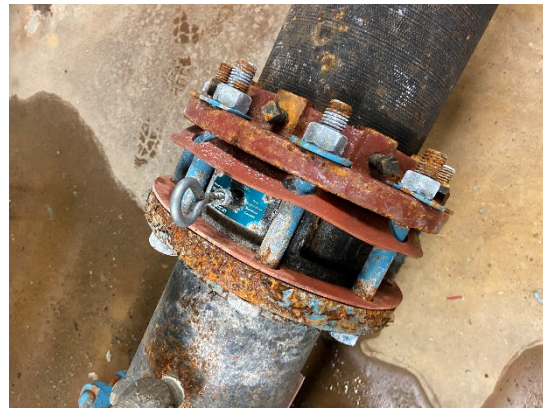
Figure 6: Another coupling

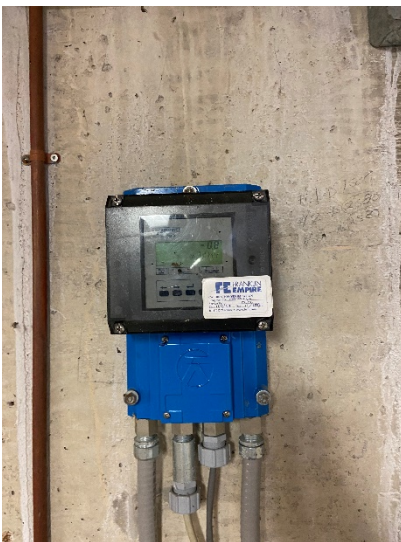
Figure 7: Water meter?

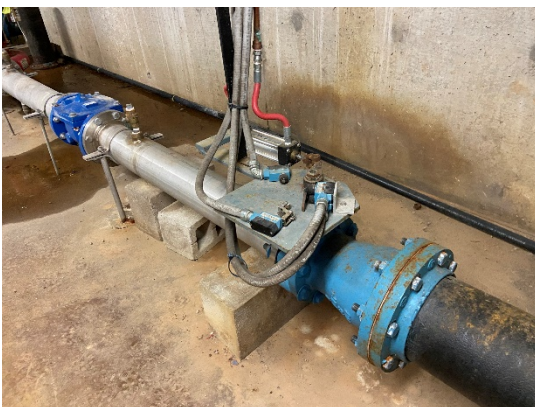
Figure 9: Check valve and reducer

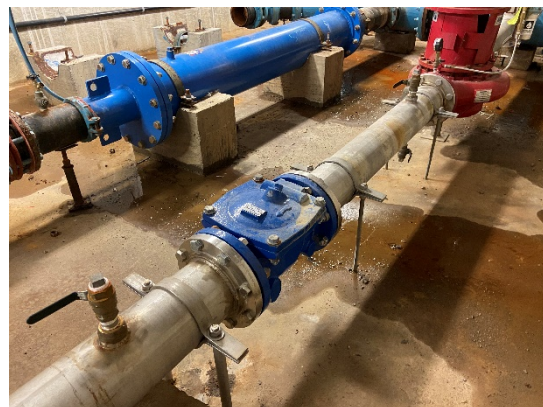
Figure 10: Check valve and inline pump

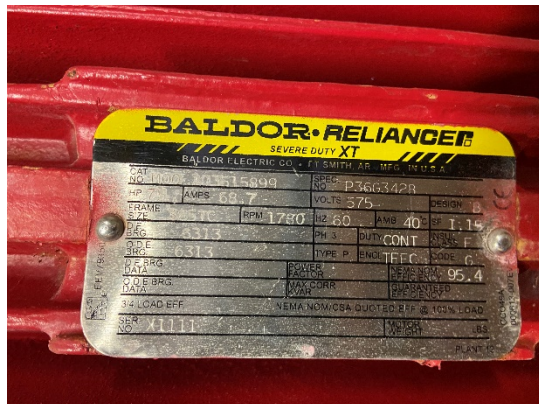
Figure 13: Label on pump 1

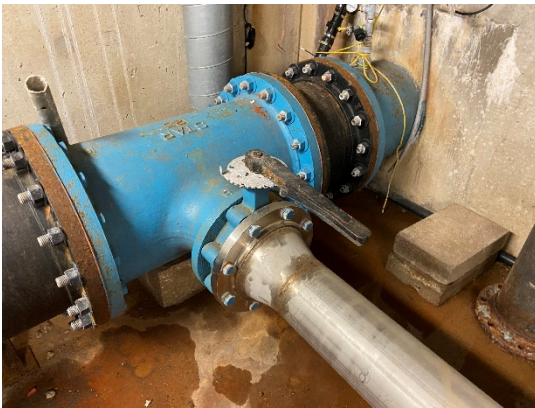
Figure 15: Butterfly valve on pump 1

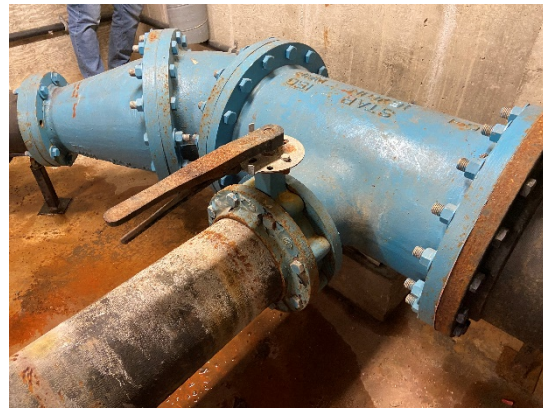
Figure 16: Butterfly valve on pump 2

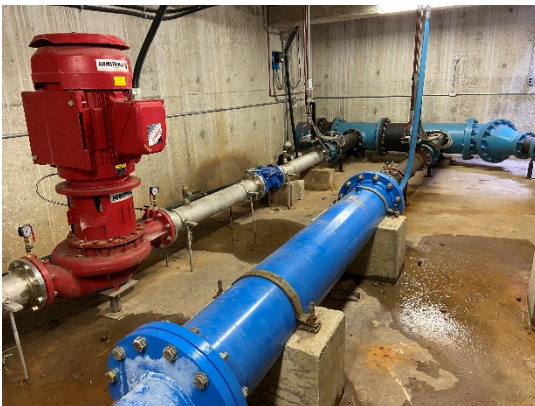
Figure 17: Pump 1 and 2

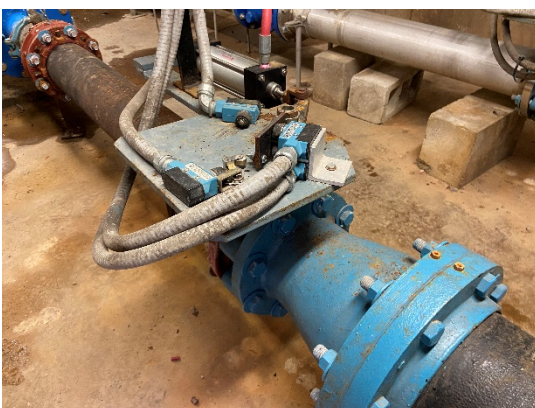
Figure 19: Reducer on pump 2

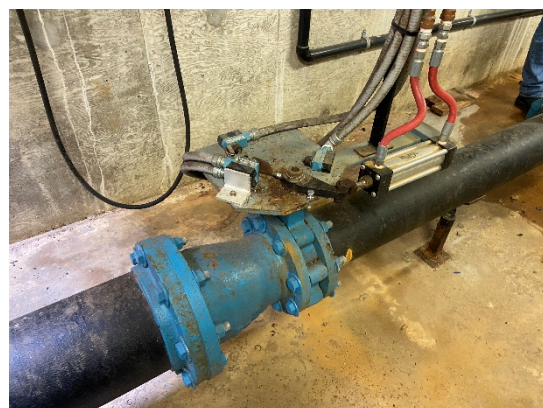
Figure 20: Reducer on pump 3

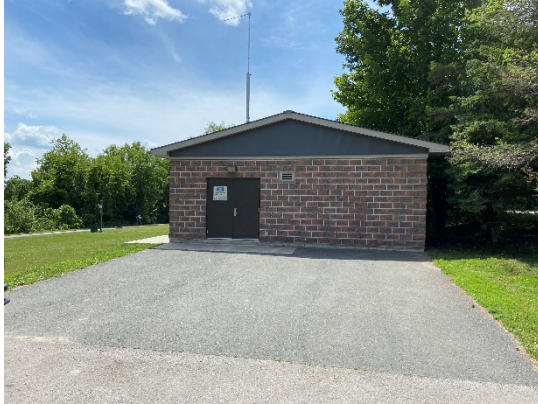
The Cumberland Booster Pumping Station is one of the newer stations in Peterborough as it was built in 2008, replacing an aging facility. Since its construction, no changes have been made to the building or infrastructure other than routine maintenance. All equipment in the station is above grade except for the 300mm inflow pipe. The building is in good condition and no major building and process structural concerns were identified.

Figure 1: Cumberland BPS facing south

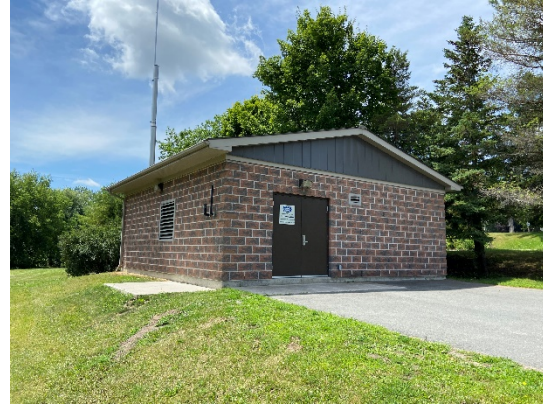
The station is one-story building made of concrete blocks, with a decorative finish on the exterior. It has a low peaking roof, finished with shingles and a communication antenna. The building borders a tree line to the west and the Parkway Trail to the south and to the east. To the north of the building, there is a parking lot adjacent to Cumberland Ave that can accommodate three (3) cars comfortably. The station has three (3) exhaust vents which are not blocked or covered by any obstacles. All walls, interior, exterior, and floors are clean and do not need cleaning, painting or replacement.

Figure 2: Cumberland BPS facing southwest

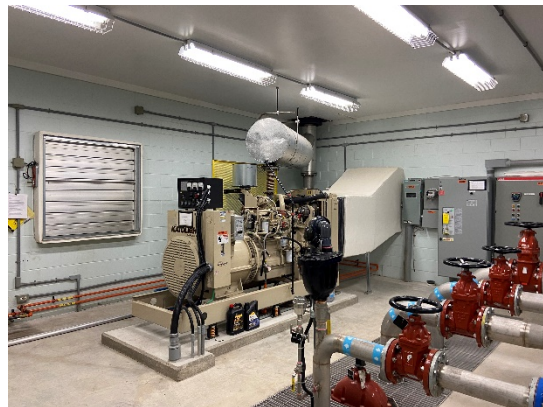
The station has a diesel generator and fuel tank, which is used to supply power to the pumps in the event of a power outage. The generator is inspected annually by a third-party vendor. The generator is in good condition and does not need to be replaced. All gate valves, butterfly valves, check valves and air release valves are in good condition.

Figure 4: Generator in the southeast station

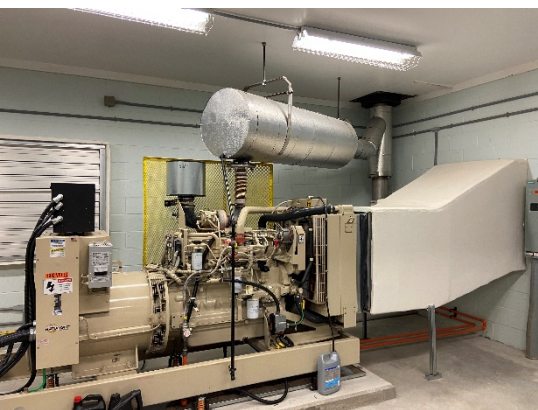
Figure 5: 180 kW Generator

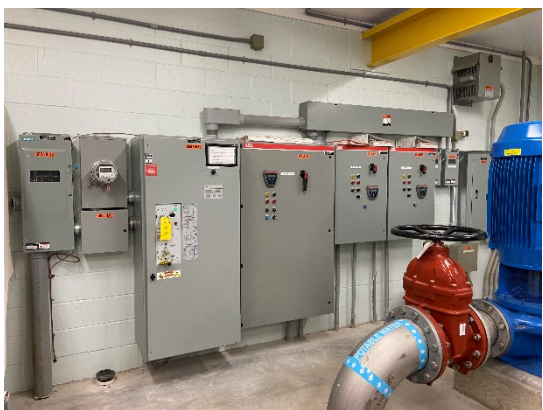
All SCADA components are in very good condition and do not need to be replaced.

Figure 6: SCADA and electrical equipment

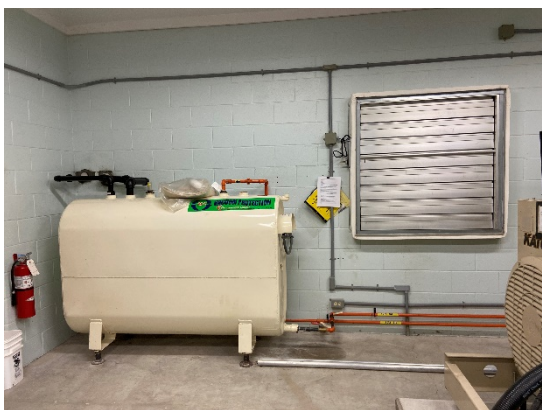
Figure 7: Fuel tank in the northeast corner of the station

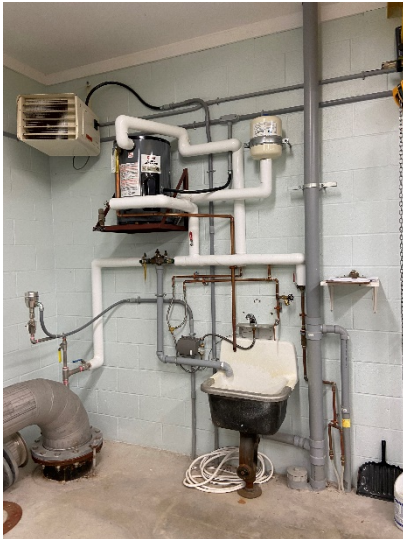
Figure 11: Electric water heater and service sink

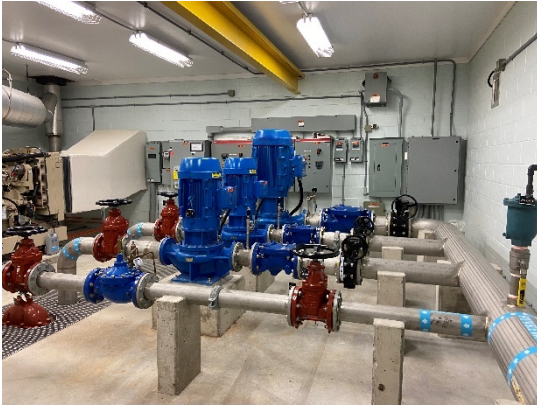
All the piping in the station is 304 stainless steel and is in very good condition as the station is only 15 years old. The station is functioning satisfactorily, and it is not recommended that the pipes be replaced. No deficiencies were observed at the time of the inspection.

Figure 15: View of internal piping and pumps

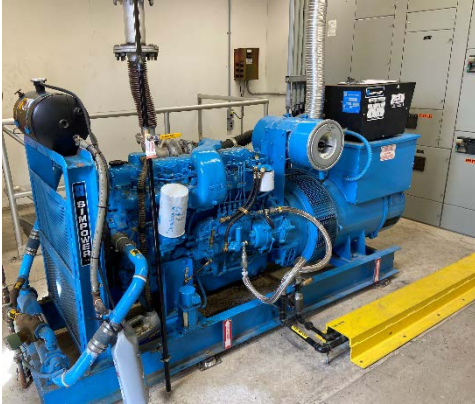
Figure 1: 192 kW generator

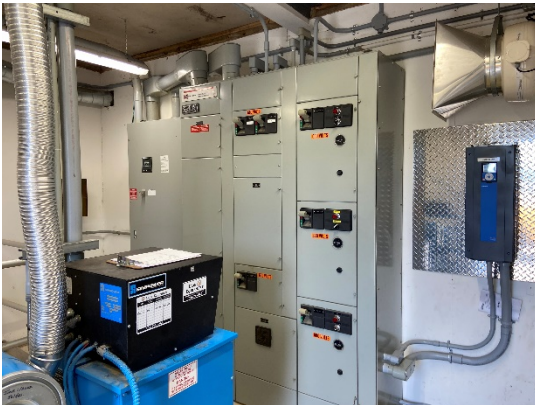
All SCADA components are in good condition and do not need to be replaced.

Figure 3: Electrical and SCADA equipment

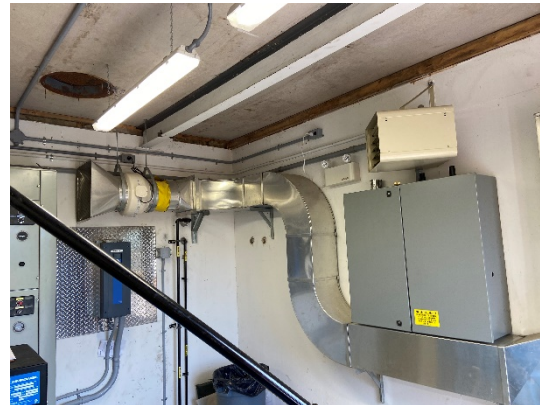
Figure 4: Ventilation system for generator

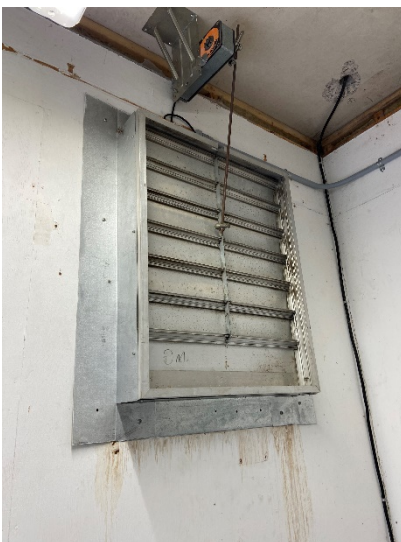
Figure 5: Vent

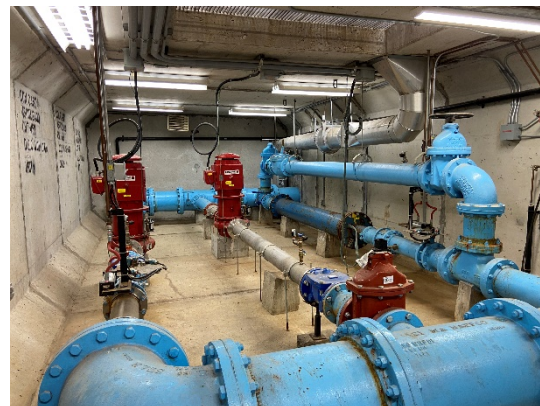
Figure 6: View in the basement of the station facing southeast

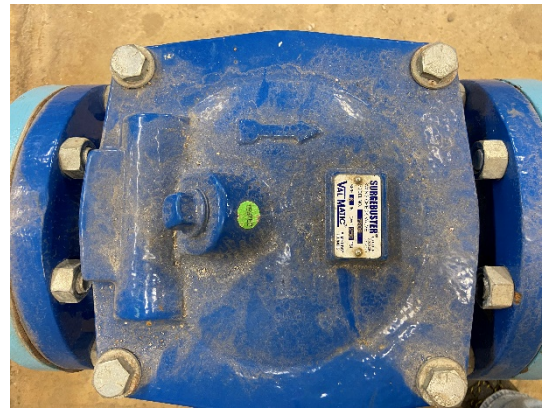
Figure 8: Check valve on pump 1

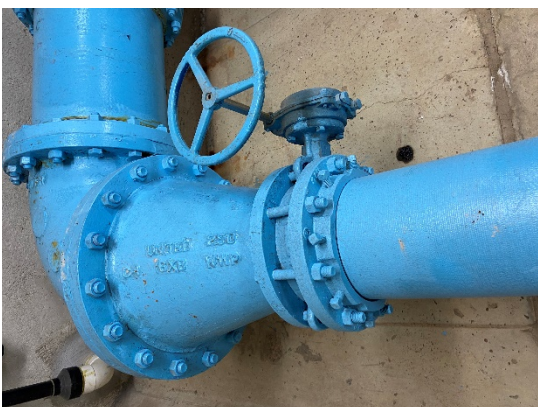
Figure 11: Butterfly valve on pump 1 (suction)

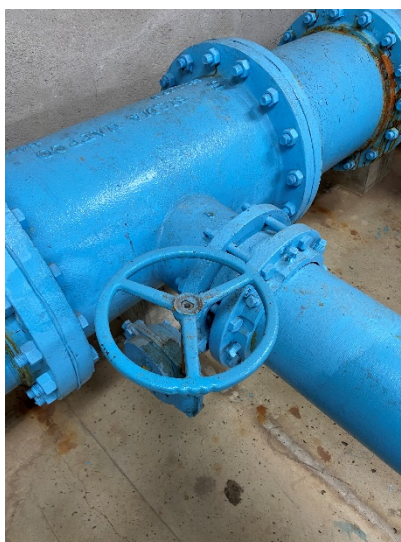
Figure 12: Butterfly valve on pump 2 (suction)

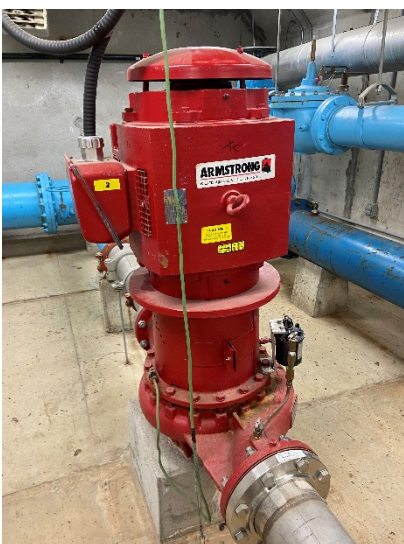
Figure 13: Pump 2

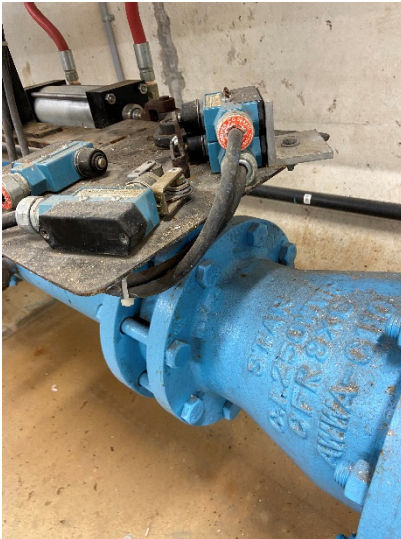
Figure 15: Butterfly valve on pump 3 (discharge)

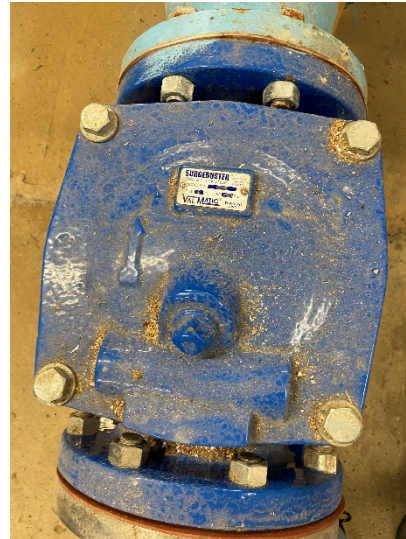
Figure 16: Check valve on pump 2

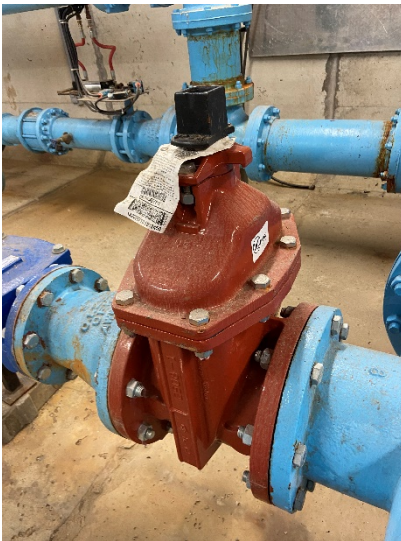
Figure 17: Gate valve on pump 2

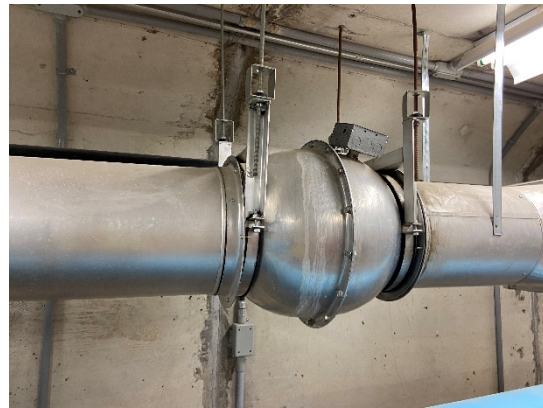
Figure 20: Exhaust Fan

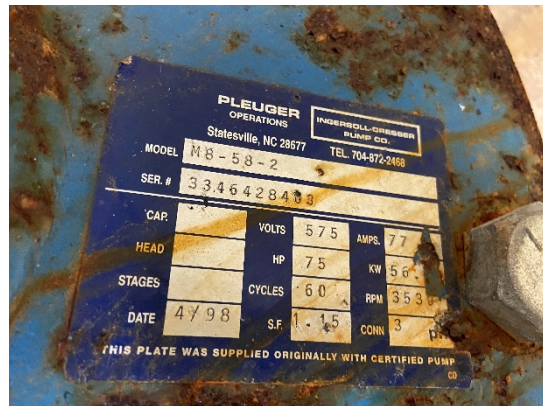
Figure 22: Label on pump 3

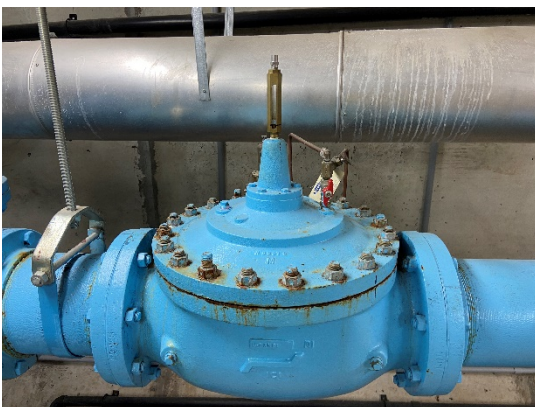
Figure 23: Pressure release valve

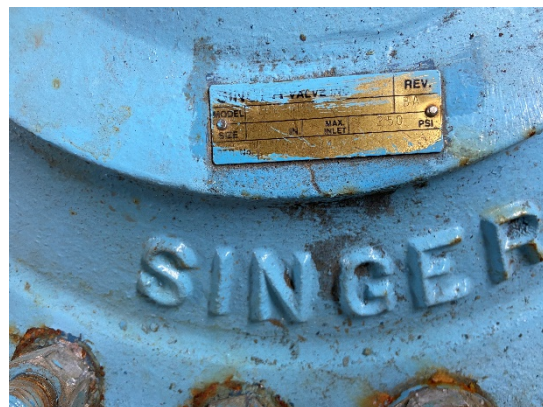
Figure 24: Label on pressure release valve

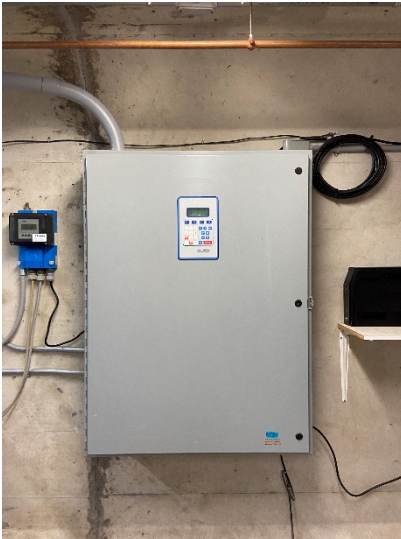
Figure 25: Controller

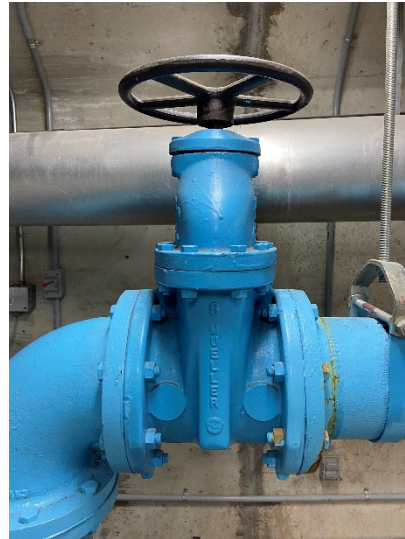
Figure 26: Gate valve on pressure release valve

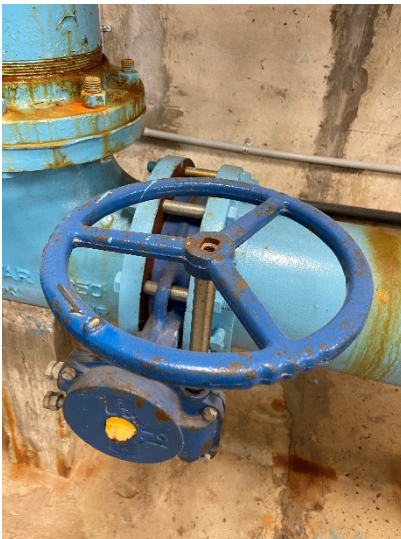
Figure 27: Discharge butterfly valve of pump 3 and pressure reducing valve

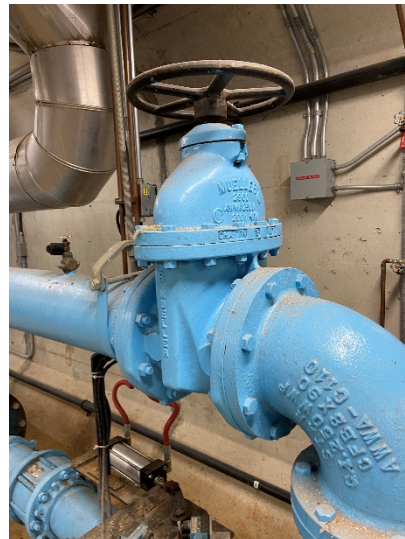
Figure 28: Discharge gate valve on pressure release valve

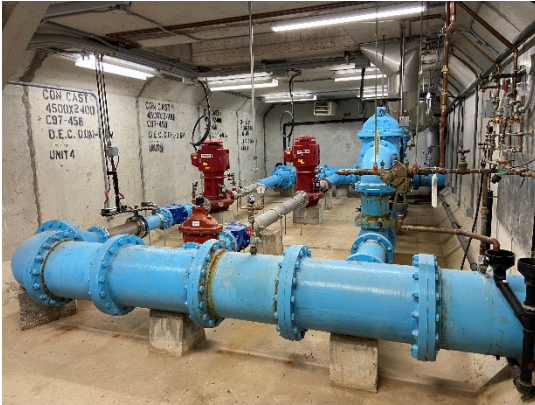
Figure 29: View of station facing northeast

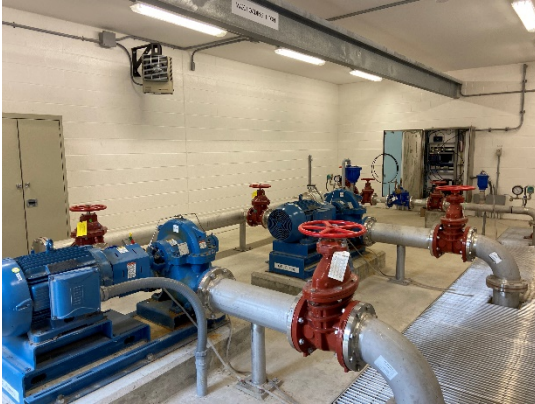
Figure 1: View of station facing northeast

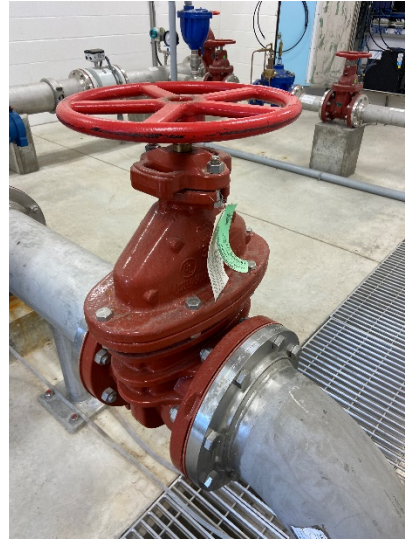
Figure 2: 8" suction gate valve on pump 1

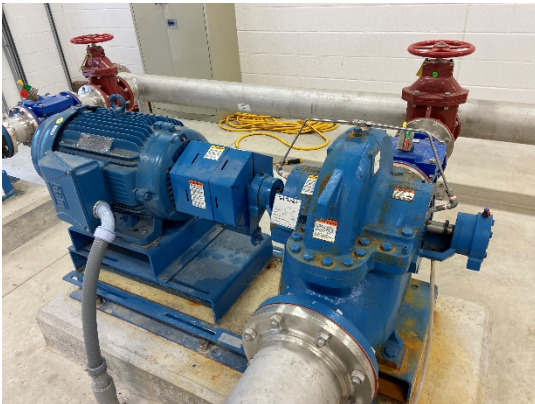
Figure 3: Pump 1

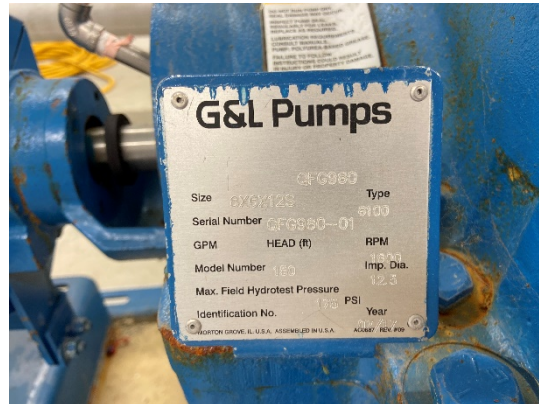
Figure 4: Label on pump 1

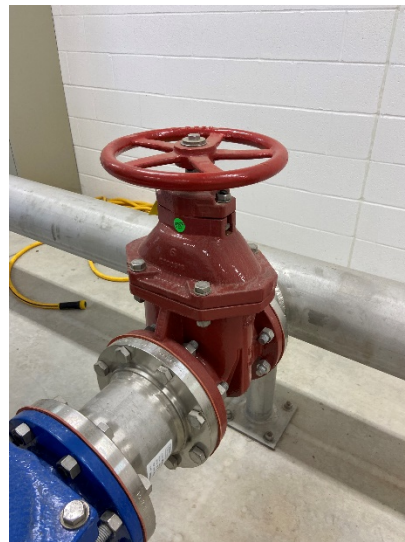
Figure 6: 6" discharge gate valve on pump 1

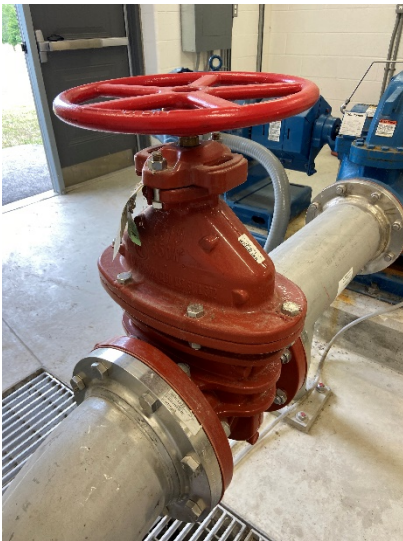
Figure 7: 8" suction gate valve on pump 2

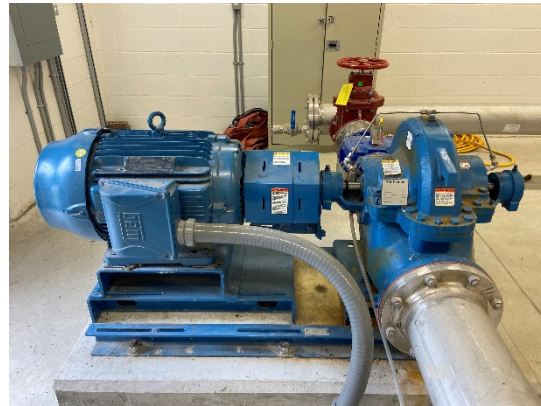
Figure 8: Pump 2

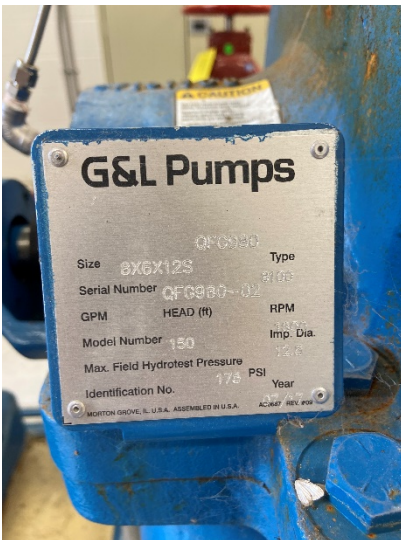
Figure 9: Label on pump 2

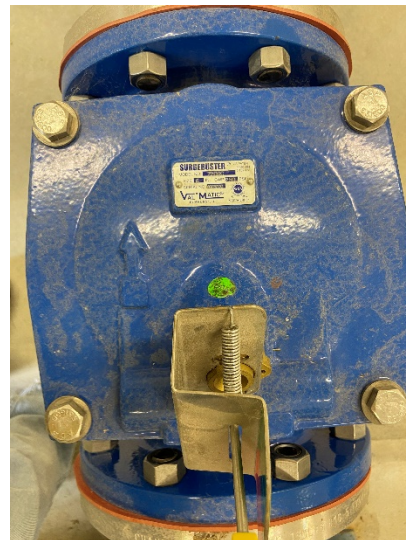
Figure 10: Check valve on pump 2

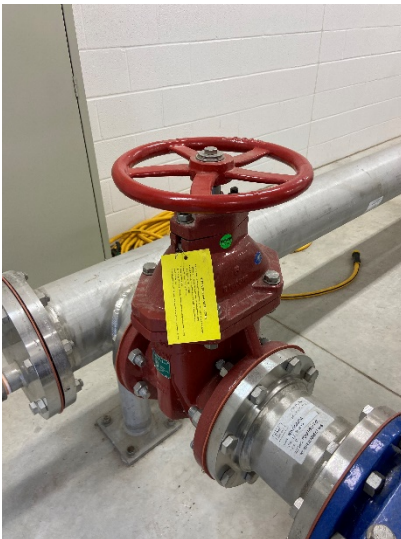
Figure 11: 6" discharge gate valve on pump 2

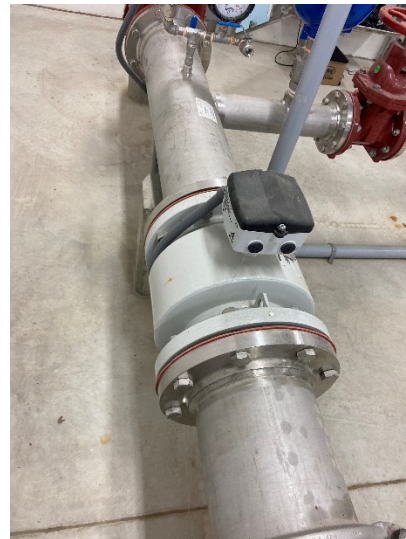
Figure 12: Flow meter
