Peterborough Utilities Commission Water Utility Asset Management Plan

ASSET MANAGEMENT INSPECTION REPORT

Low Lift Pumps –
Peterborough Water
Treatment Plant
1230 Water Street North,
Peterborough ON

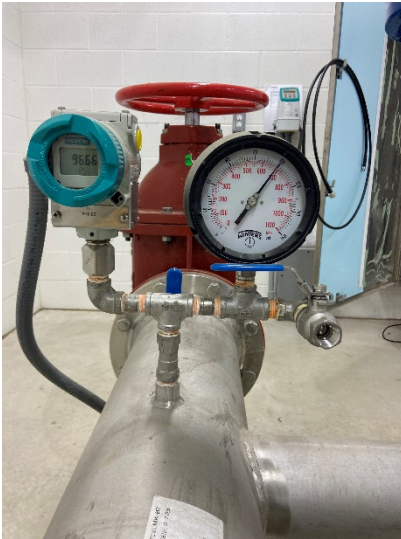
Figure 13: Discharge pressure gauge (Zone 3)

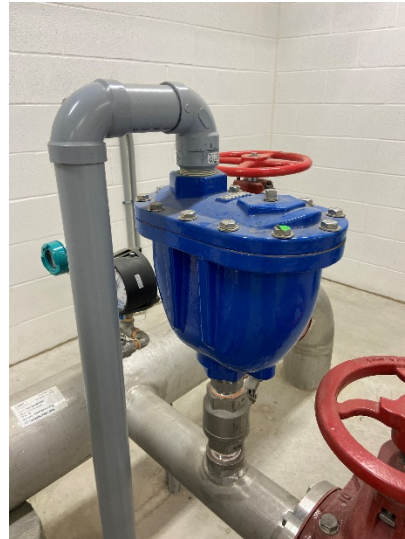
Figure 14: Air release valve

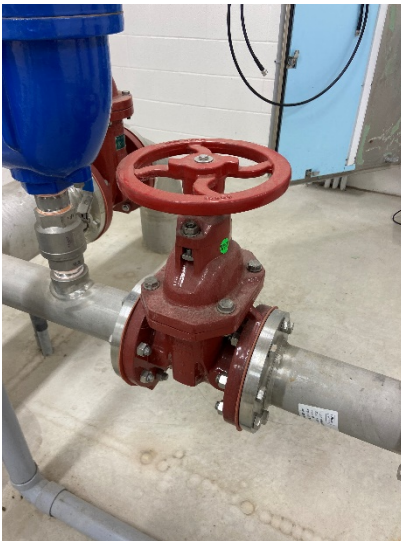
Figure 15: Discharge gate valve on pressure reducing valve

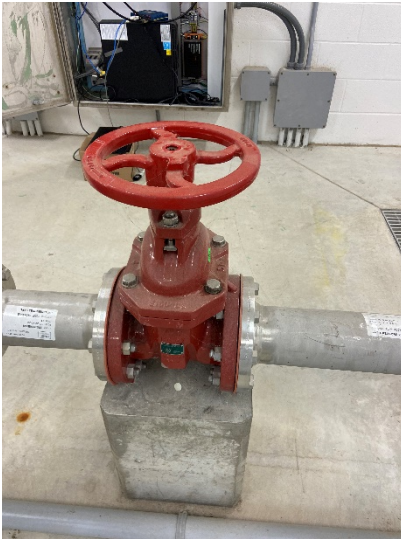
Figure 16: Pressure reducing valve

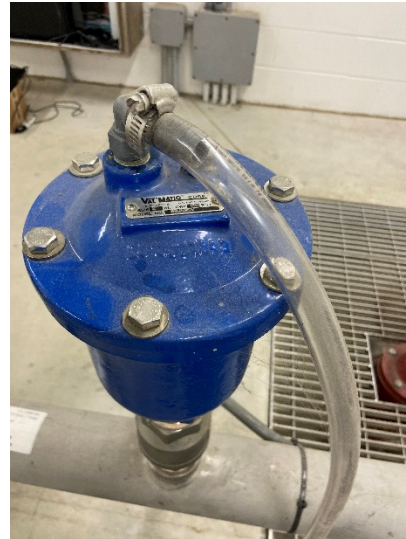
Figure 17: Suction gate valve on pressure reducing valve

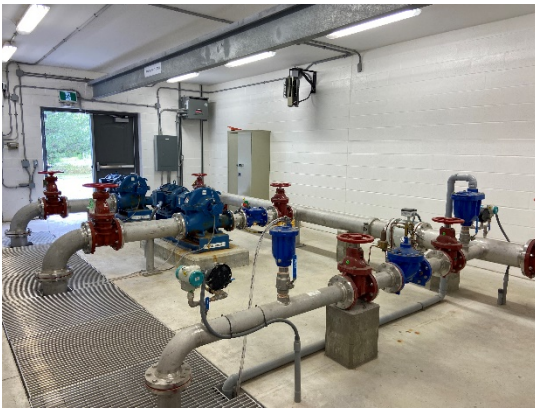
Figure 20: 8" suction gate valve

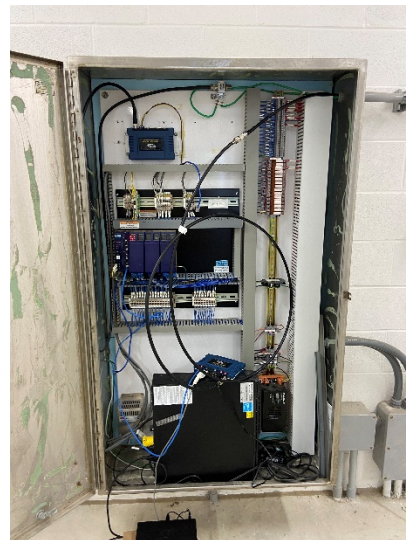
Figure 21: View of station facing northwest

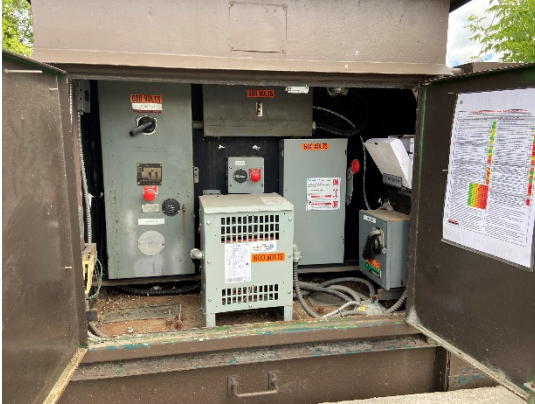
Figure 1: Electrical and SCADA equipment

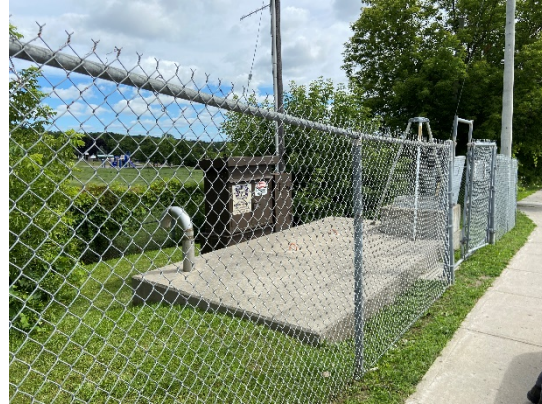
Figure 2: Above ground view of station facing northeast

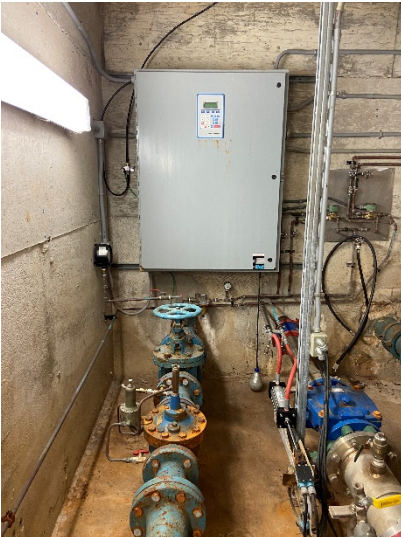
Figure 3: Pump controls in southwest corner of the station

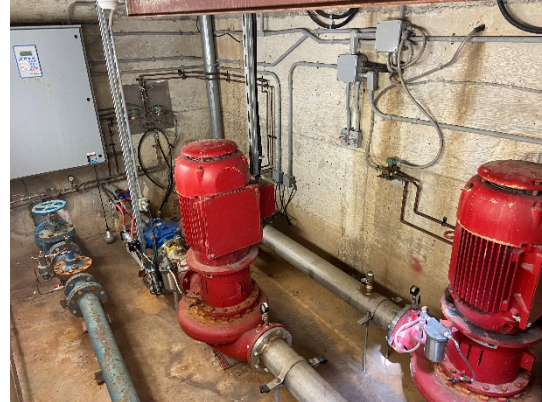
Figure 4: View of station facing northwest from ladder

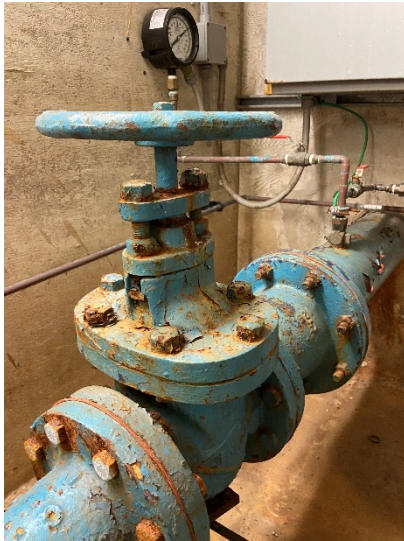
Figure 5: Gate valve on bypass

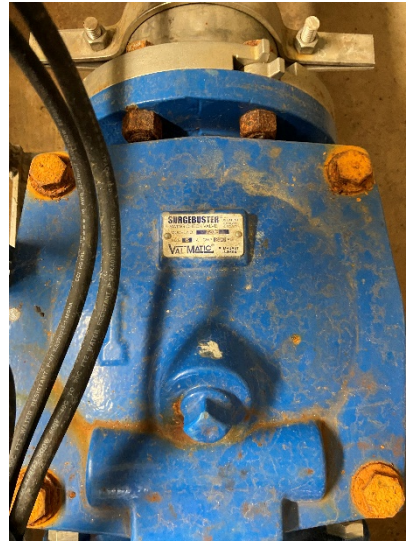
Figure 6: Check valve on pump 2

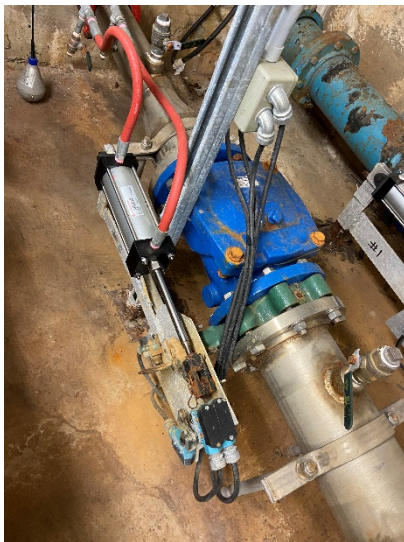
Figure 7: Butterfly and check valve on pump 2

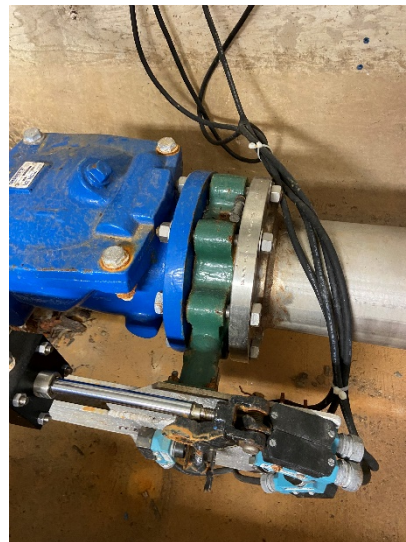
Figure 8: Butterfly and check valve on pump 1

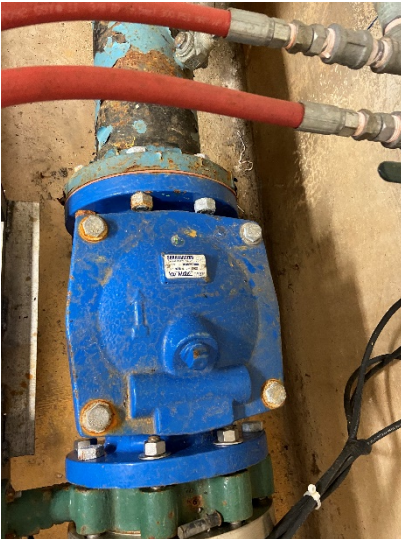
Figure 9: Check valve on pump 1

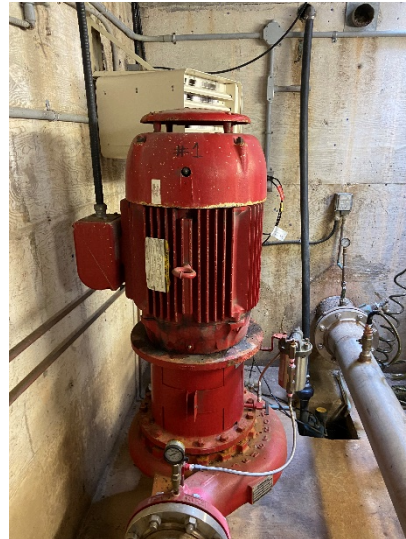
Figure 10: Pump 1

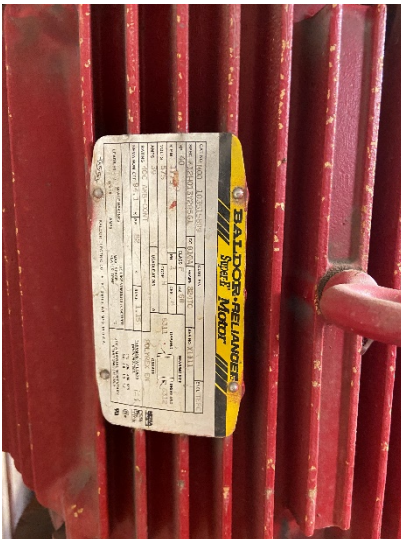
Figure 11: Label on pump 1

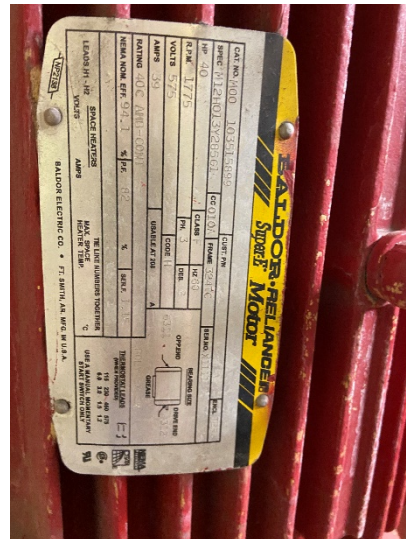
Figure 12: Label on pump 2

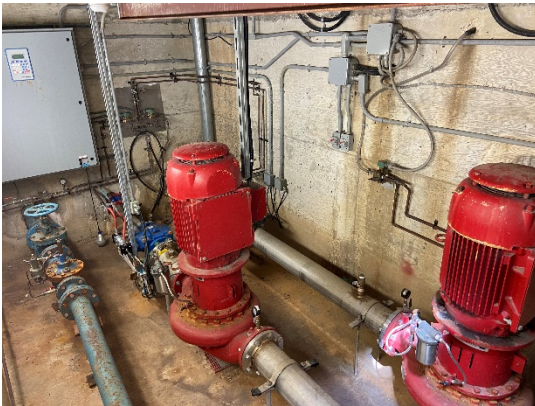
Figure 15: View of station facing northwest from ladder

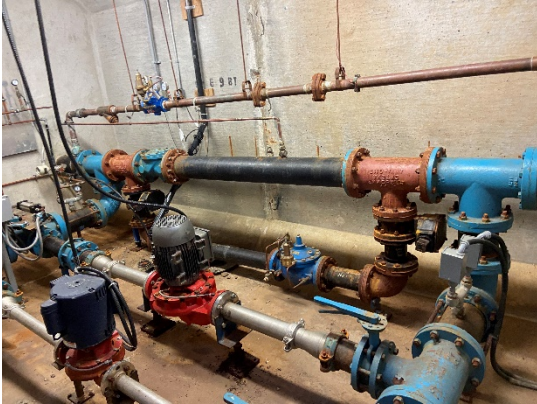
Figure 1: View of station facing northeast

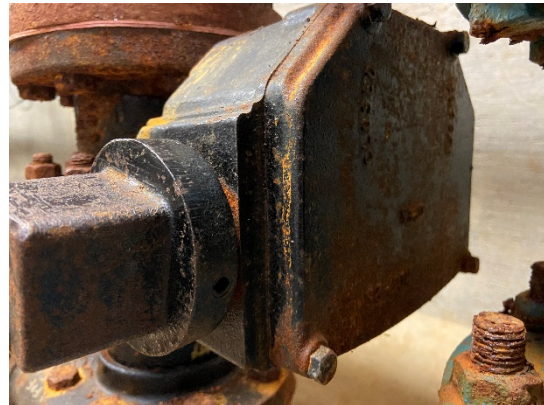
Figure 4: Butterfly valve on pressure reducing valve (discharge)

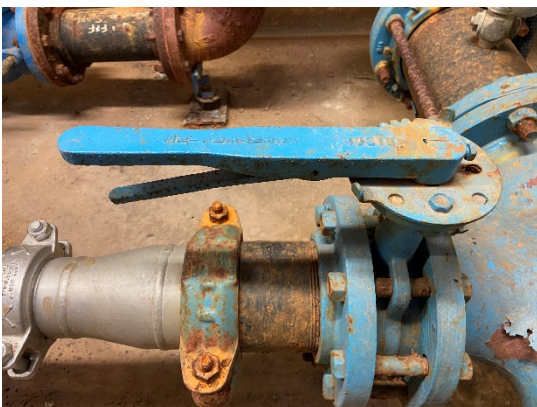
Figure 5: Butterfly control valve on pump 1

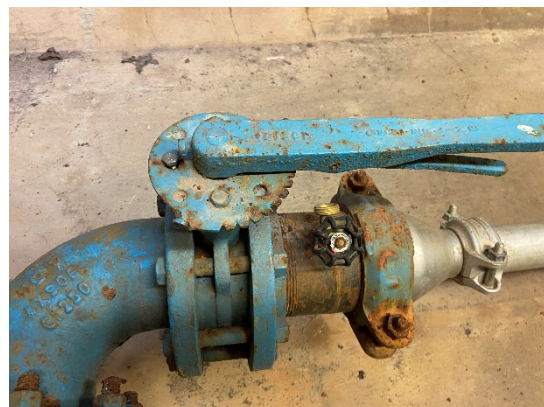
Figure 6: Butterfly control valve on pump 2

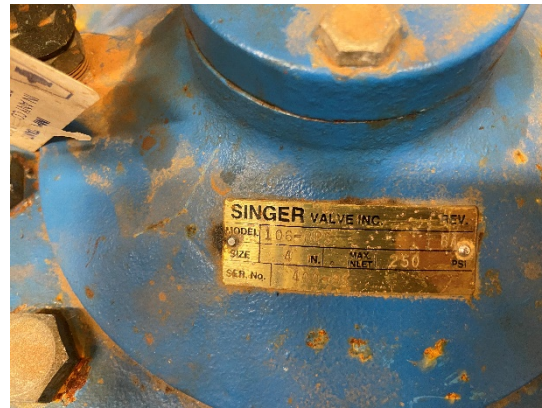
Figure 8: Label on 6" pressure reducing valve

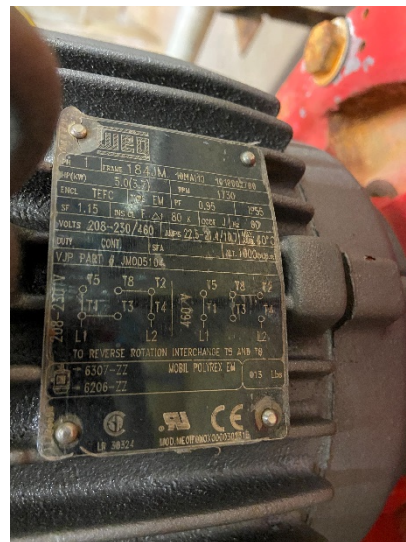
Figure 10: Label on pump 1

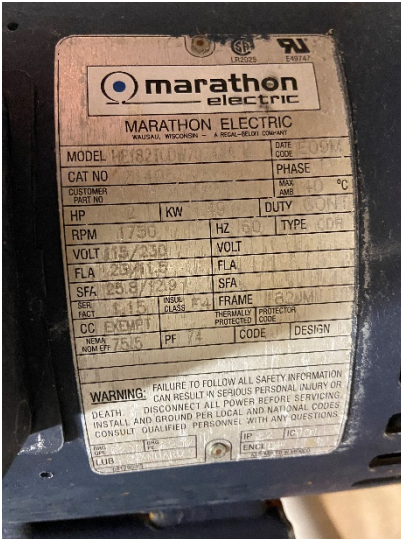
Figure 11: Label on pump 2

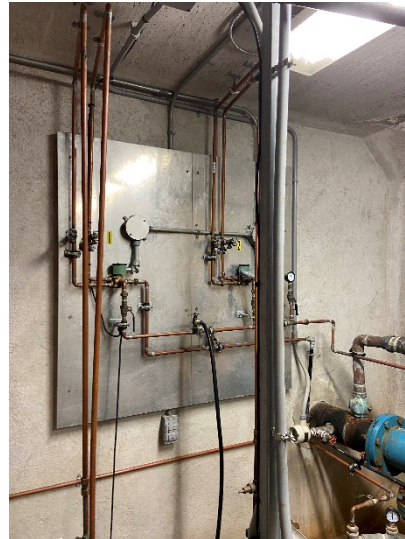
Figure 12: Automatic valve controls

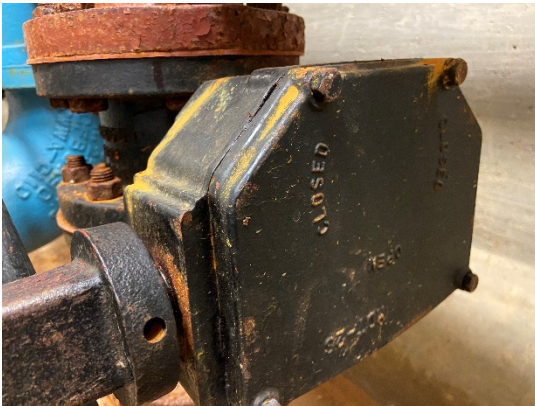
Figure 13: Butterfly valve on pressure reducing valve (suction)

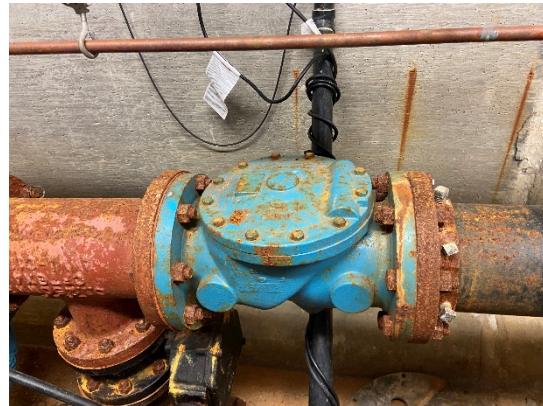
Figure 14: Check valve on by-pass

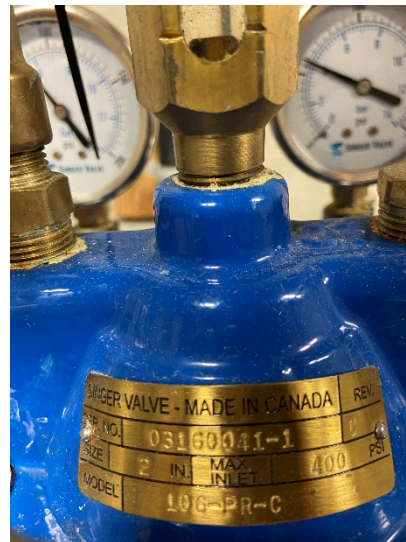
Figure 16: Label on 2" pressure reducing valve

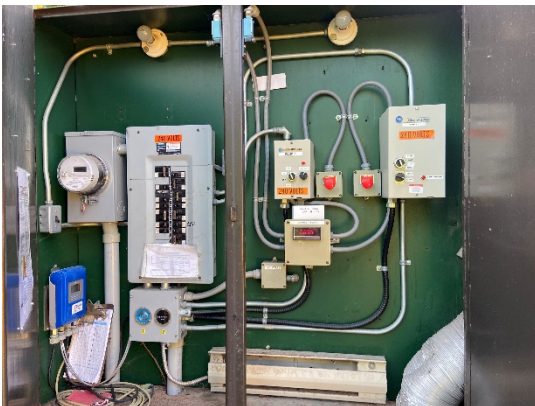
Figure 17: Electrical and SCADA box above station

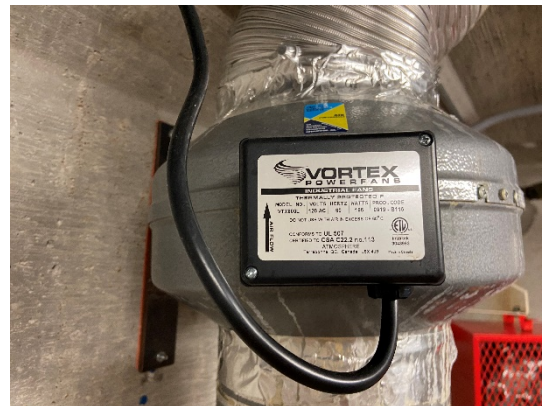
Figure 18: Exhaust Fan

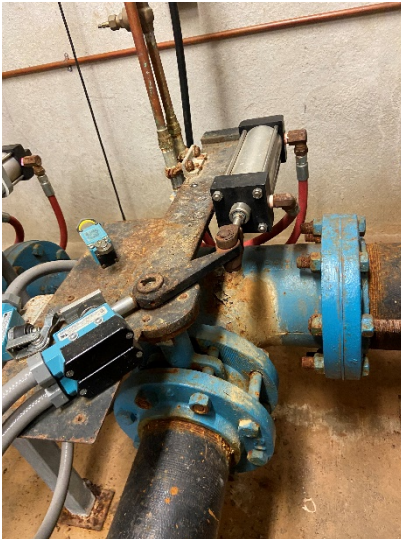
Figure 19: Butterfly valve on pump 1 (suction)

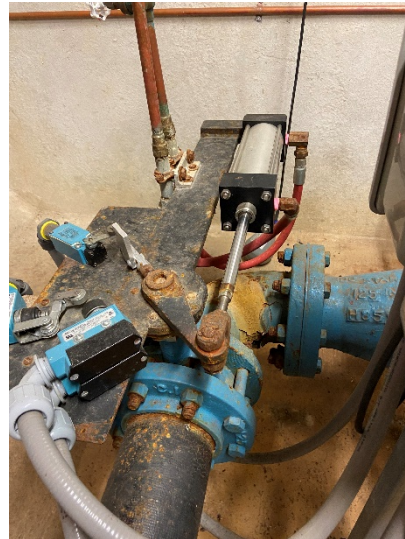
Figure 20: Butterfly valve on pump 2 (suction)

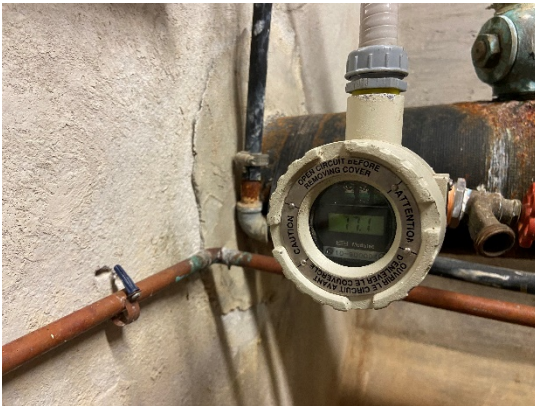
Figure 21: Water Meter

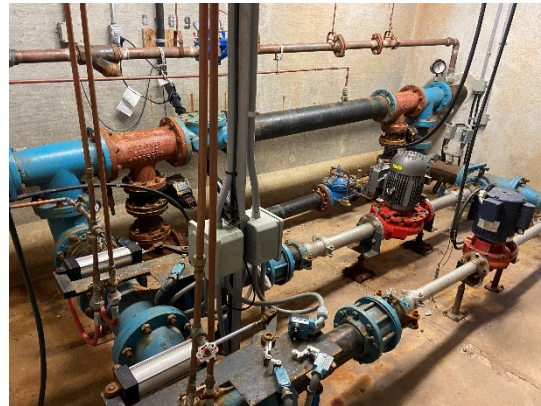
Figure 22: View of station facing northwest

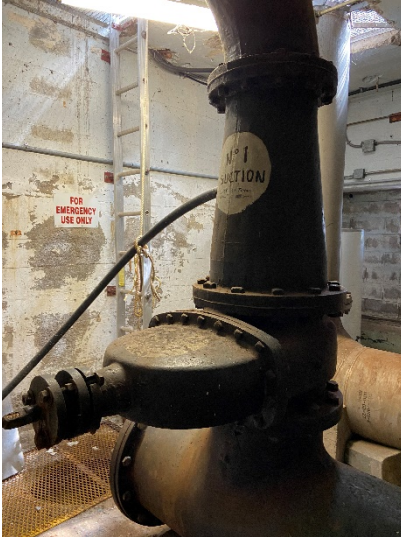
Figure 1: Pump 1 18" suction gate valve

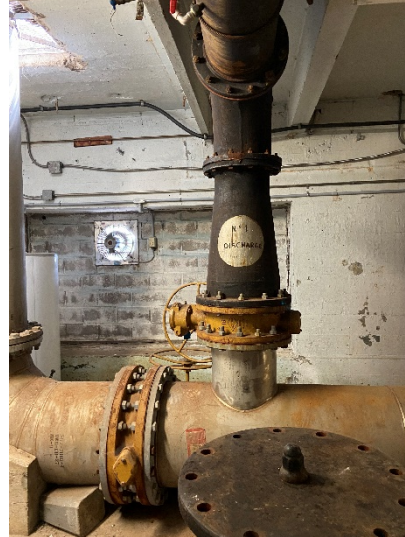
Figure 2: Pump 1 16" discharge butterfly valve

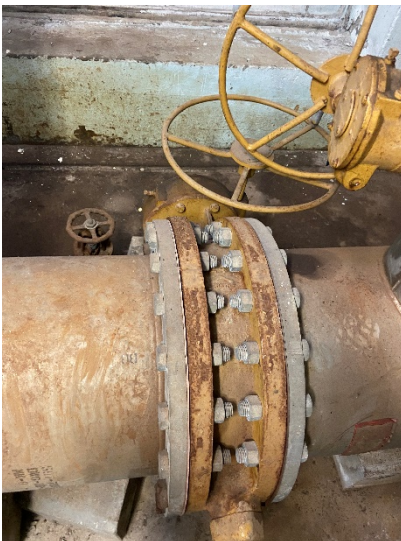
Figure 3: 24" butterfly valve

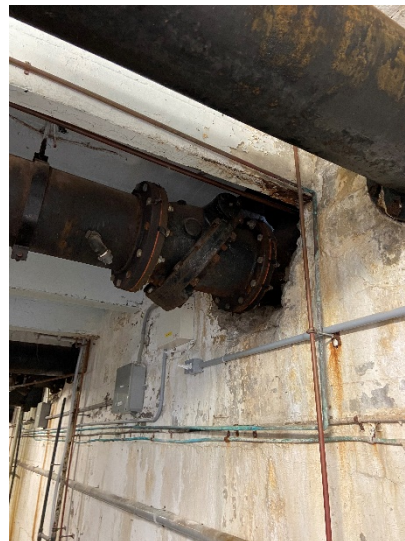
Figure 4: Pump 1 12" discharge check valve

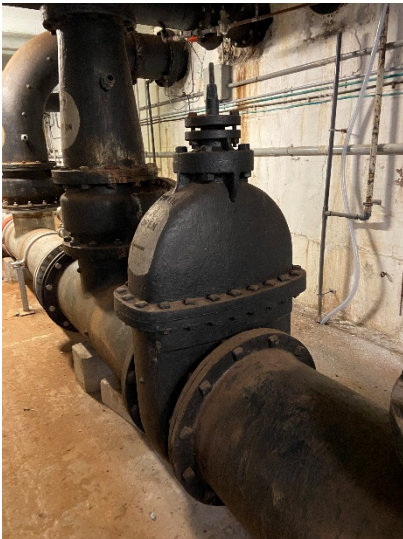
Figure 5: 20" gate valve

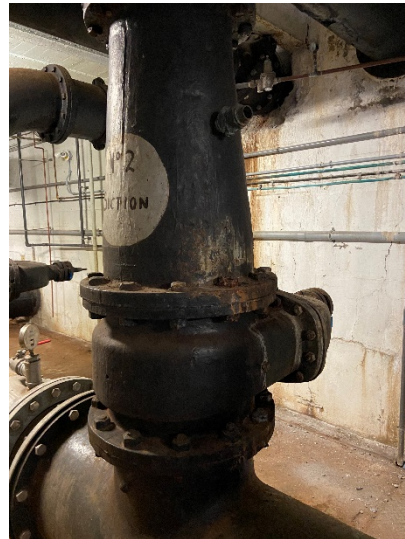
Figure 6: Pump 2 18" suction gate valve

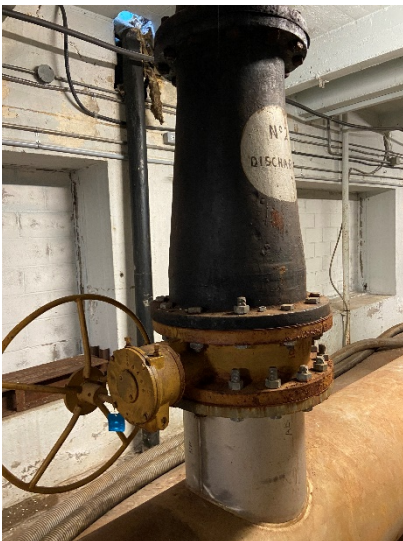
Figure 7: Pump 2 16" discharge butterfly valve

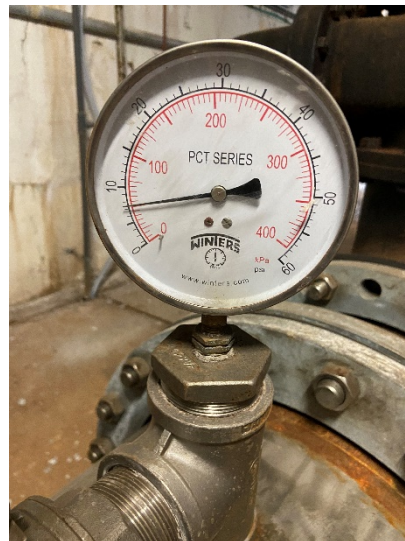
Figure 8: Suction pressure gauge

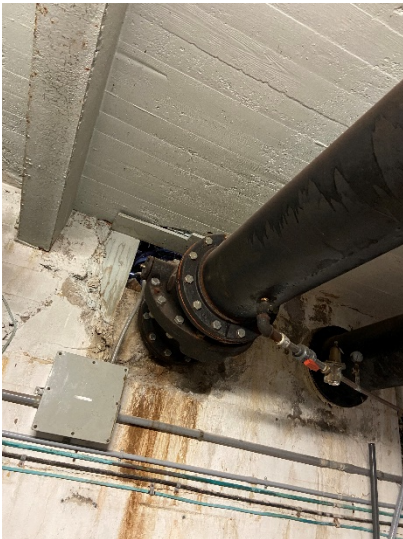
Figure 9: Pump 2 12" discharge check valve

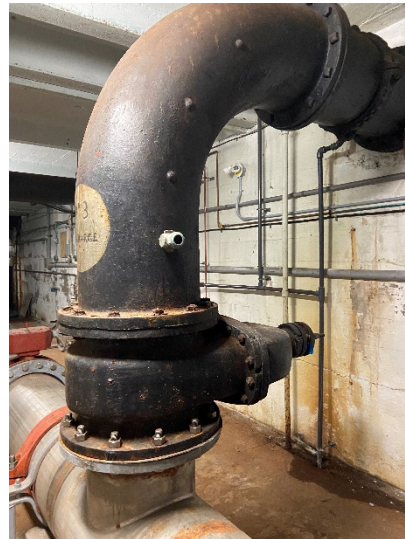
Figure 10: Pump 3 16" suction gate valve

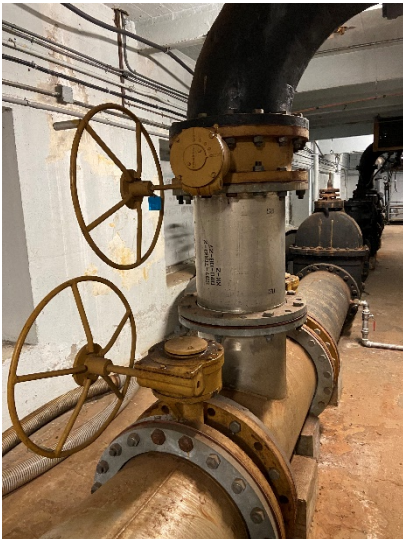
Figure 11: Pump 3 16" discharge butterfly valve

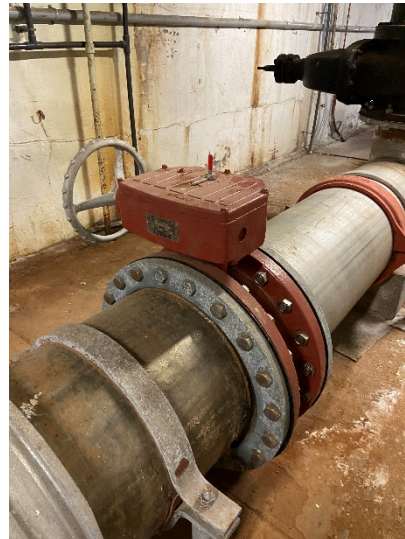
Figure 12: 20" butterfly valve

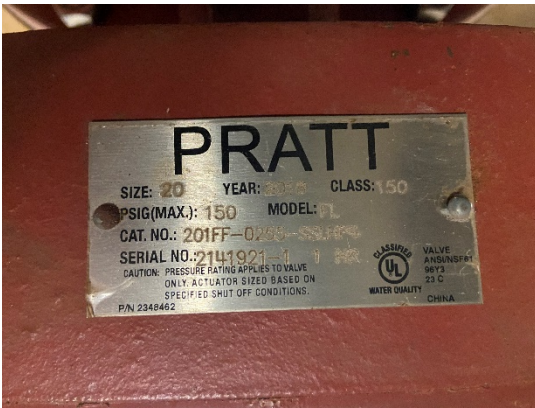
Figure 13: Label on butterfly valve

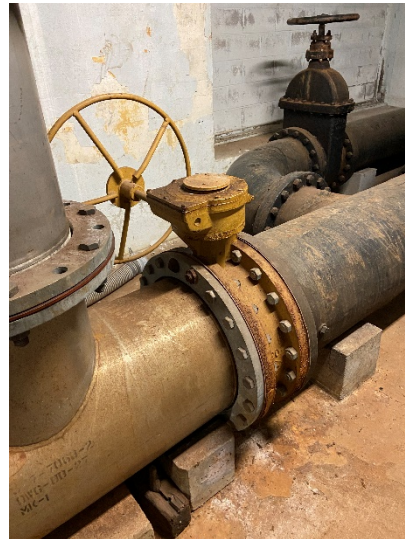
Figure 14: 20" butterfly valve

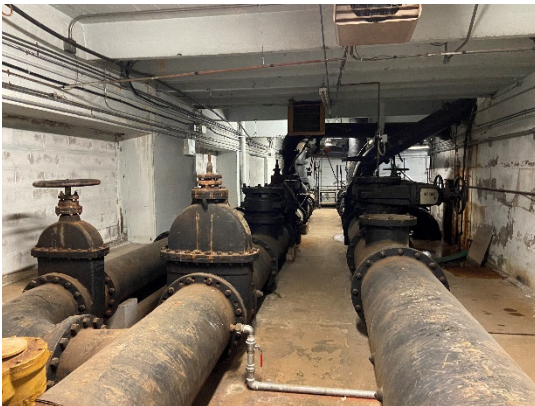
Figure 15: View of station's basement facing west

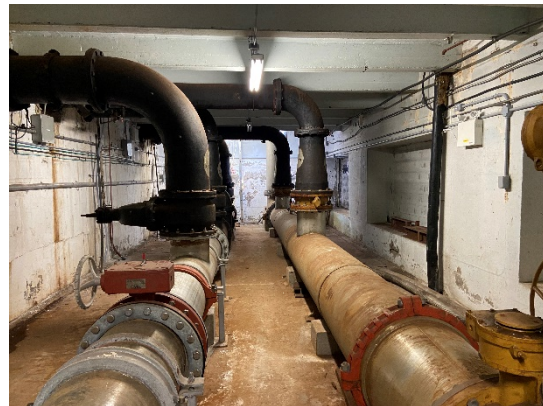
Figure 16: View of station's basement facing east

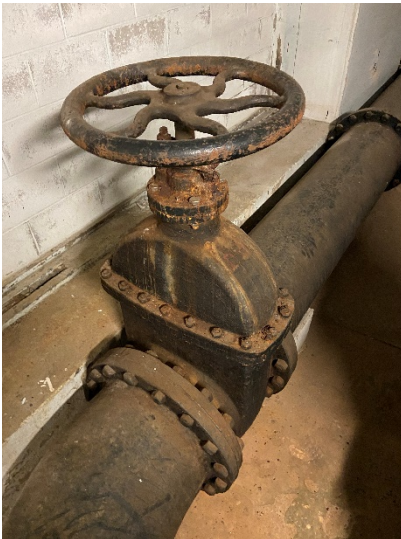
Figure 17: Zone 1 discharge gate valve

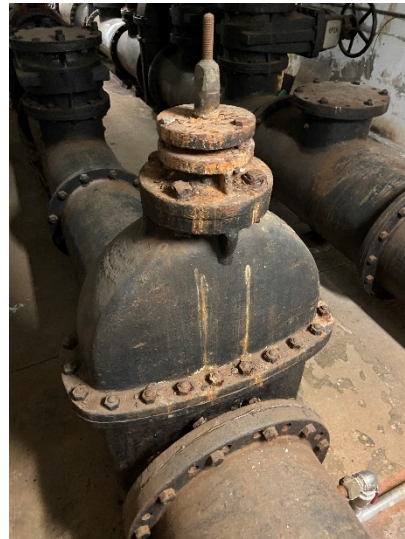
Figure 18: 20" gate valve

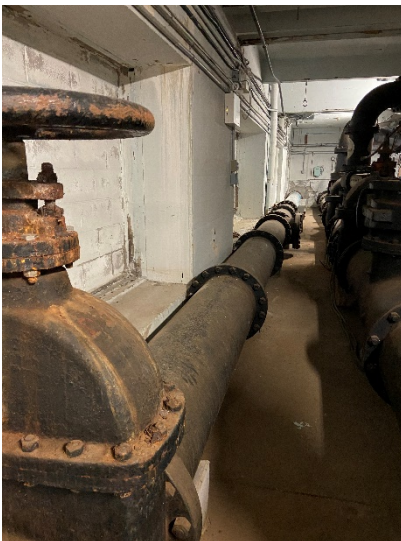
Figure 19: Zone 1 discharge

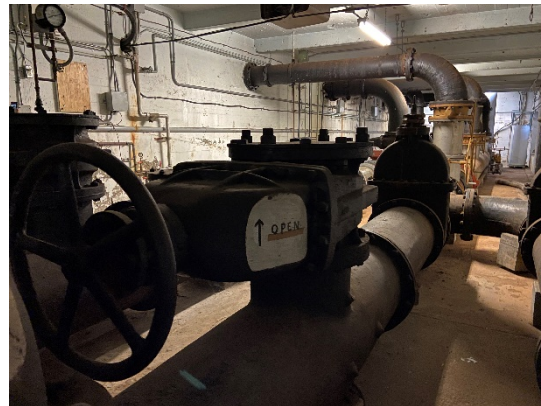
Figure 20: Gate valve on tee

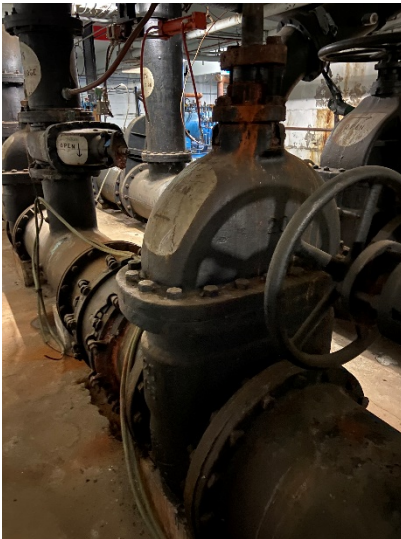
Figure 21: 20" discharge gate valve

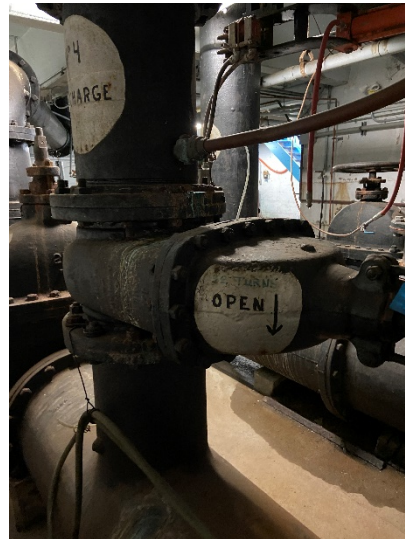
Figure 22: Pump 4 10" discharge gate valve

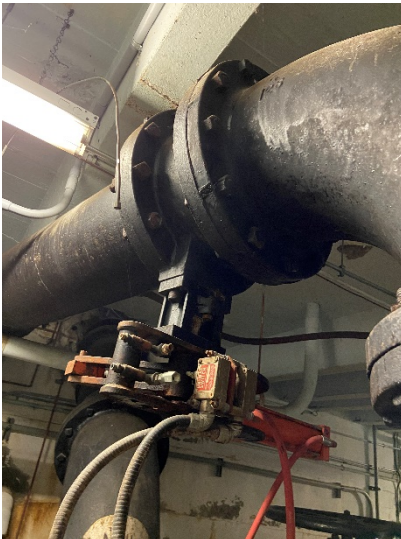
Figure 23: Pump 4 suction butterfly valve

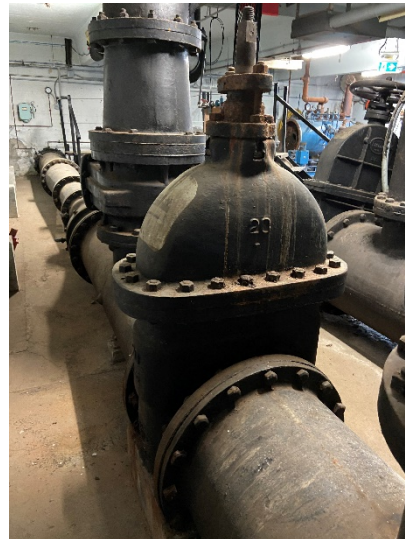
Figure 24: Zone 1 20" discharge gate valve

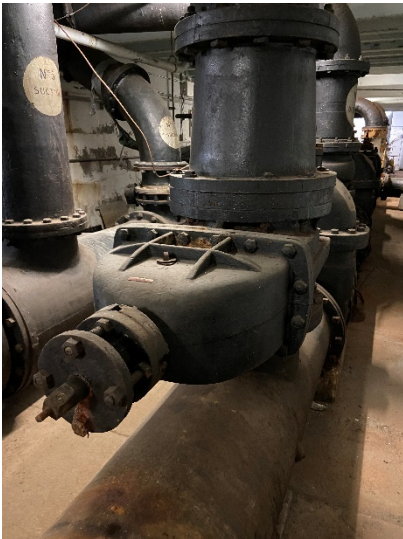
Figure 25: Pump 5 16" discharge gate valve

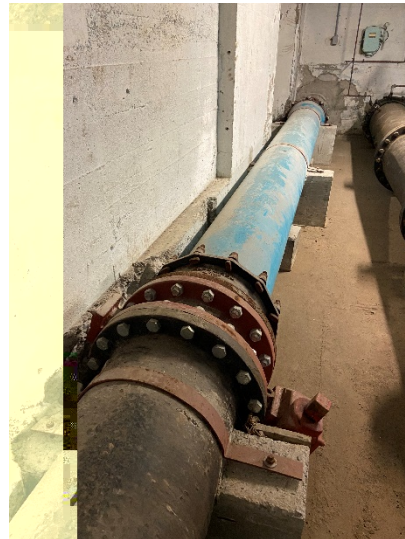
Figure 26: Zone 1 discharge

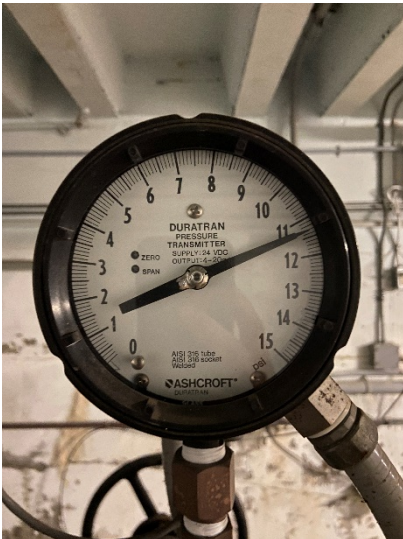
Figure 27: Zone 1 pressure

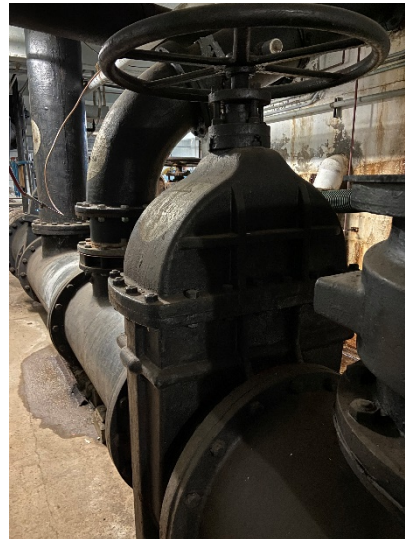
Figure 28: Suction gate valve

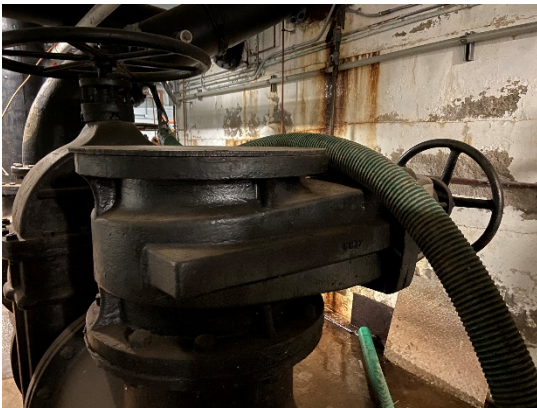
Figure 29: Out of use gate valve

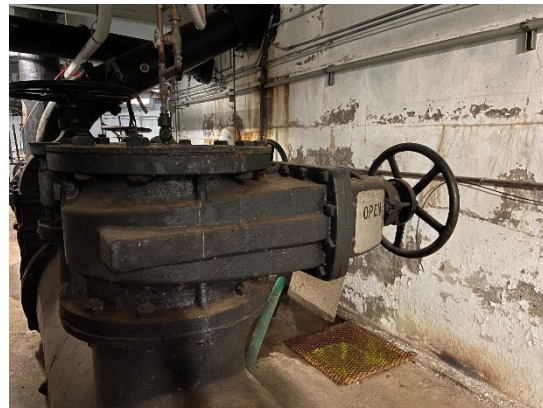
Figure 30: Disused gate valve

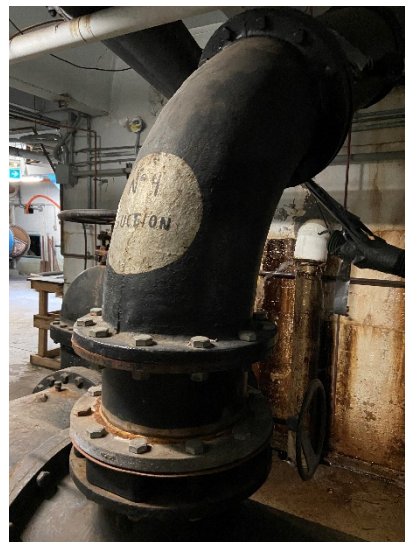
Figure 31: Pump 4 suction butterfly valve

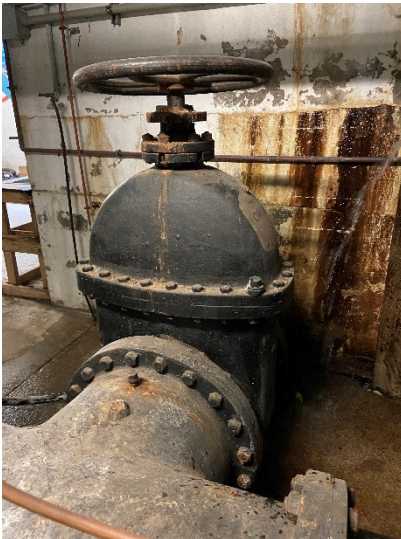
Figure 32: Pump 4 suction pipe

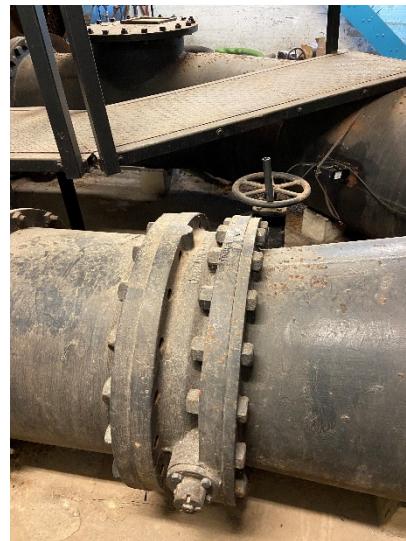
Figure 35: Suction gate valve

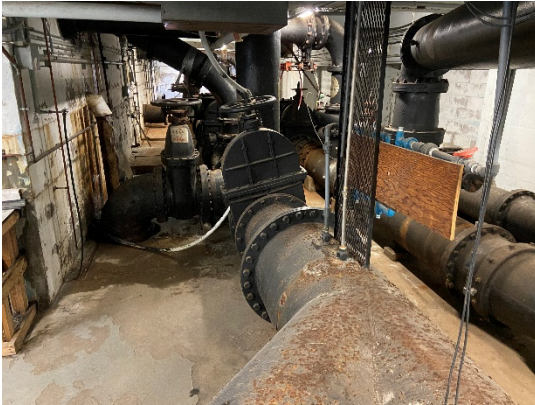
Figure 36: 24" butterfly valve

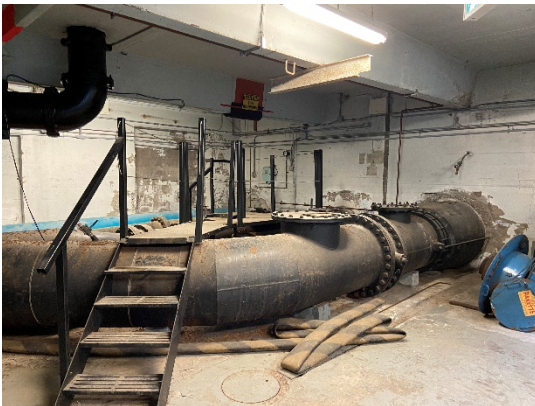
Figure 38: 30" butterfly valve

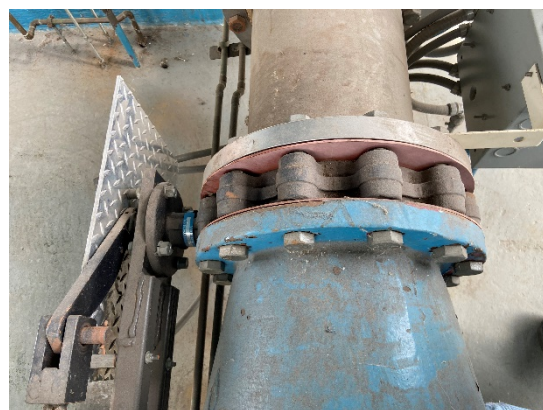
Figure 41: Pump 5 and motor

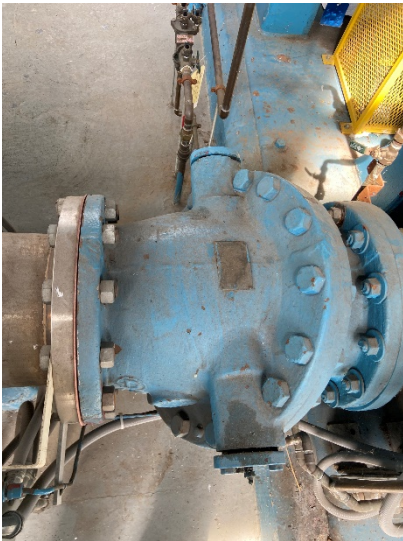
Figure 42: 10" butterfly valve on pump 5 with hydraulic controls

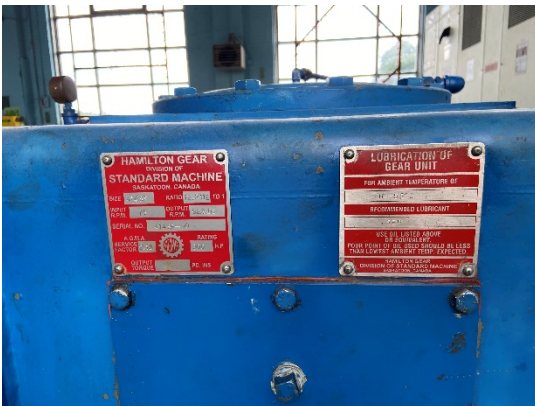
Figure 52: Generator 3 gear box

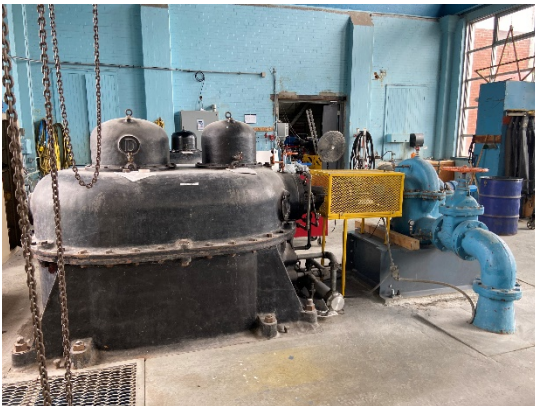
Figure 58: Pump 3

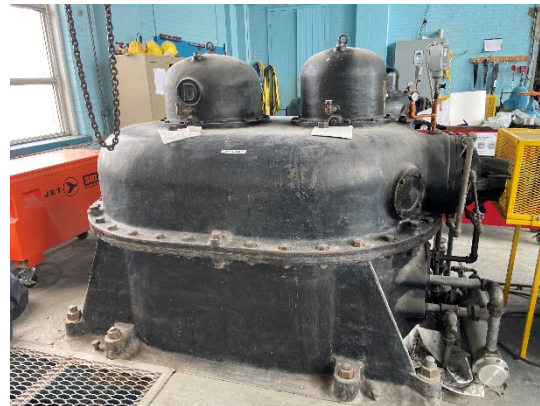
The pumps, turbines, waterwheels, gear increasers and decreasers are all in working condition, however, are at the end of their serviceable design life. Pump one (1) and two (2) were installed in 1945. Pump four was installed in 1935. The age of pumps three (3) and five (5) are unknown. The generators are in fair condition. The gate valves, butterfly valves and check valves have some discolouration and surface rust due to age and environmental factors. The process mechanical equipment is in poor to fair condition.

Figure 59: Pump 2 and motor

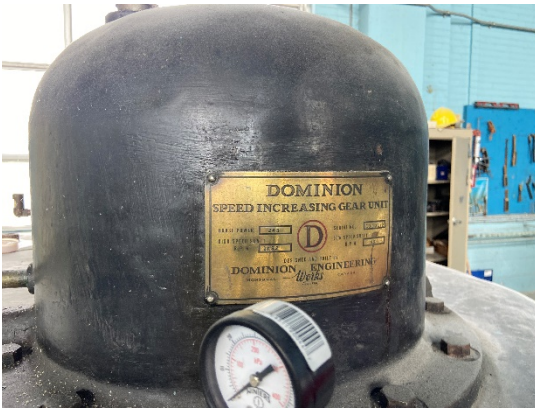
Figure 60: Gear increaser on pump 2

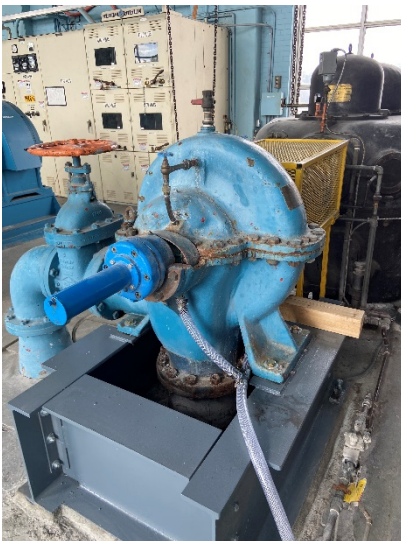
Figure 62: 8" gate valve on pump 2

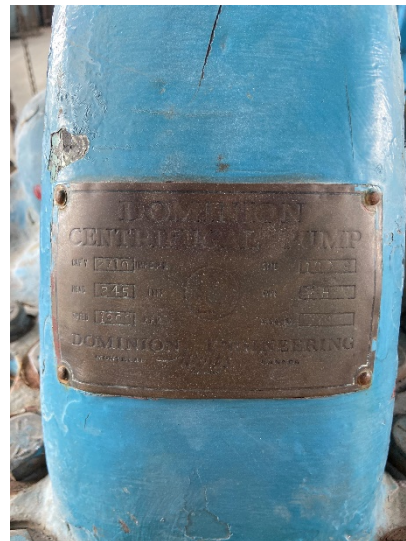
Figure 63: Pump 2

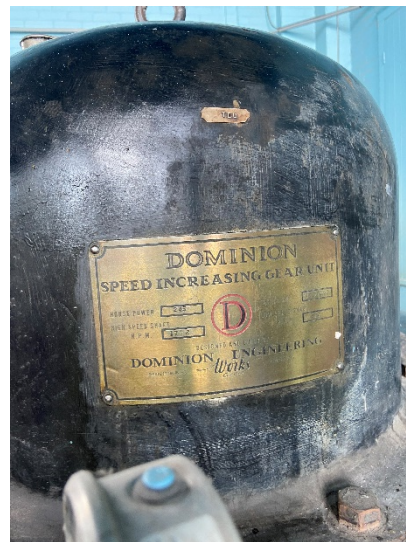
Figure 65: Pump 1 and motor

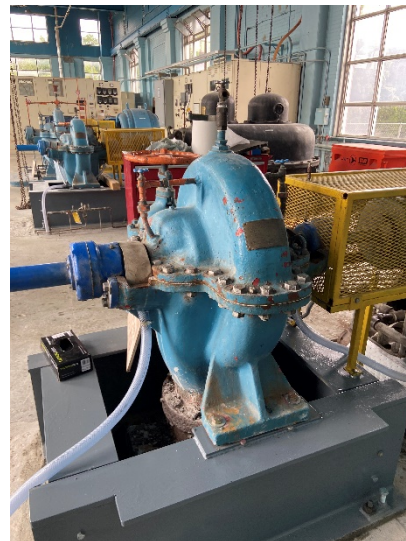
Figure 67: 8" gate valve on pump 1

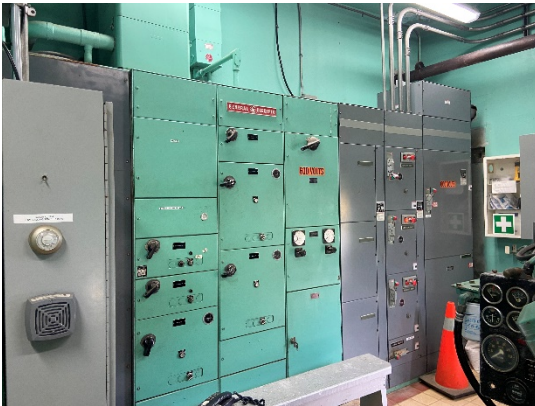
Figure 7: Electrical cabinets

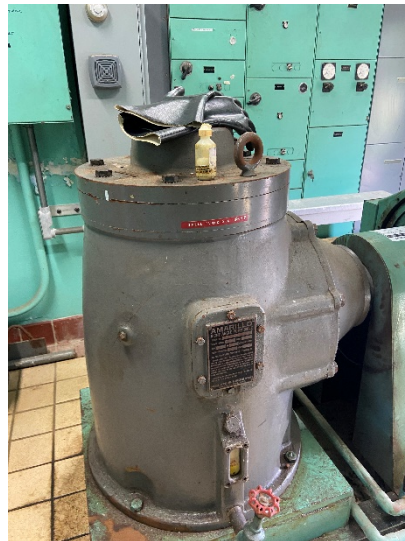
Figure 8: Pump 4 drive

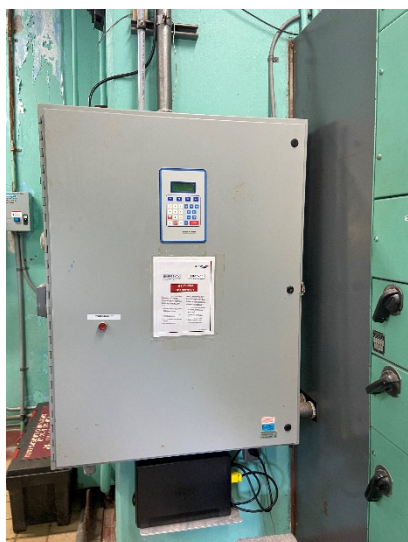
Figure 9: Electrical control box

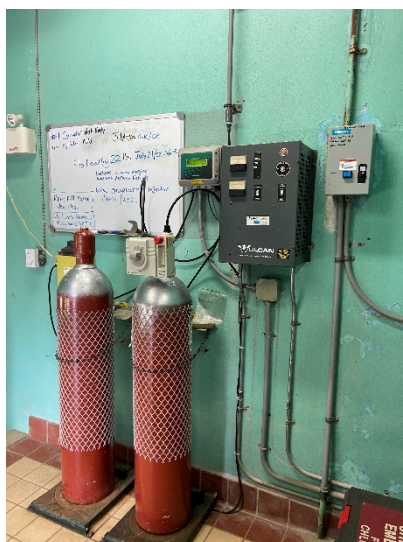
Figure 10: Chlorine injection system

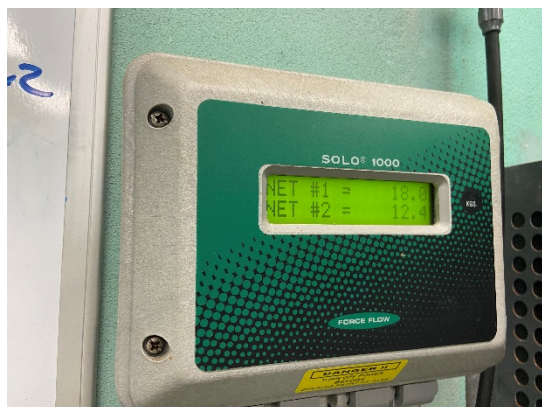
Figure 11: Chlorine scale

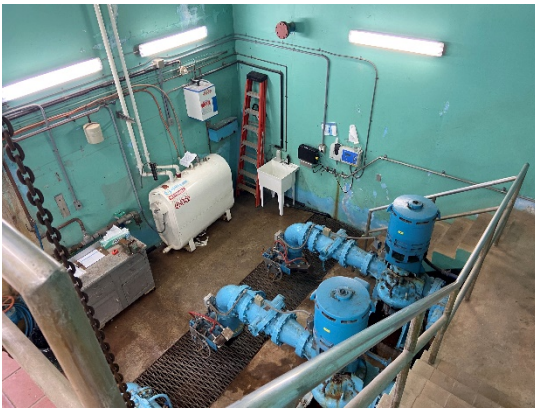
Figure 13: View of pumps from above

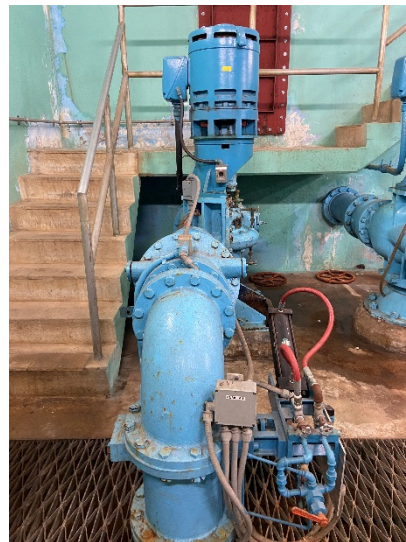
Figure 14: Pump 1 and butterfly valve

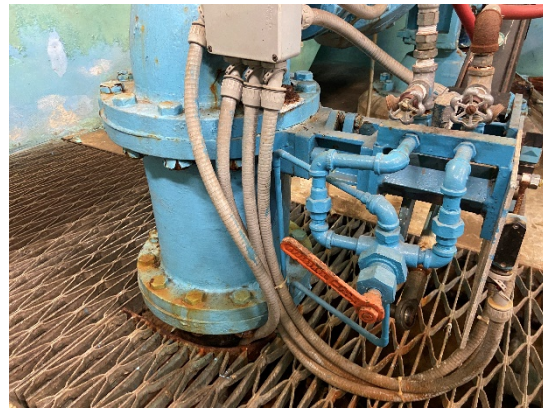
Figure 18: Hydraulic butterfly valve on pump 1

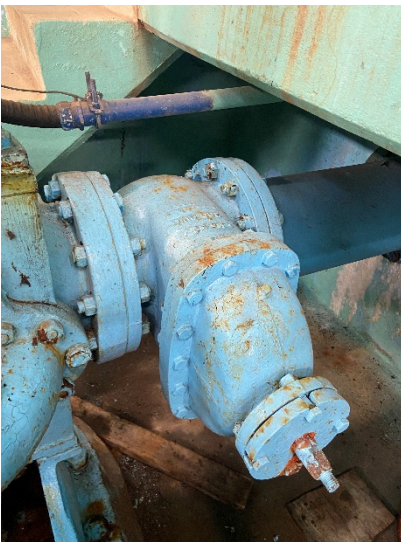
Figure 19: Gate valve on pump 1

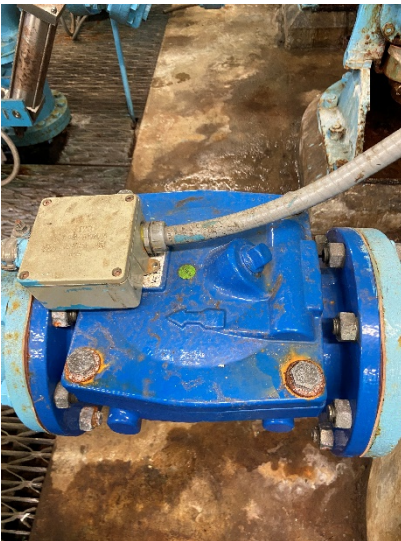
Figure 27: New check valve on pump 3

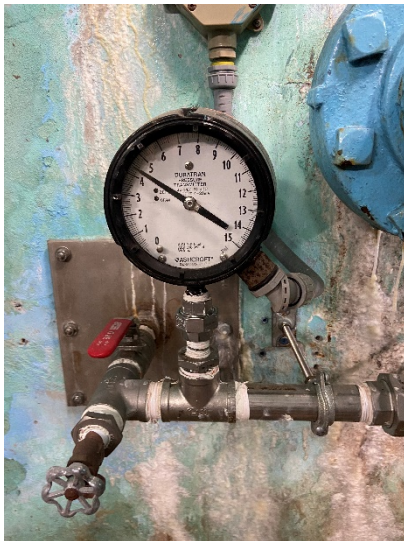
Figure 31: Pressure gauge

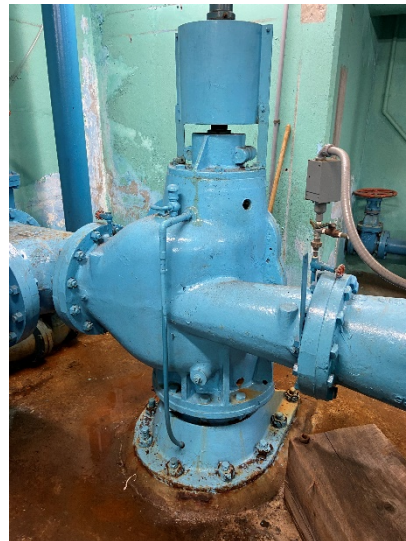
Figure 32: Pump 4

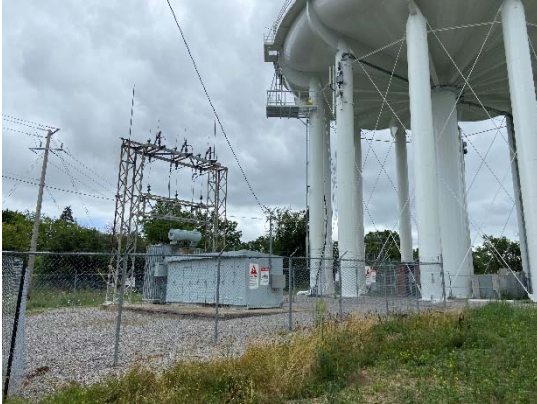
Figure 1: Hydro 1 sub-station

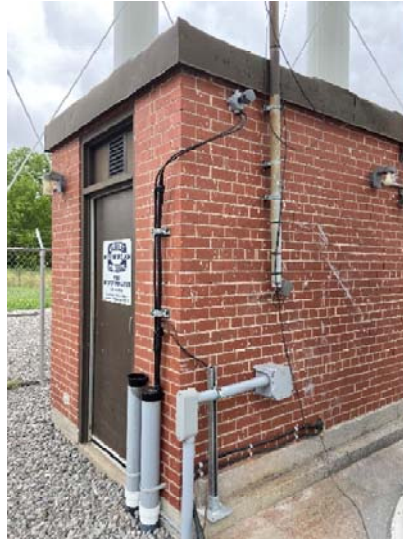
Figure 2: Electrical building

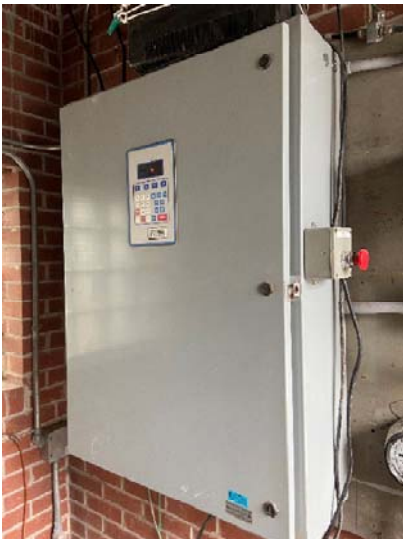
Figure 3: Electrical/SCADA cabinet

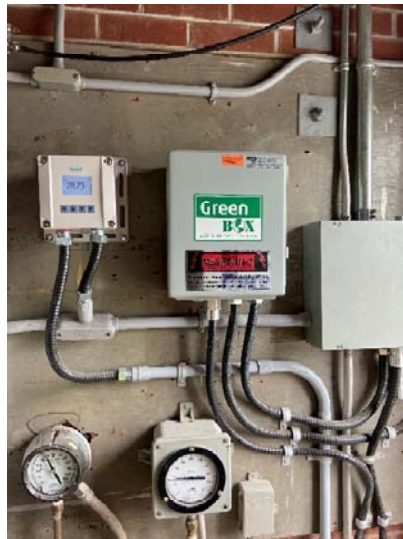
Figure 4: Electrical/SCADA equipment

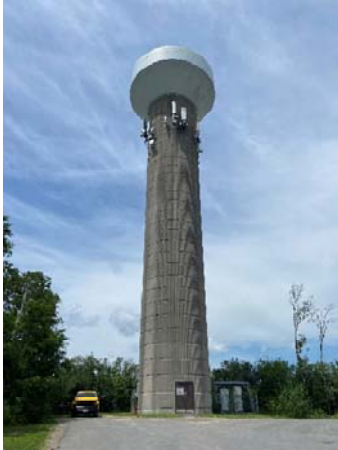
The Milroy Elevated Tank is a composite water tank and the newest water tower in Peterborough. Since its construction in 1987, no changes have been made to the tower or water tank other than routine maintenance and cleaning. All equipment is above grade at the base of the tower. The inlet/outlet pipe is a 300mm ductile iron watermain. The structure appears to be in fair to good condition and no concerns were identified, however it is expected that the interior of the tank may be exhibiting signs of corrosion. An internal inspection is recommended for the tank to verify condition, but it is anticipated to be fair to poor.

Figure 1: Milroy Elevated Tank

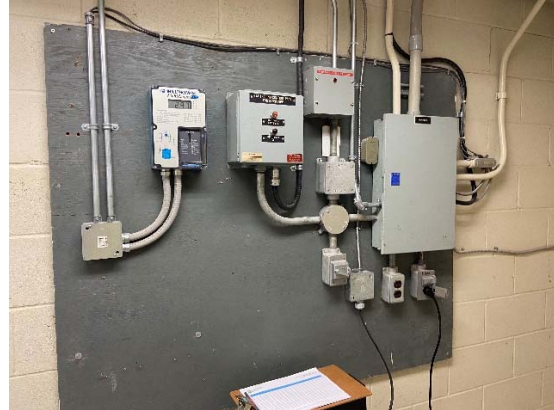
Figure 2: Control Panel in valve room
