Peterborough Utilities Commission Water Utility Asset Management Plan

ASSET MANAGEMENT INSPECTION REPORT

Low Lift Pumps –
Peterborough Water
Treatment Plant
1230 Water Street North,
Peterborough ON

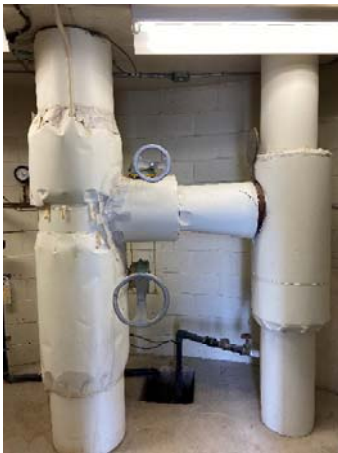
Inside the valve room there is a sump pump, and it appears to be in good condition. The two (2) butterfly valves are wrapped in insulation. The valves are in fair condition with limited inspection due to insulation. All valves in the bulk fill station are in as new condition.

Figure 3: Two butterfly valves on 12" feed pipe and 6" overflow pipe

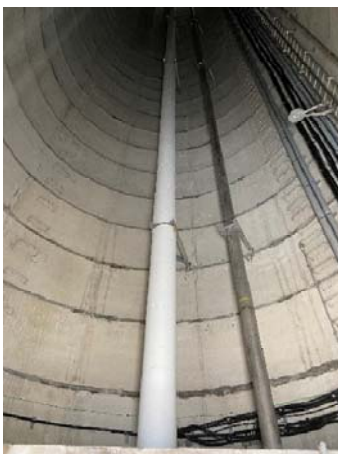
The tower is fed with a 300mm inlet pipe and is in good condition. At the time of the inspection, the insulation around the pipe appeared adequate. The process piping for the bulk fill station is in excellent condition.

Figure 5: 12" feed pipe

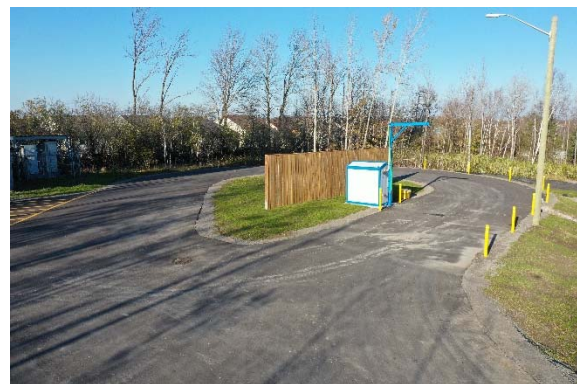
The bulk fill station is a pre-engineered building, with steel cladding, a keypad and card reader on the south face of the building for customers. The structure is anchored to a concrete slab foundation.

Figure 6: Bulk Water Fill Station

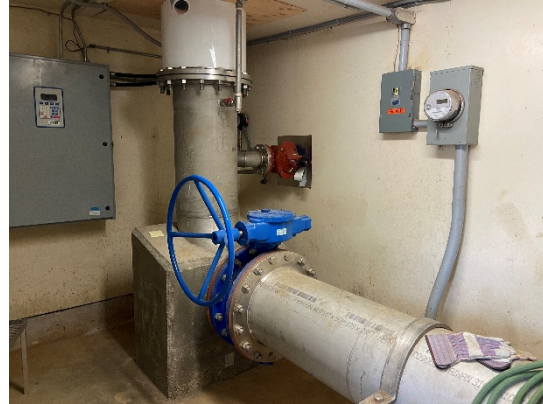
Figure 2: 16" Butterfly valve

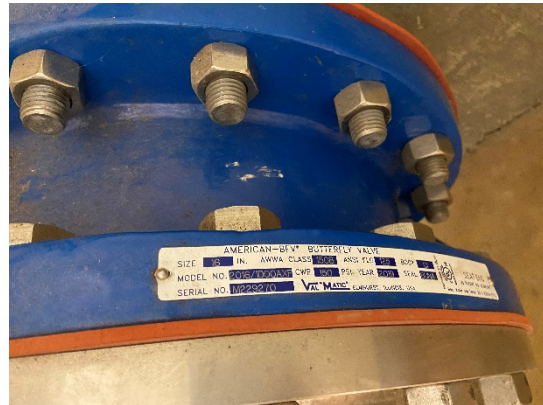
Figure 4: Label on butterfly valve

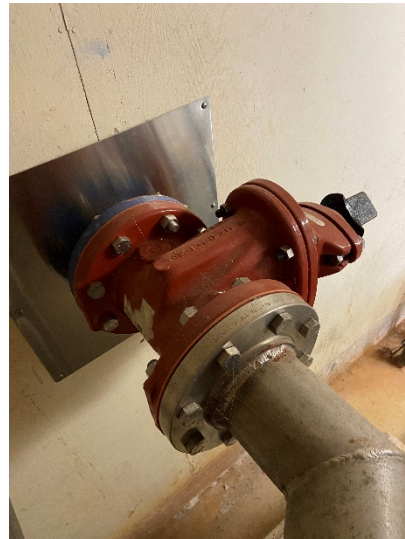
Figure 6: 4" gate valve (drain valve)

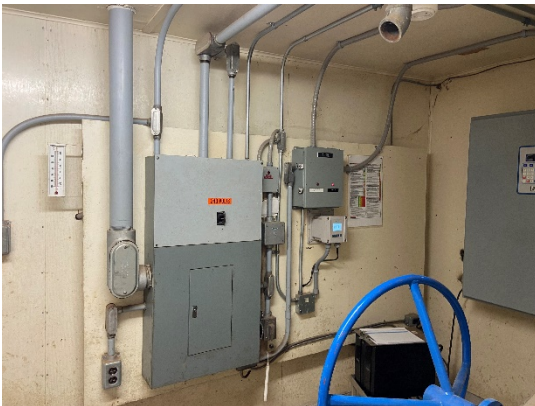
Figure 7: Electrical box

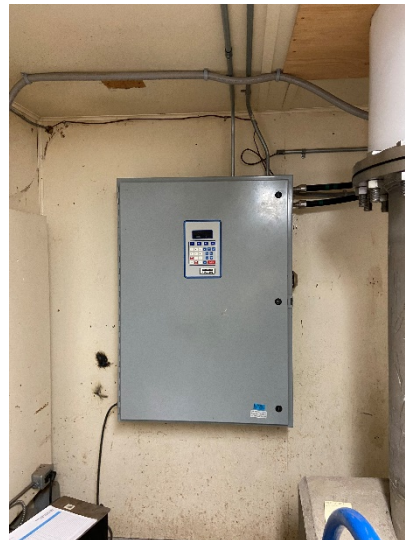
Figure 8: Electrical cabinet

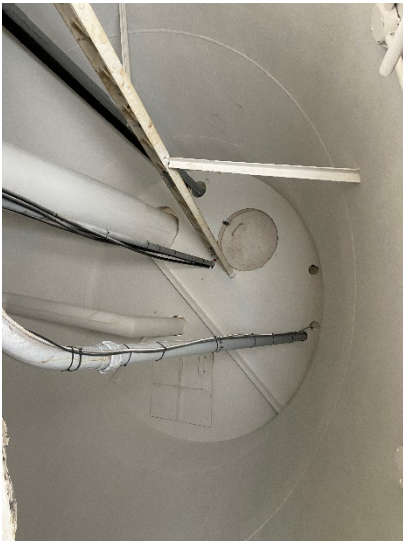
Figure 9: View looking up tower from inside

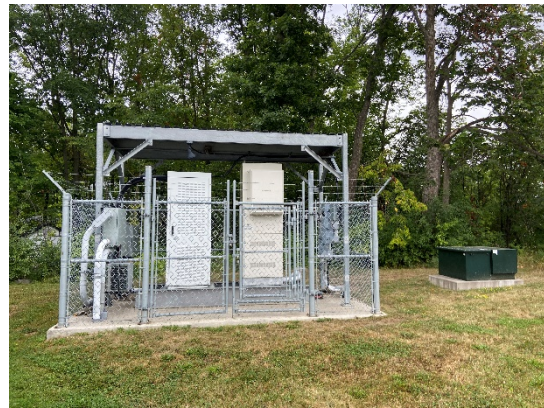
Figure 10: Electrical equipment outside (Freedom Mobile)

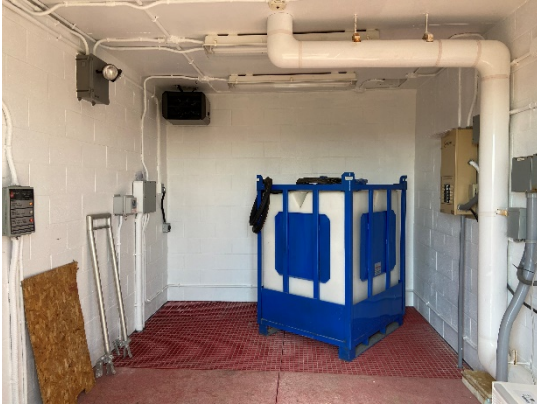
Figure 1: Chlorine tank in bricked building

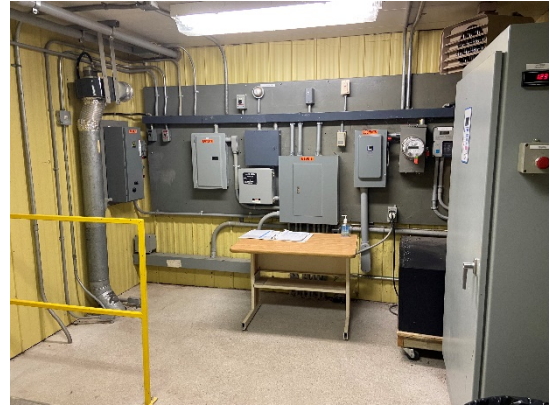
Figure 8: Electrical equipment in white building

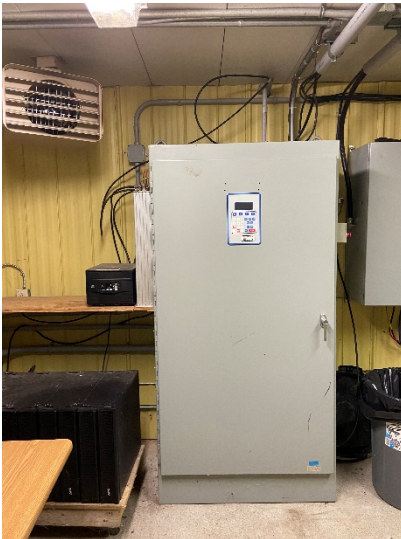
Figure 9: Electrical cabinet

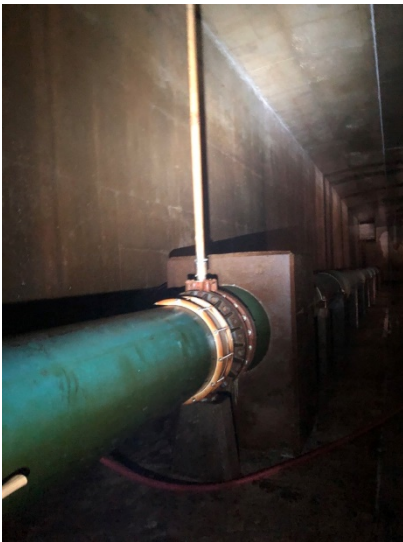
Figure 11: Inline pipe inside reservoir

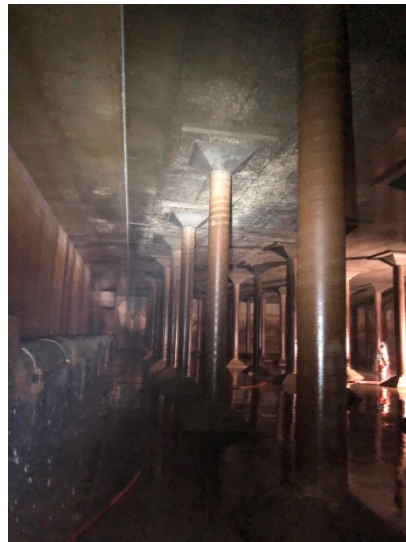
Figure 12: Inside towerhill reservoir

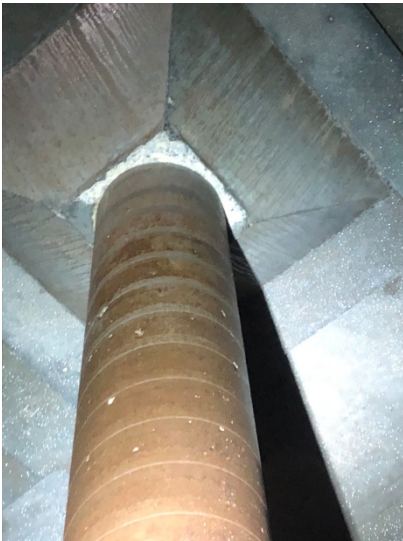
Figure 13: Support pole in reservoir

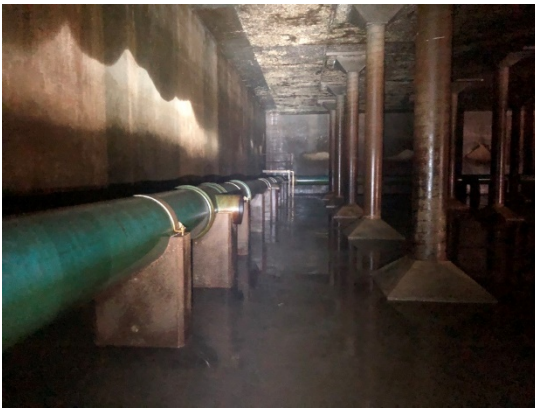
Figure 15: Another view of feed pipe
